**Report: TAB REPORT
Function: Test, Adjust, & Balance
Date: 11/11/2022**

**PROJECT
11-07 CULVERS - SPARTA, WI**

Project: 11-07 CULVERS - SPARTA, WI

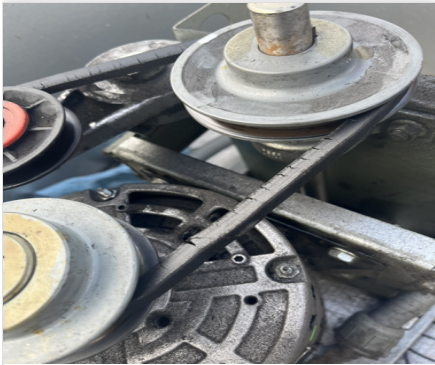
Issue Name : 3. PRV-3 (fryer) needs belt replacement.

Description : Belt is cracked and worn, recommend replacement. Belt size installed is AP23.

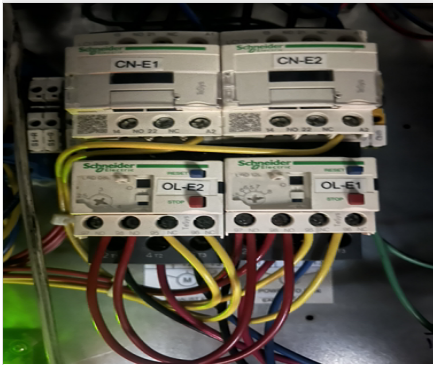
Issue Name : RESOLVED: PRV-2 and PRV-3 wired to incorrect contactors.

Description : PRV-2 is wired to the incorrect contactor with lower amperage rating and causing the fan to trip above 4amps. Motor is rated for 5.9 amps. PRV-3, with lower motor amperage rating, is wired to the higher rated contactor (8amps). Recommend swapping contactors so PRV-2 can be set to design airflow.

- **11/11/2022 National TAB - Michael McDonnell**
 - E.C. swapped contactors and fan was sped to design airflow. No further action necessary.

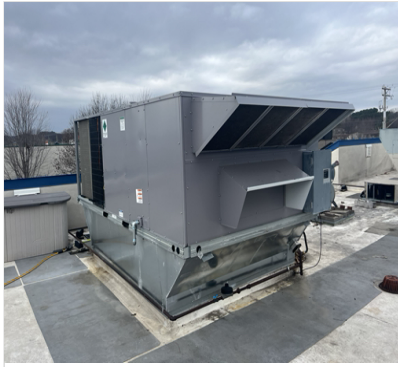
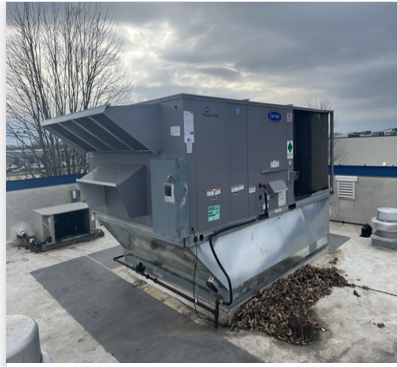
RTU-2 (Kitchen)

General		
	Design	Actual
Fan Rotation Correct	-	YES
Unit Filters Clean	-	VERY DIRTY, NEED REPLACEMENT
Condensate Drain Installed	-	YES

Notes: [1] BACK STORAGE AREA HAD NOTICEABLY DIFFERENT SPACE TEMPERATURE. FULLY CLOSED 2 GRILLES IN STORAGE AREA TO PUSH MORE AIR INTO KITCHEN SPACE WHILE BEING CAREFUL TO NOT DISRUPT HOOD CAPTURE AND MAINTAIN TOTAL UNIT SUPPLY AIRFLOW.
