**Report: TAB REPORT
Function: Test, Adjust, & Balance
Date: 11/11/2022**

**PROJECT
11-07 CULVERS - SPARTA, WI**

Project: 11-07 CULVERS - SPARTA, WI

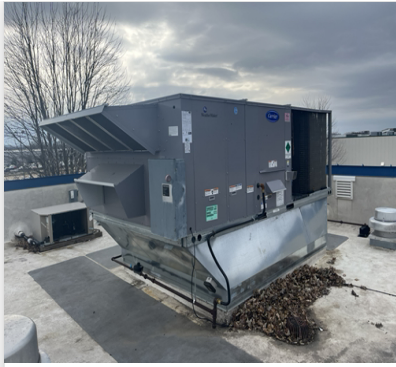
RTU-2 (Kitchen)

General		
	Design	Actual
Fan Rotation Correct	-	YES
Unit Filters Clean	-	VERY DIRTY, NEED REPLACEMENT
Condensate Drain Installed	-	YES

Notes:[1] BACK STORAGE AREA HAD NOTICEABLY DIFFERENT SPACE TEMPERATURE. FULLY CLOSED 2 GRILLES IN STORAGE AREA TO PUSH MORE AIR INTO KITCHEN SPACE WHILE BEING CAREFUL TO NOT DISRUPT HOOD CAPTURE AND MAINTAIN TOTAL UNIT SUPPLY AIRFLOW.
