**Report: TAB REPORT
Function: Test, Adjust, & Balance
Date: 11/11/2022**

**PROJECT
11-07 CULVERS - SPARTA, WI**

Project: 11-07 CULVERS - SPARTA, WI

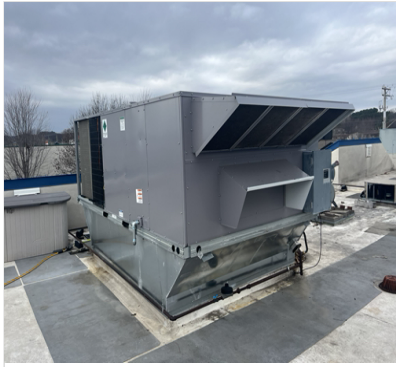
RTU-2 (Kitchen)

General		
	Design	Actual
Fan Rotation Correct	-	YES
Unit Filters Clean	-	VERY DIRTY, NEED REPLACEMENT
Condensate Drain Installed	-	YES

Notes: [1] BACK STORAGE AREA HAD NOTICEABLY DIFFERENT SPACE TEMPERATURE. FULLY CLOSED 2 GRILLES IN STORAGE AREA TO PUSH MORE AIR INTO KITCHEN SPACE WHILE BEING CAREFUL TO NOT DISRUPT HOOD CAPTURE AND MAINTAIN TOTAL UNIT SUPPLY AIRFLOW.
