**Report: TAB REPORT**  
**Function: Test, Adjust, & Balance**  
**Date: 10/06/2023**

## 09-04-23 PENN STATION - BELLEVUE, NE

C&T DESIGN  
4025 PORT UNION RD.  
FAIRFIELD, OH 45014

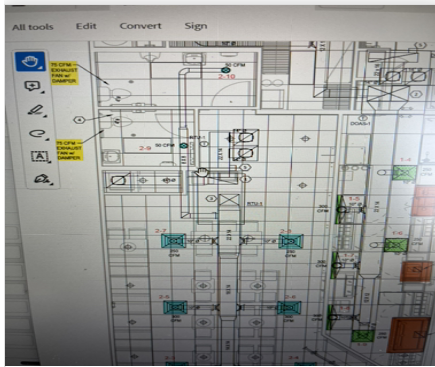
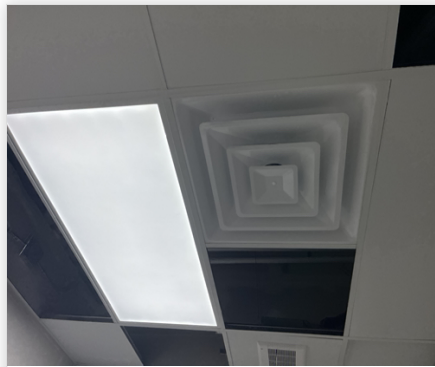
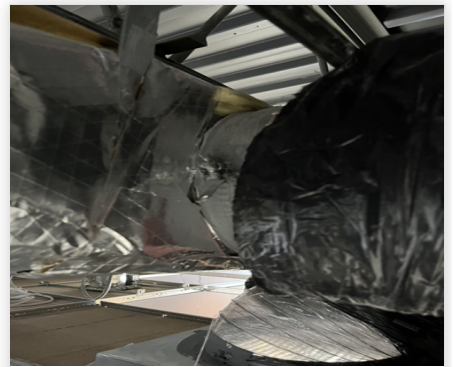
**Issue Name :** DIFFUSER 2-9 plastered shut  
**Description :** Damper on diffuser 2-9 on the GRD is plastered shut and is allowing no airflow through. The damper needs to be free to be locked down at the proper airflow.  
**Created By :** National TAB                      **Assigned To :** National TAB - Jacob Davidson  
**Status :** Open  
**Originated Date :** 09/11/2023 - Jacob Davidson - National TAB

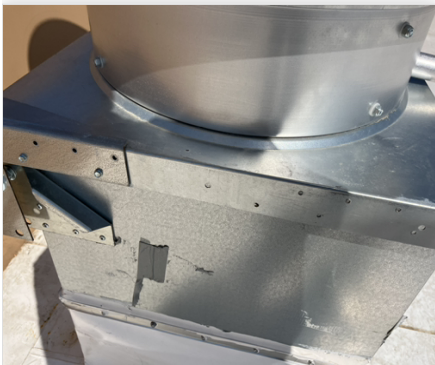
**EF3(1)**  
**09/12/2023**

**Issue Name :** EF1 and EF3 air leakage  
**Description :** On the sides of EF1 and EF3 there is air leakage which will have grease escape onto the roof. Recommend sealing off the sides of these fans.  
**Created By :** National TAB                      **Assigned To :** National TAB - Jacob Davidson  
**Status :** Open  
**Originated Date :** 09/12/2023 - Jacob Davidson - National TAB

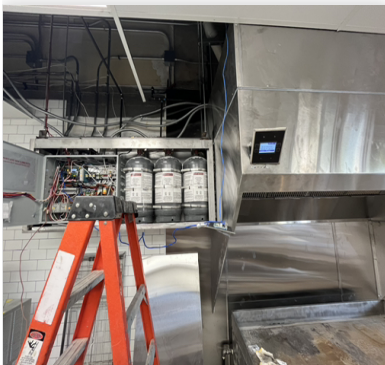
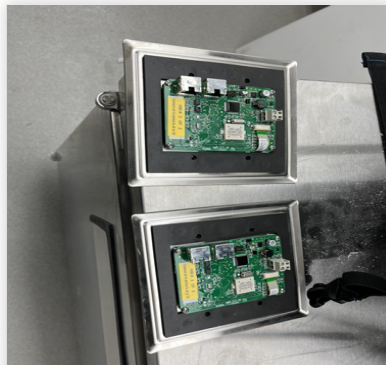
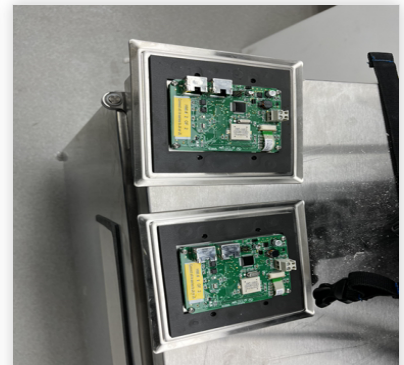
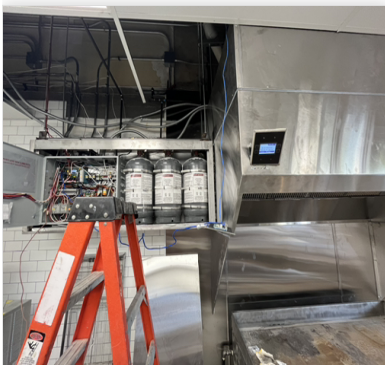
**Issue Name :** EF1-3 fans won't start up when breakers are on.  
**Description :** With the breakers on for the fans, none of the fans or HMIs start up. The fire panel gives a pressure switch fault and there are 2 wires that are not connected to anything in the panel.  
**Created By :** National TAB                      **Assigned To :** National TAB - Jacob Davidson  
**Status :** Open  
**Originated Date :** 09/12/2023 - Jacob Davidson - National TAB

- **09/12/2023 National TAB - Jacob Davidson**
  - Adding pic of temporary solution

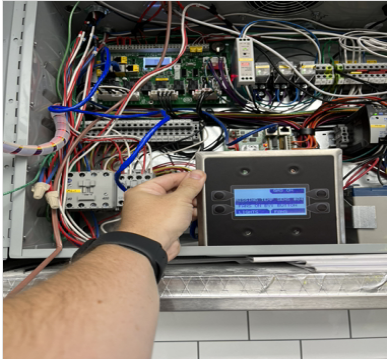
Hmi  
09/12/2023

- After more investigating, we found that the cat 5 from the HMI were not connected to the board. After connecting them in series, the hoods started up. Recommend getting longer cat 5 cables to connect them in series to the J4 or J5 port on the control board for proper operation.

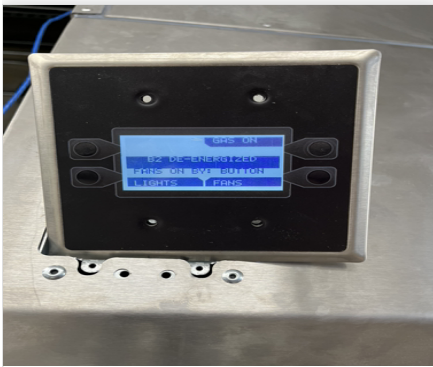
**Hmi2**  
09/12/2023

**Issue Name :** Hood HMI errors  
**Description :** After powering the HMI to the hoods, HMI 1 reads “MISSING TEMP SENSOR #4” and HMI 2 reads “B2 De-Energized”. These error codes need to be investigated but don’t affect airflow values.  
**Created By :** National TAB                      **Assigned To :** National TAB - Jacob Davidson  
**Status :** Open  
**Originated Date :** 09/12/2023 - Jacob Davidson - National TAB

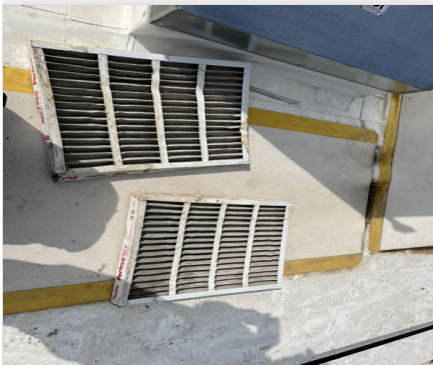
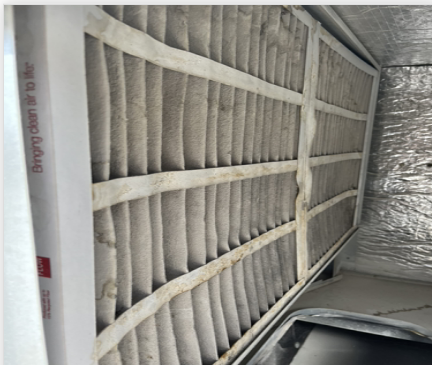
**Issue Name :** RTU2 filters dirty  
**Description :** Filters for RTU2 we're very dirty. Balancing will be done with filters removed. Unit needs 2 20x25x2 filters  
**Created By :** National TAB                      **Assigned To :** National TAB - Jacob Davidson  
**Status :** Open  
**Originated Date :** 09/11/2023 - Jacob Davidson - National TAB
