**Report: ISSUES**

**Function: Test, Adjust, & Balance**

## 09-04-23 PENN STATION - BELLEVUE, NE

Project: 09-04-23 PENN STATION - BELLEVUE, NE

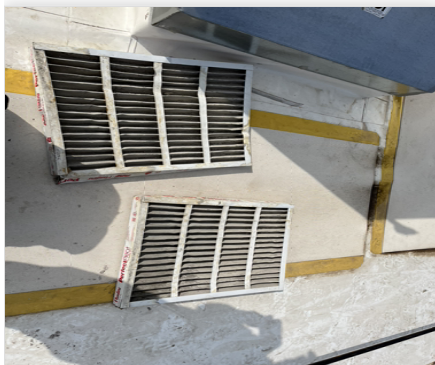
**Filters**  
09/11/2023

**Issue Name :** RTU2 filters dirty  
**Description :** Filters for RTU2 we're very dirty. Balancing will be done with filters removed. Unit needs 2 20x25x2 filters  
**Created By :** National TAB                      **Assigned To :** National TAB - Jacob Davidson  
**Status :** Open  
**Originated Date :** 09/11/2023 - Jacob Davidson - National TAB
