PlanGrid Task Report - Jun 21, 2024

Prepared by Stephen Tassinaro

18 tasks in this report.

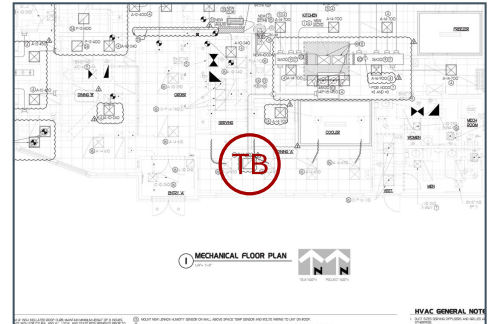
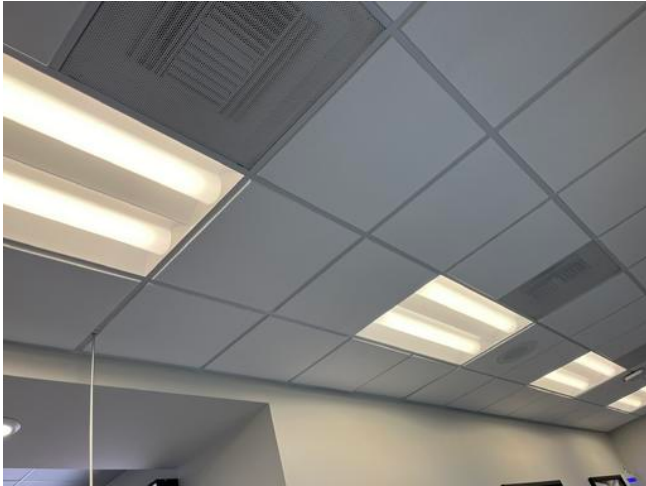
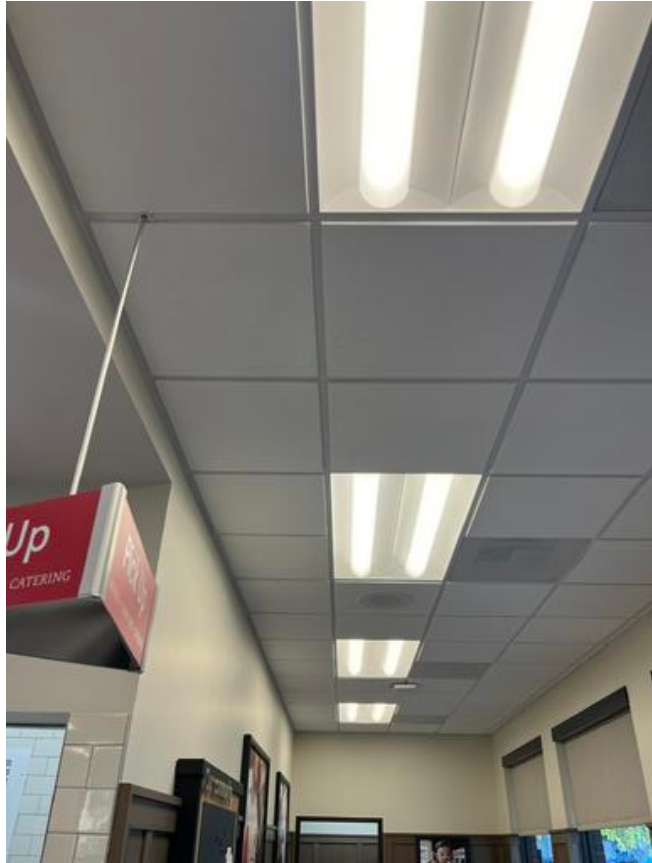
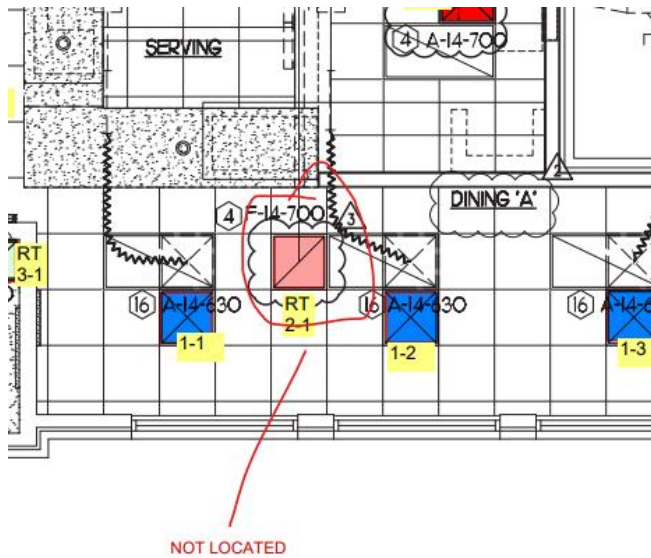
#429 Return Grille 2-1 Not Located

Description
Return Grille 2-1 could not be located in the space. Per M1.1 it should be located adjacent to diffusers 1-1 and 1-2 (side dining area).
*Reference NTi GRD Layout.

No change

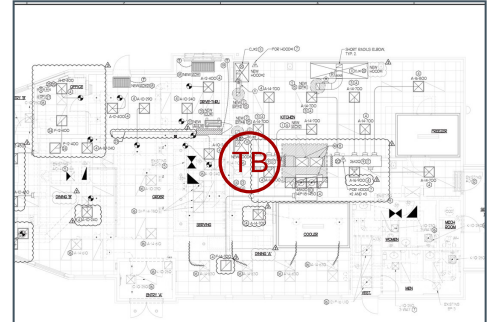
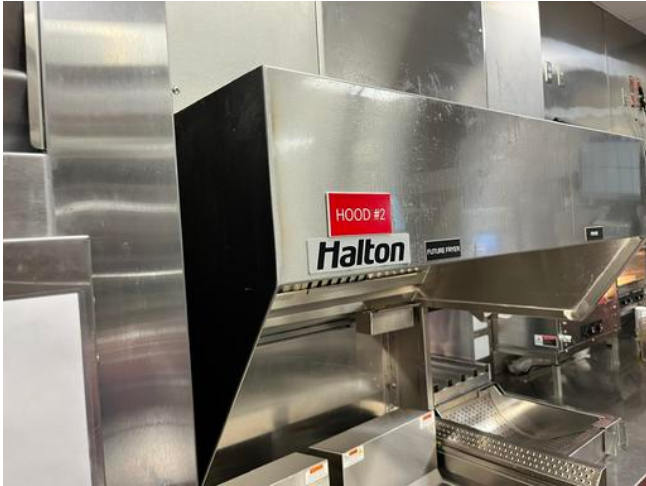
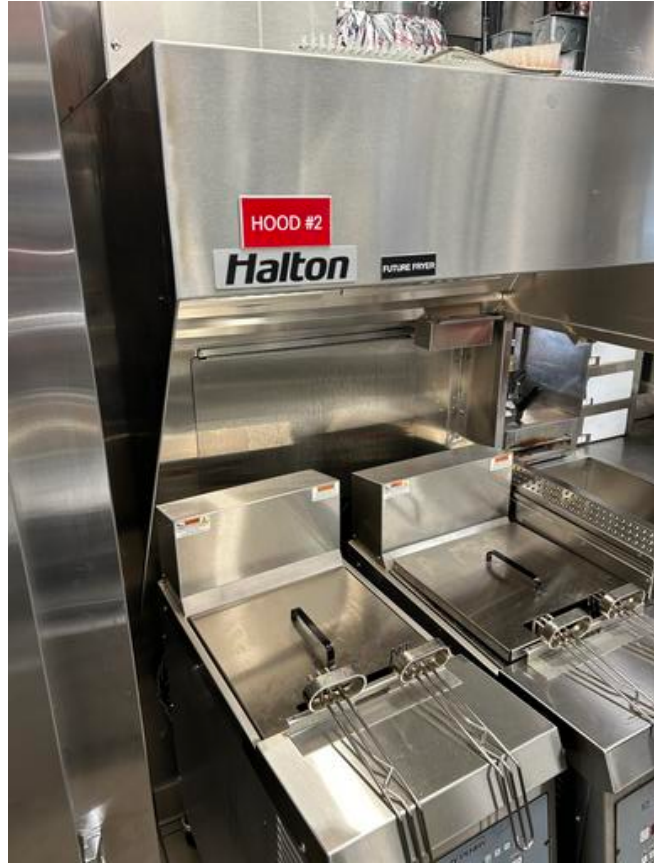
#426 [HOOD 999] [NEW] (MISC) Hood 3 Labeled Incorrectly

Hood 3 is currently labeled Hood 2. Recommend a corrected label be installed

No change

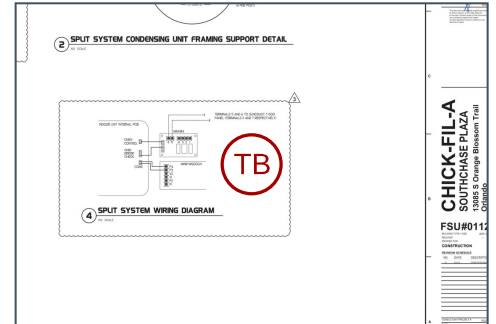
#425 [CNTL 999] [NEW] (MISC) Mini Split Wiring

Description
Mini split control wires not landed in suncoast panel.

No wires landed 6/19

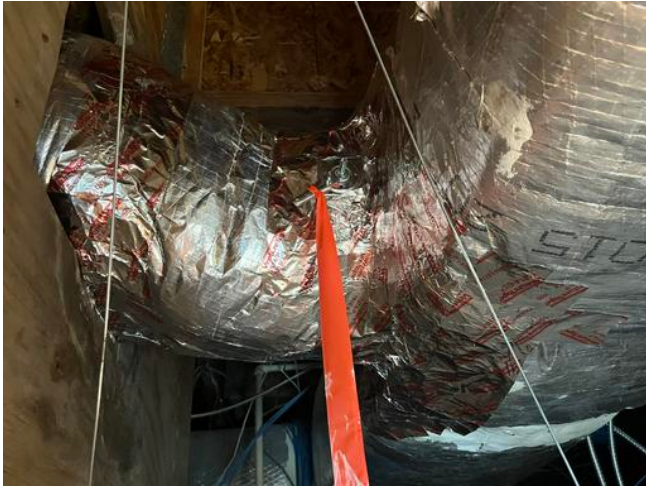
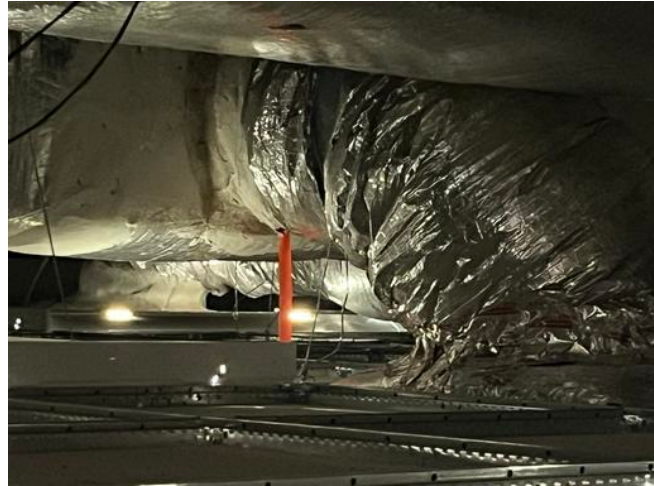
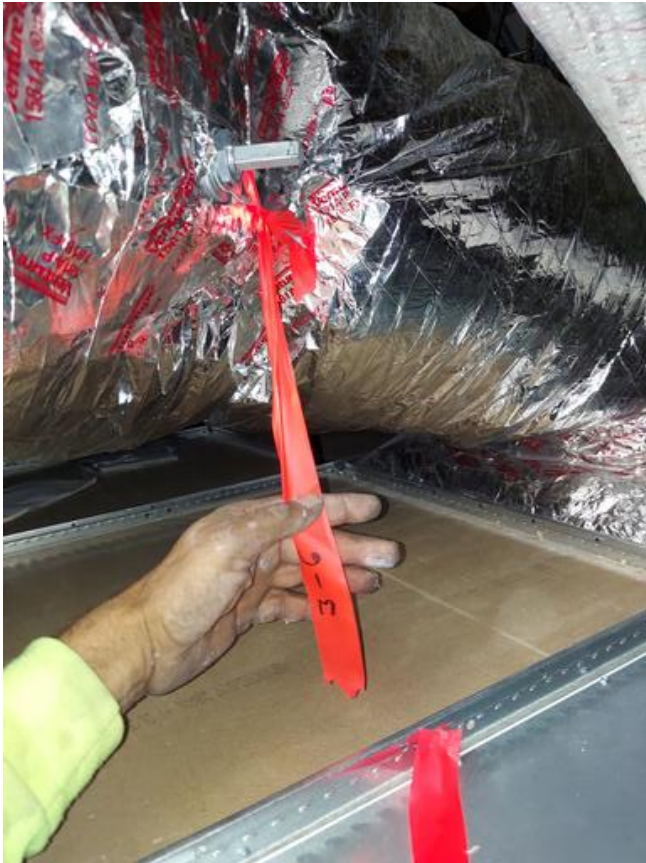
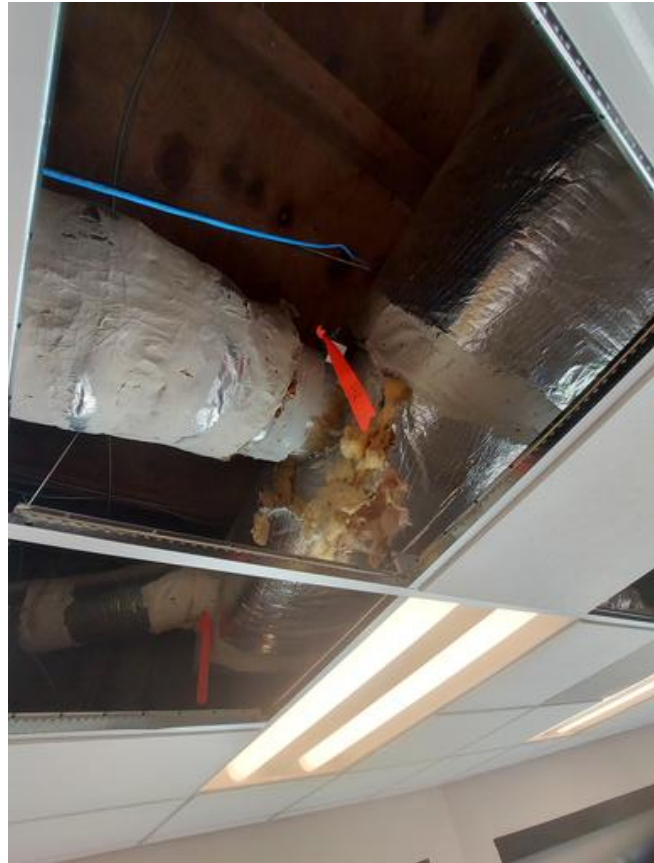
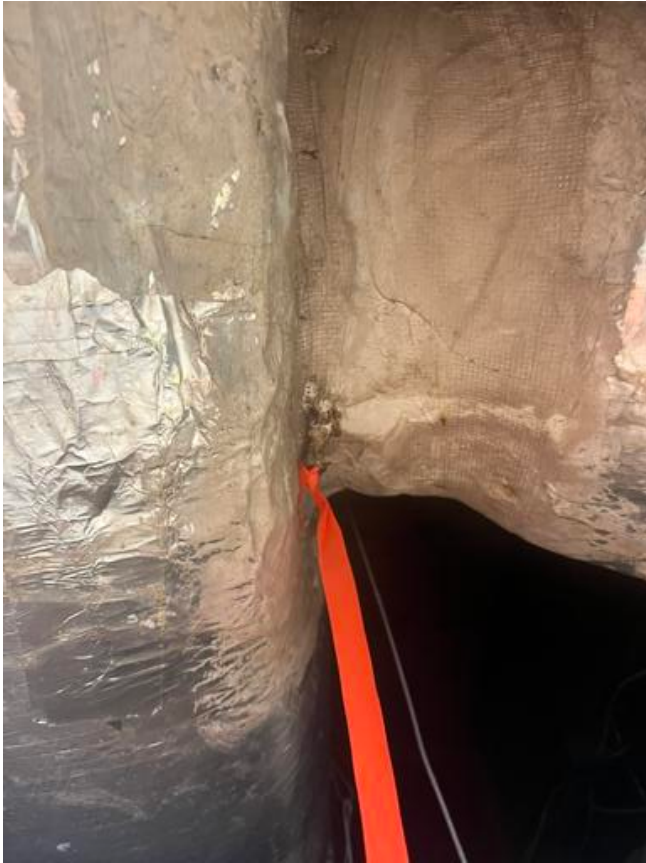
#423 [DUCT 008] [EXIST] CRITICAL – Start collar damper orientation.

Dampers to be installed parallel to airflow. In horizontal runs, position damper on left or right at 9 or 3 o'clock. On vertical ducts position damper on bottom only (6 o'clock). All existing dampers mounted in 6 o'clock positions, balanced as-is.

All units balanced successfully

Any existing dampers that needed to be replaced due to functional issues have been replaced with the correct dampers in the correct orientations. Any existing dampers that were functional have been left as-is.

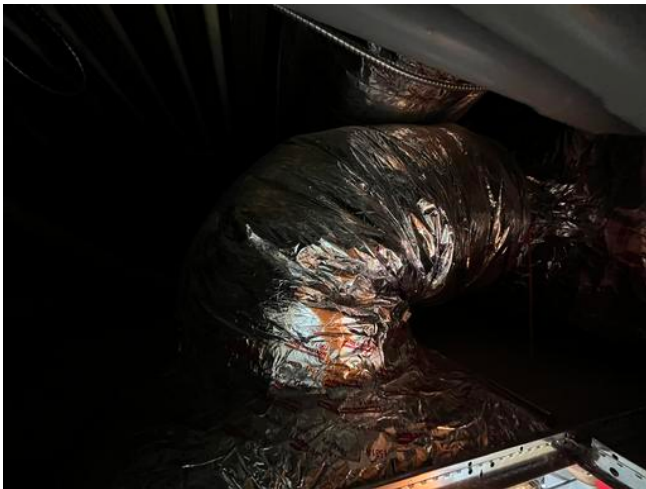
#419 [DUCT 007] [NEW] CRITICAL – Diffuser rigid 90's.

Ensure rigid 90 degree fittings are secured to diffusers, with hard pipe risers adjusted to meet take off height elevation and connected to horizontal flex. No flex in drops allowed per details. Diffuser 2-2 no rigid 90 installed.

Not possible per plan design, grill too close to main duct 5.21

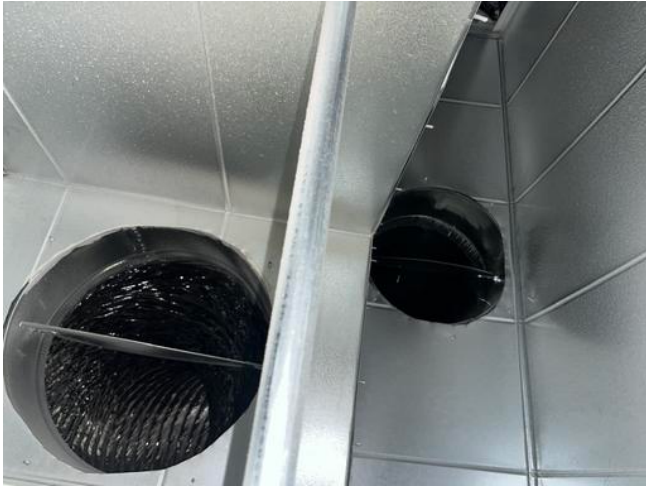
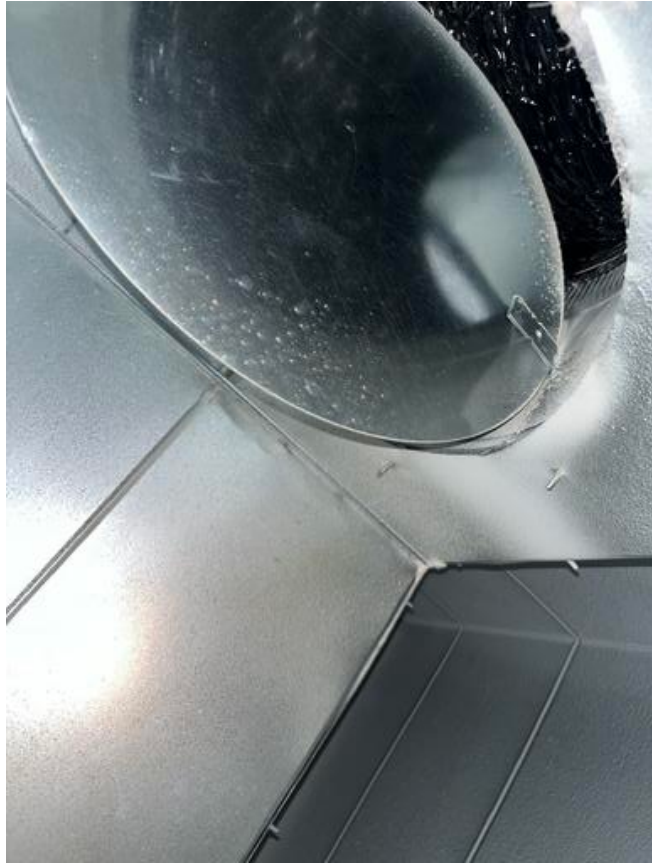
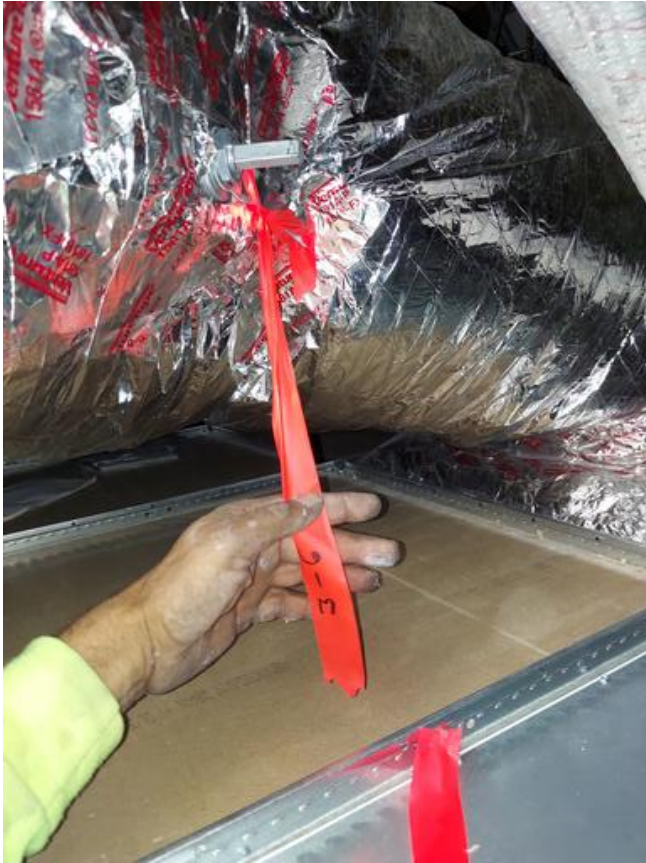
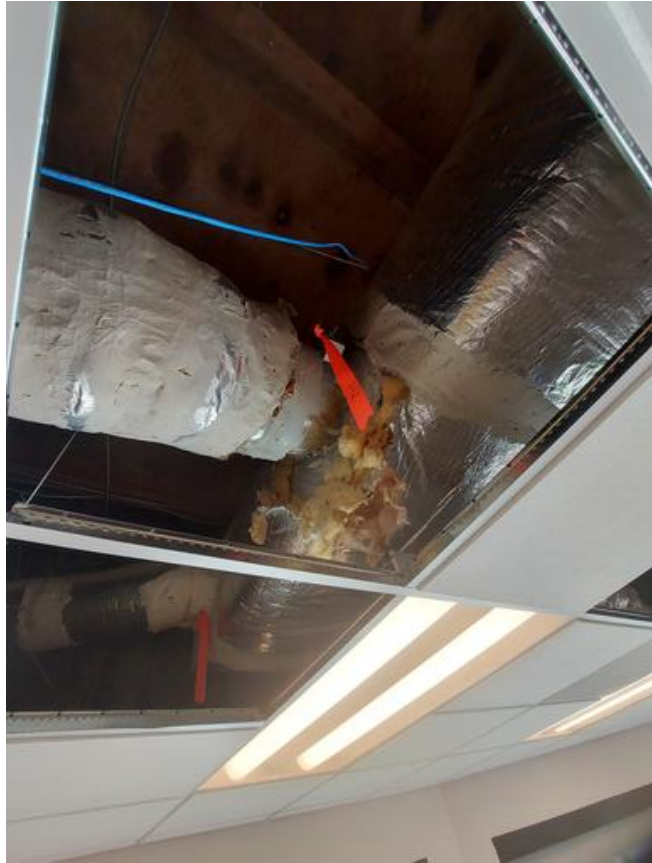
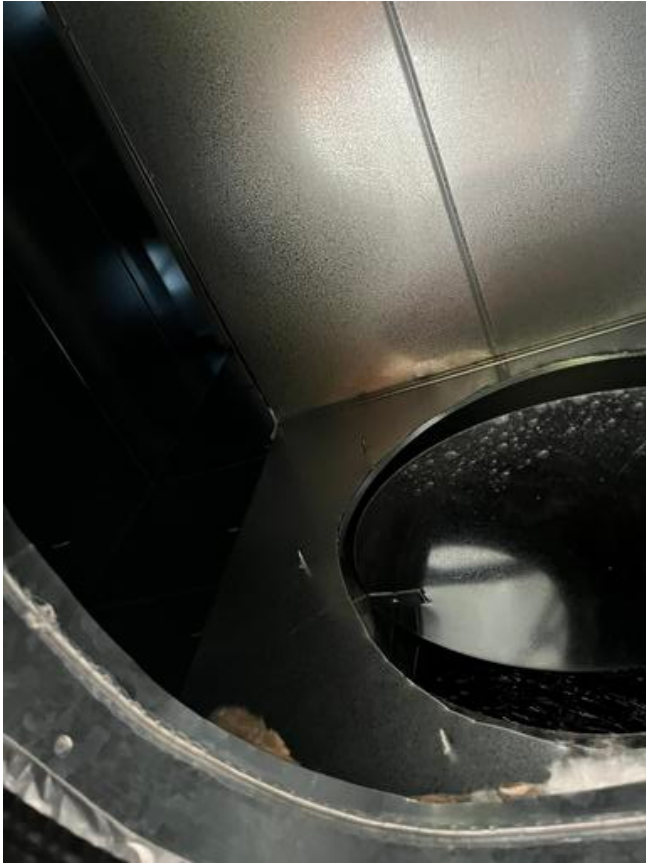
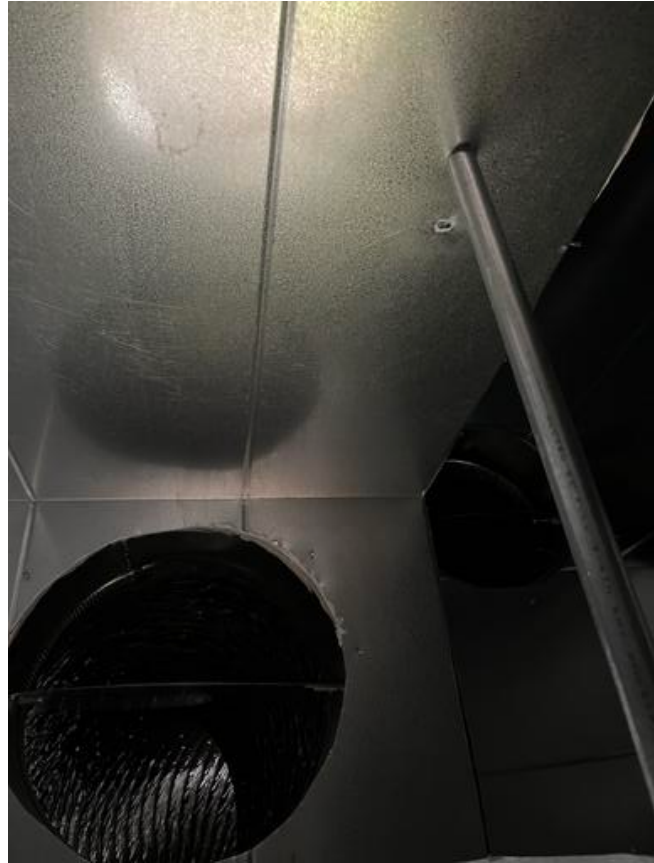
#418 [DUCT 008] [NEW] CRITICAL – Start collar damper orientation.

Dampers to be installed parallel to airflow. In horizontal runs, position damper on left or right at 9 or 3 o'clock. On vertical ducts position damper on bottom only (6 o'clock). RTU 2 return dampers incorrect orientation.

No change to return damper orientation on RTU 2

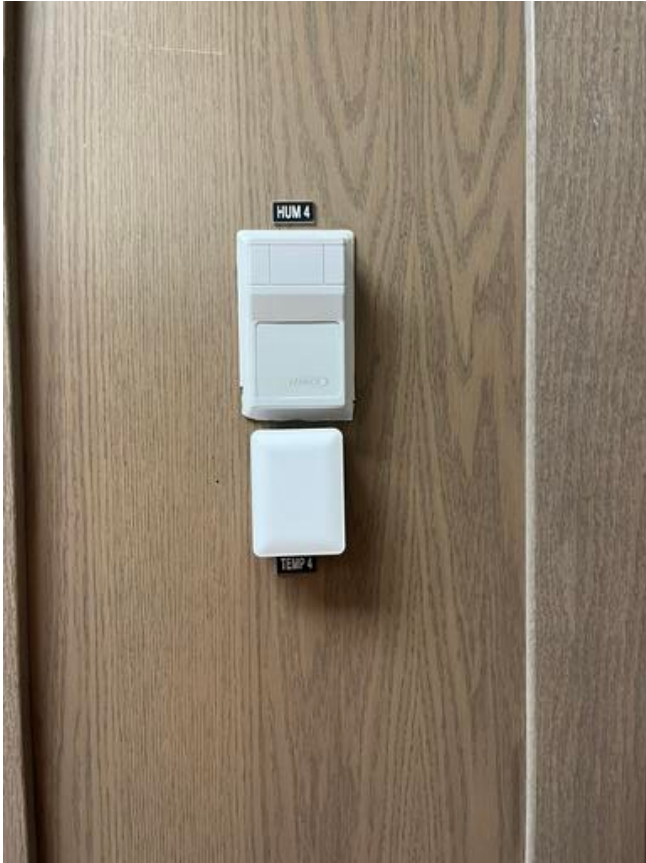
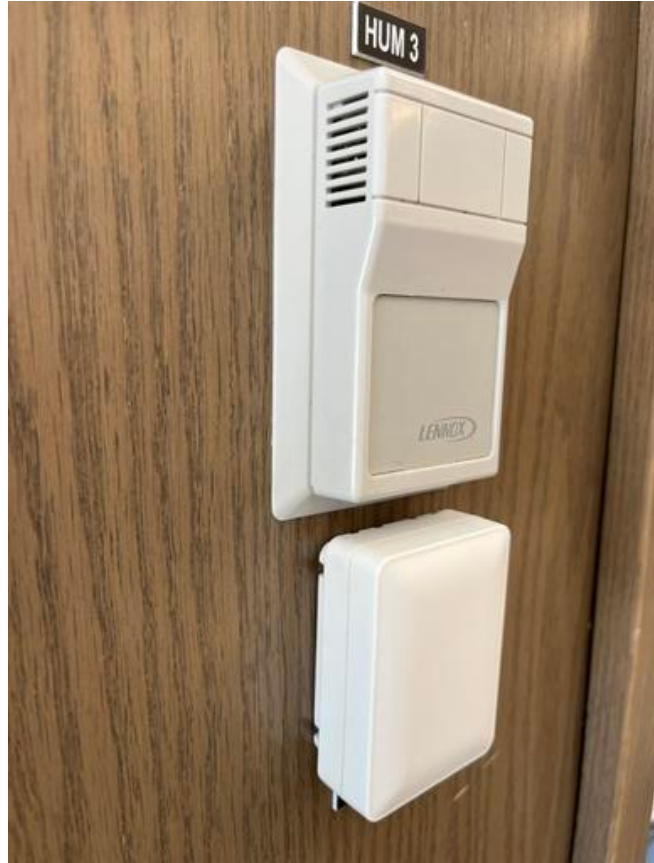
#413 [CNTL 501] [NEW] Humidistat cover.

Humidistat cover is not secured in place by backing out screws (Lennox) or tightening screw (Trane).

All covers are still loose. NTi unable to correct as the humidity sensors are installed very close to the temperature sensors.

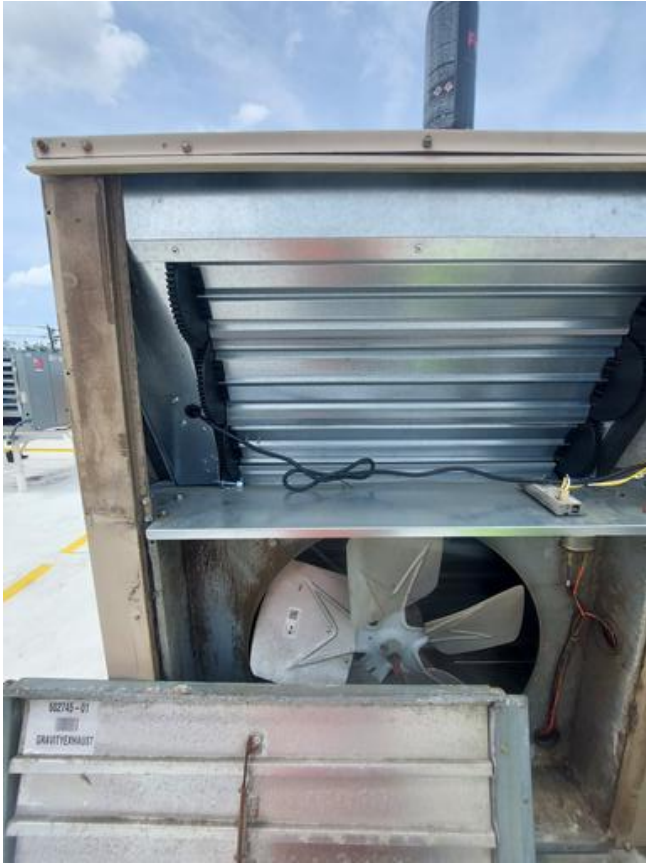
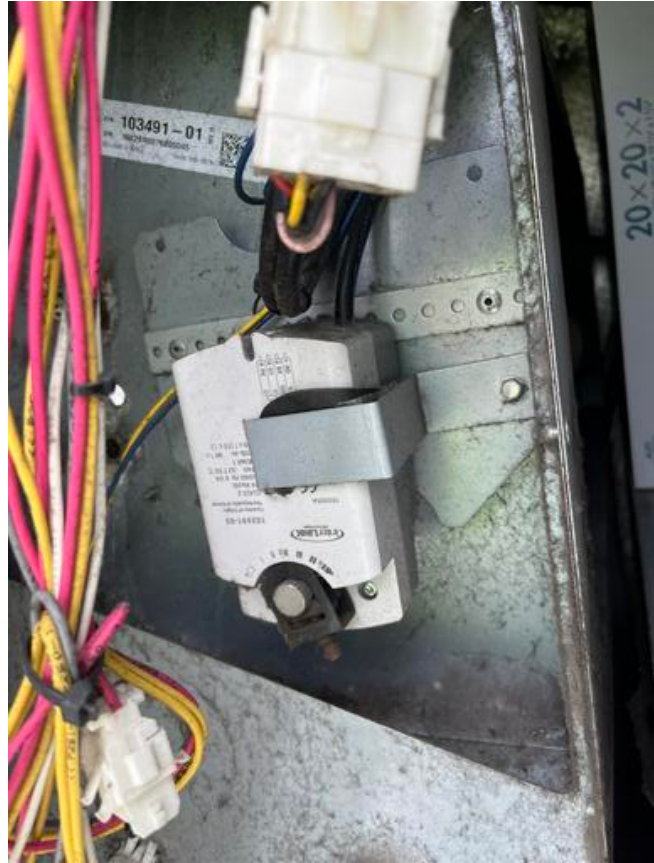
#407 [UNIT 000] [EXIST] CRITICAL – Economizer not operational.

Economizer binding or not responding to setpoint commands properly. Unable to balance outside air at time of TAB inspection. RTU 1 economizer is not responsive. NTi commanded damper to 0-100% and saw no movement.

complete.

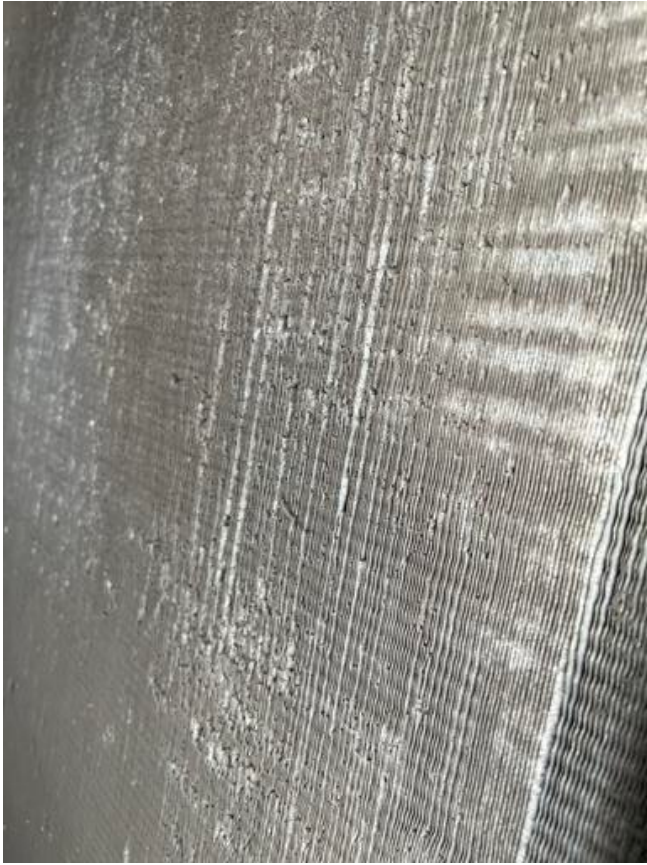
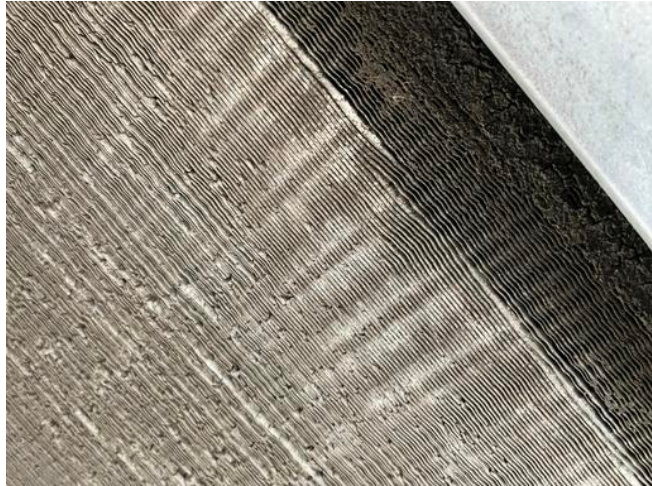
#397 [REFG 999] [EXIST] RTU 3 Condenser Coil Compacted With Debris

RTU 3 condenser coil is dirty and compacted. Cleaning recommended.

Evaporator coil confirmed to be cleaned. Condenser coil does not appear to have been cleaned.
