PlanGrid Task Report - Sep 9, 2024

Prepared by Stephen Tassinaro

Sep 9, 2024

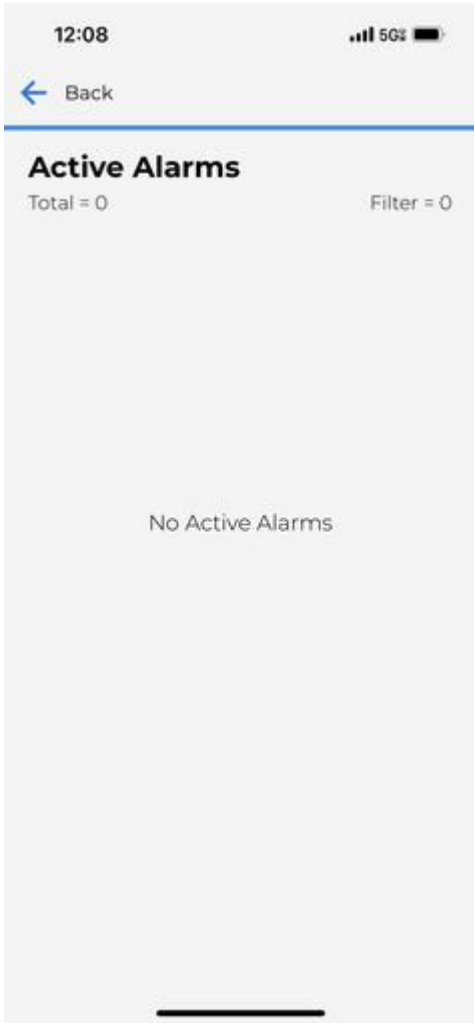
The following alarms were found on the RTUs:
RTU 3 - Alarm 147 & 137

No active alarms on RTU's 1,3,4

RTU #3 alarming 137 & 147. Economizer functioning correctly and at NTi setpoint.

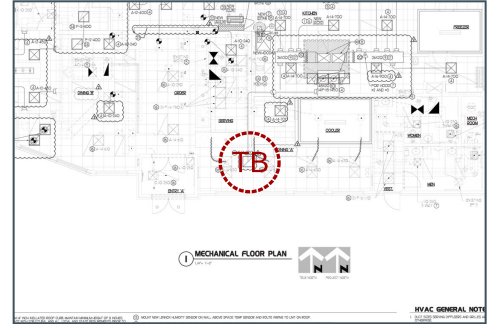
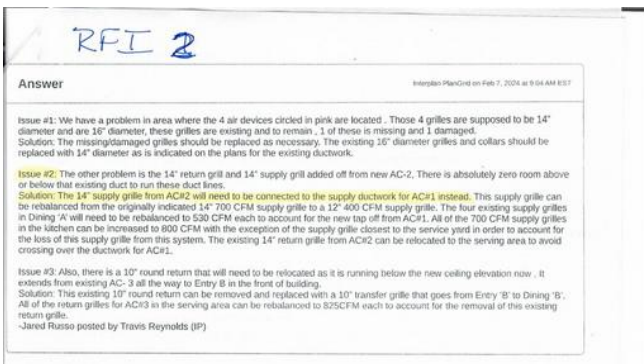
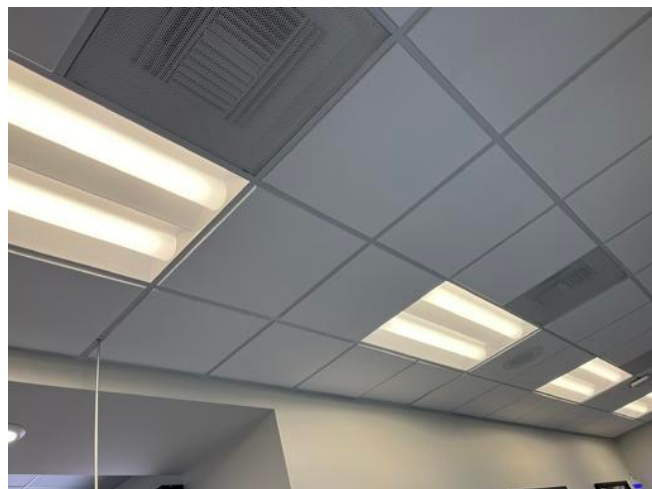
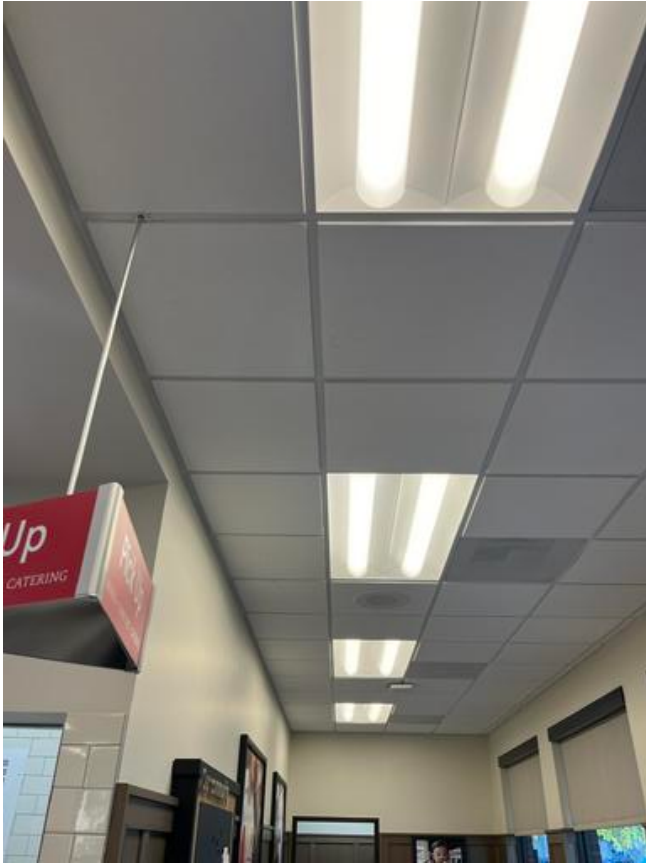
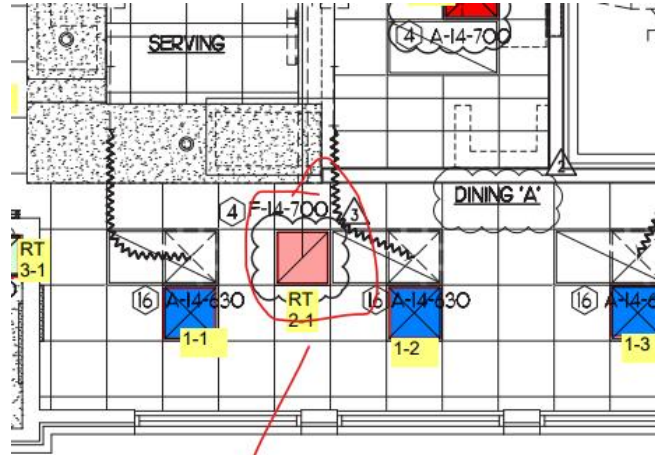
NOT LOCATED

Description
Return Grille 2-1 could not be located in the space. Per M1.1 it should be located adjacent to diffusers 1-1 and 1-2 (side dining area).
*Reference NTi GRD Layout.

NTi diffuser balance satisfies RFI #2 as-is. No changes required.

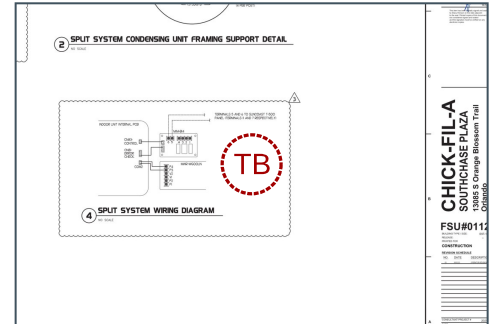
Description
Mini split control wires not landed in suncoast panel.

No wires landed 6/19

No wires landed 9/9

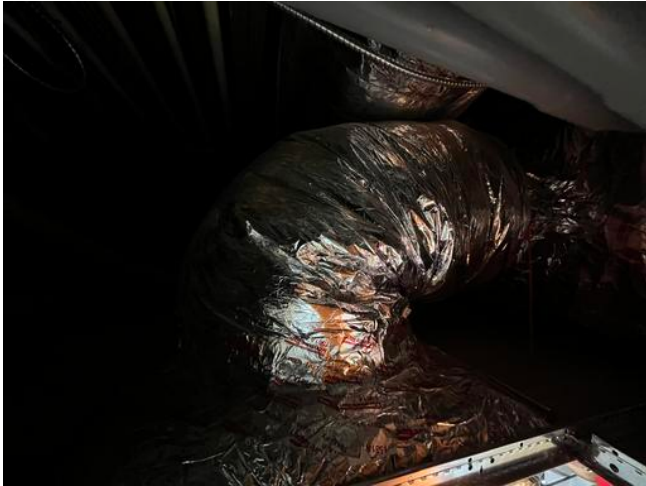
Ensure rigid 90 degree fittings are secured to diffusers, with hard pipe risers adjusted to meet take off height elevation and connected to horizontal flex. No flex in drops allowed per details. Diffuser 2-2 no rigid 90 installed.

Not possible per plan design, grill too close to main duct 5.21

Airflow within design as-is. No changes required to meet airflow requirements.

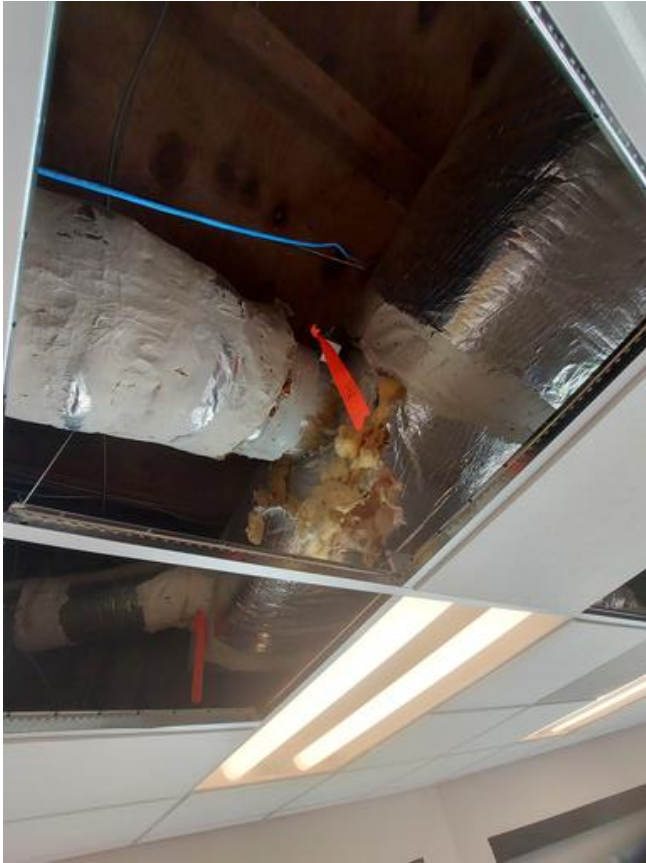
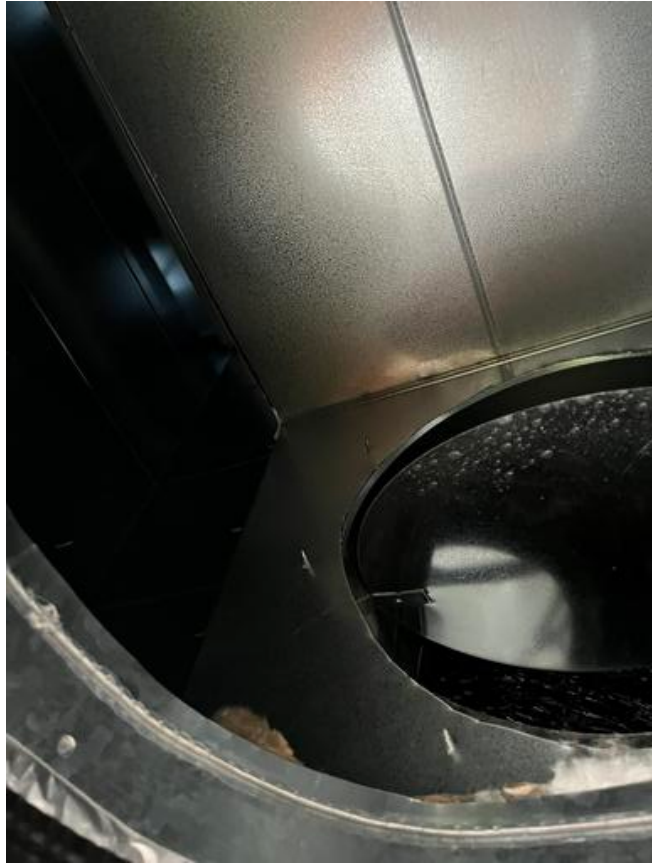
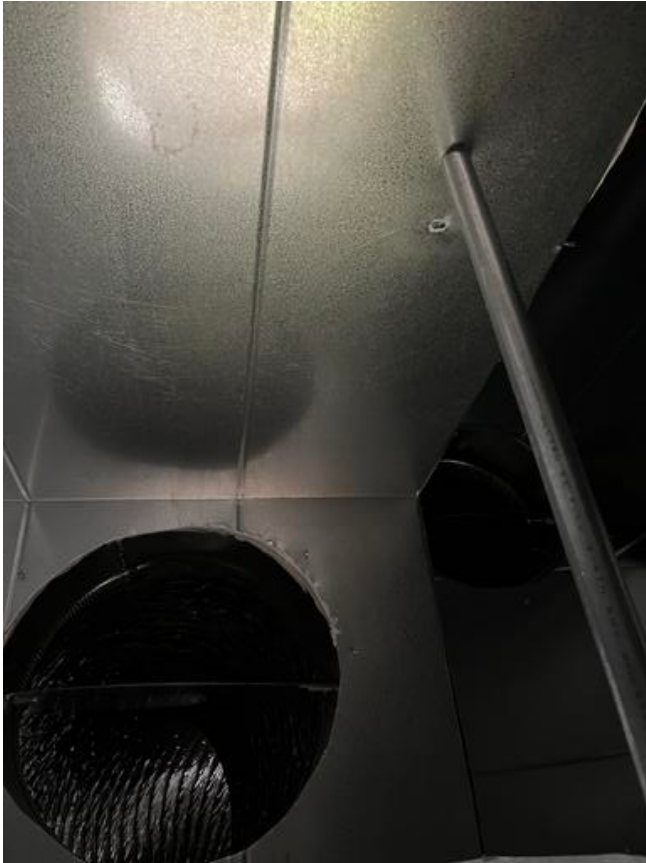
Dampers to be installed parallel to airflow. In horizontal runs, position damper on left or right at 9 or 3 o'clock. On vertical ducts position damper on bottom only (6 o'clock). RTU 2 return dampers incorrect orientation.

No change to return damper orientation on RTU 2

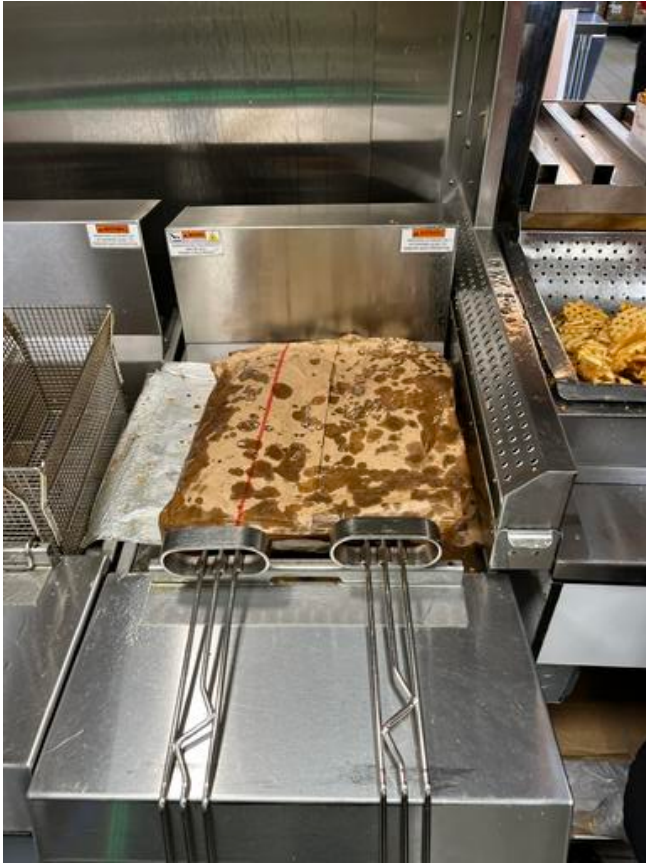
Hood is missing its grease cup and / or fry chute.

Hood 3 missing fry chute. All other fry chutes and grease cups installed.

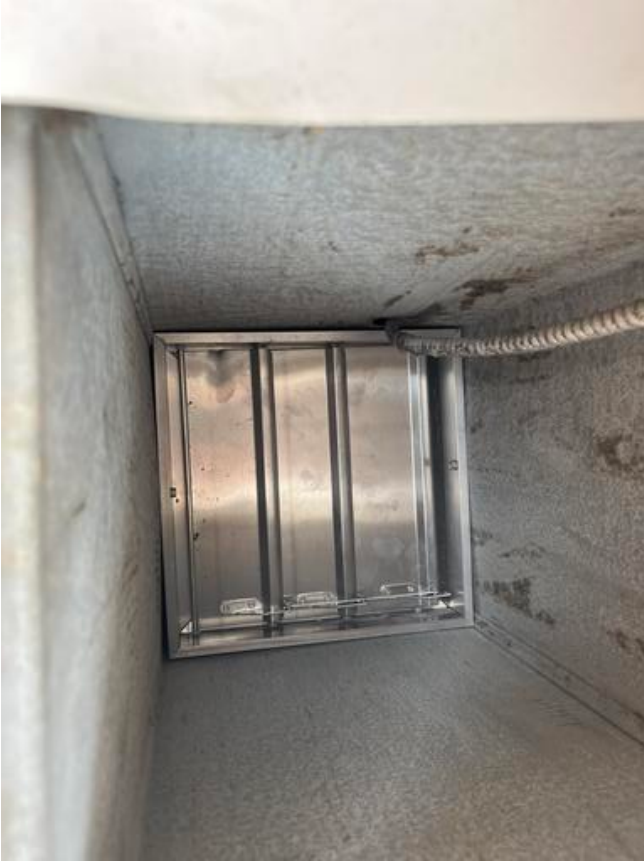
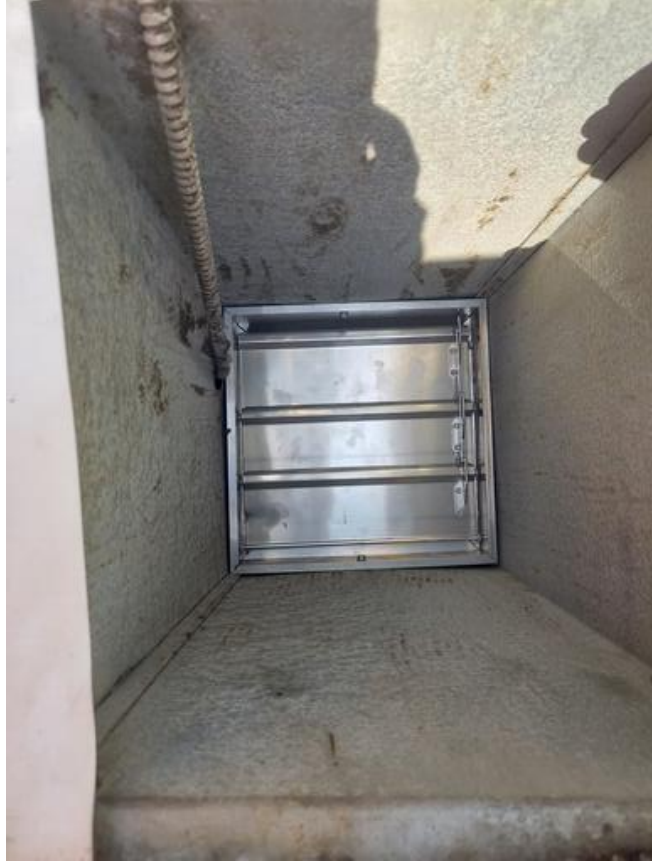
Restroom exhaust rectangular duct riser not correctly lined per specification.

Not complete. However this is an existing duct.

cannot line the duct due to existing and ceiling would need to be removed.

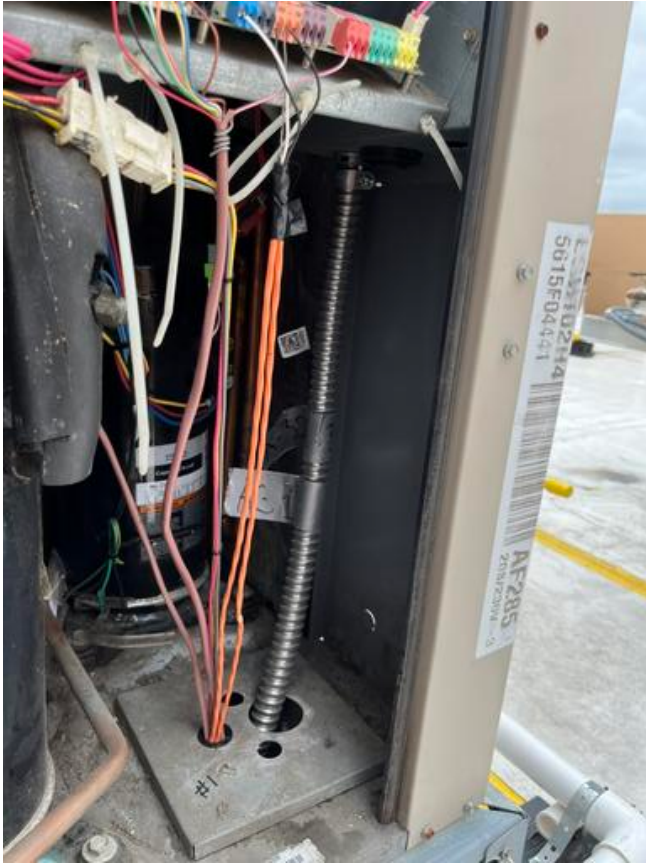
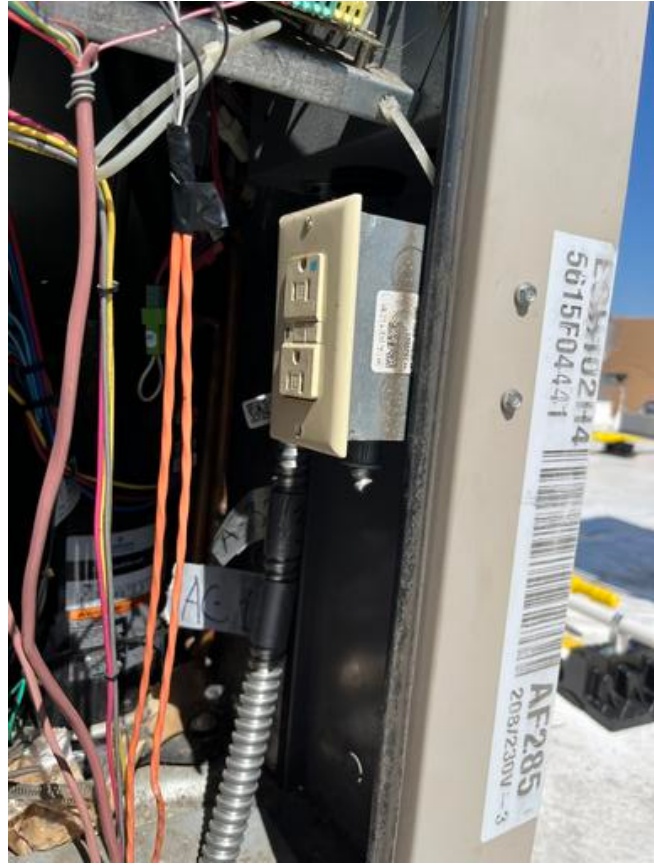
Equipment GFI outlet missing components (GFI itself, din rail with fuses) or not terminated/operational.
RTU 1

GFCI outlet removed from unit.

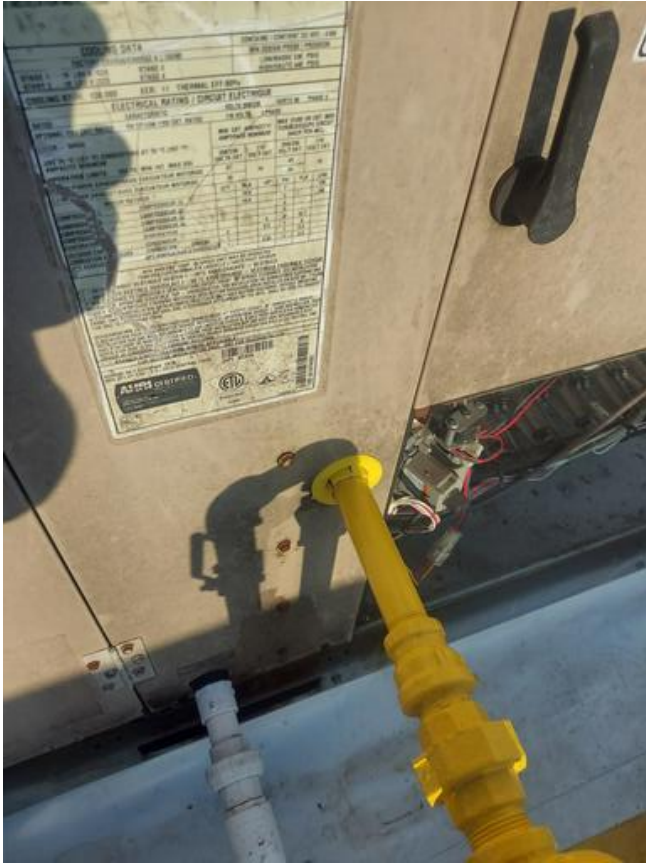
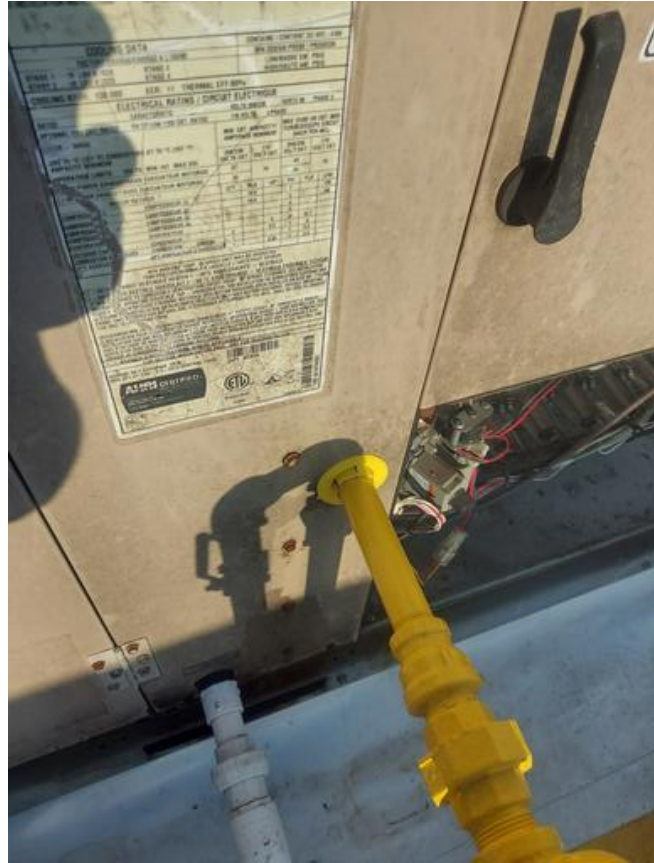
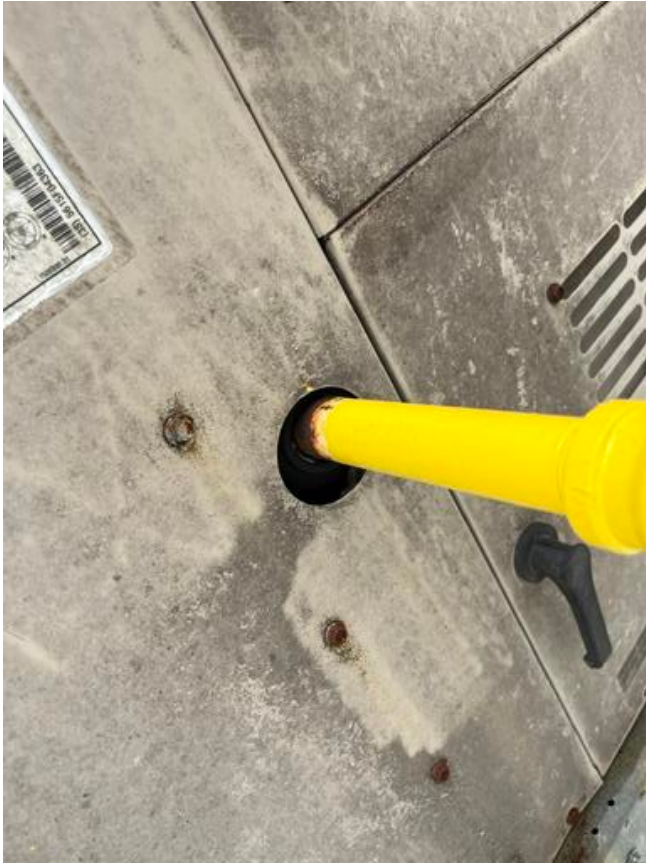
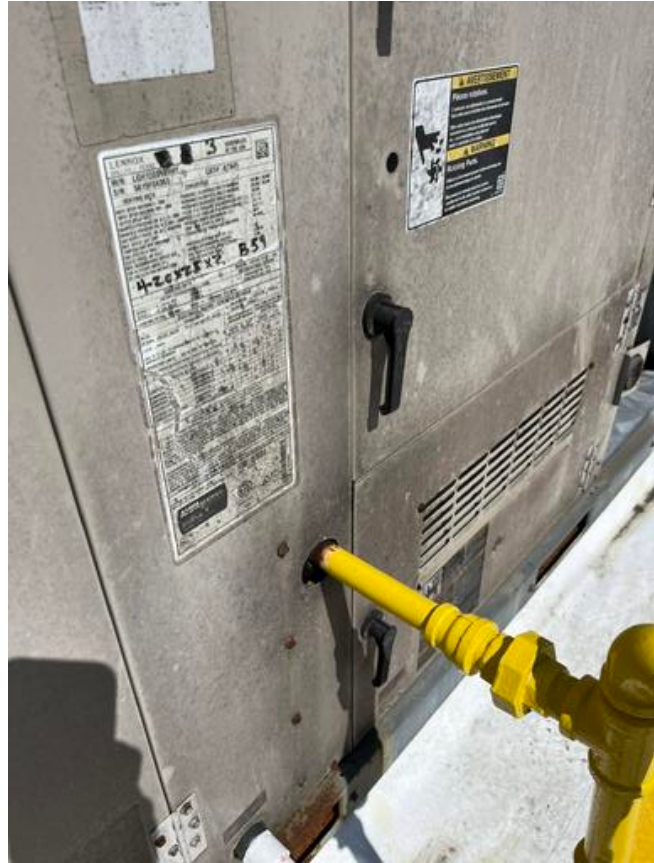
AC gas inlet grommet is missing at the gas line/RTU penetration point. RTU 3

Noticed grommet is on the gas line, but is inside of the RTU. Recommend moving to penetration of RTU.
