# PlanGrid Task Report - Sep 9, 2024

Prepared by Stephen Tassinaro

Sep 9, 2024

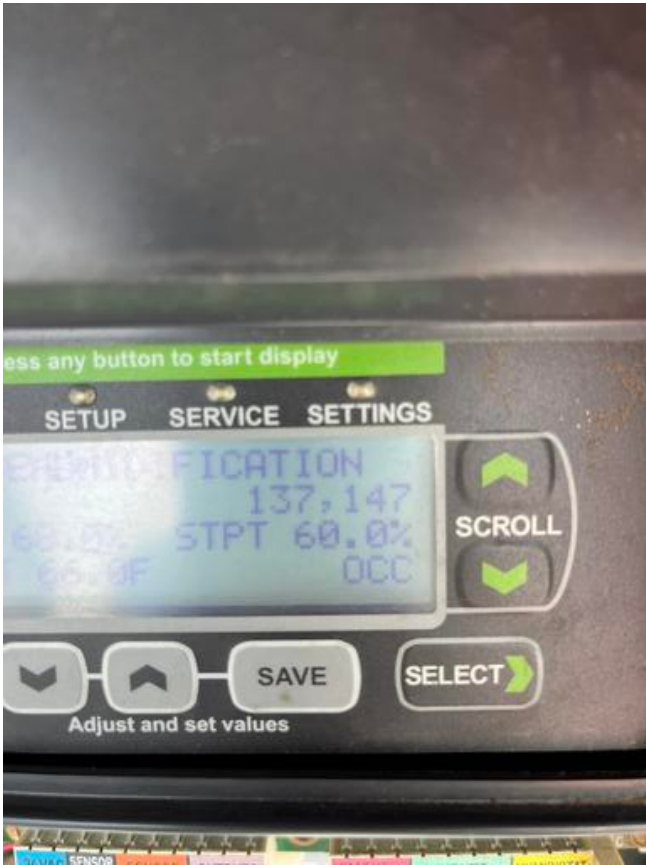
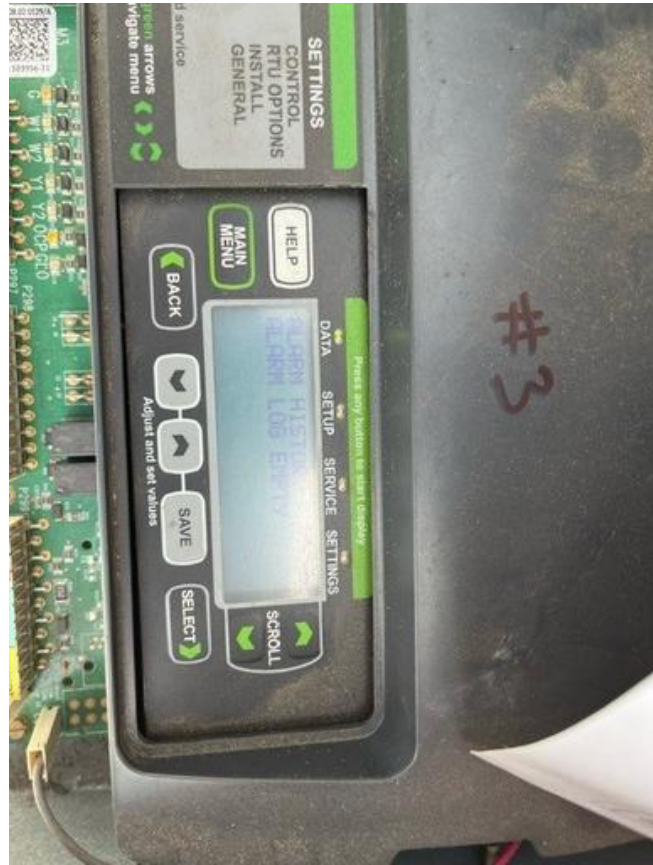
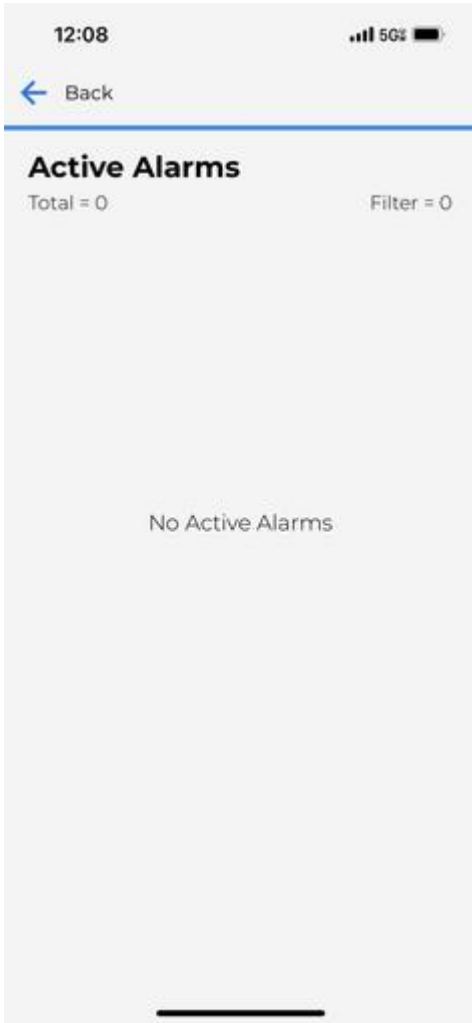
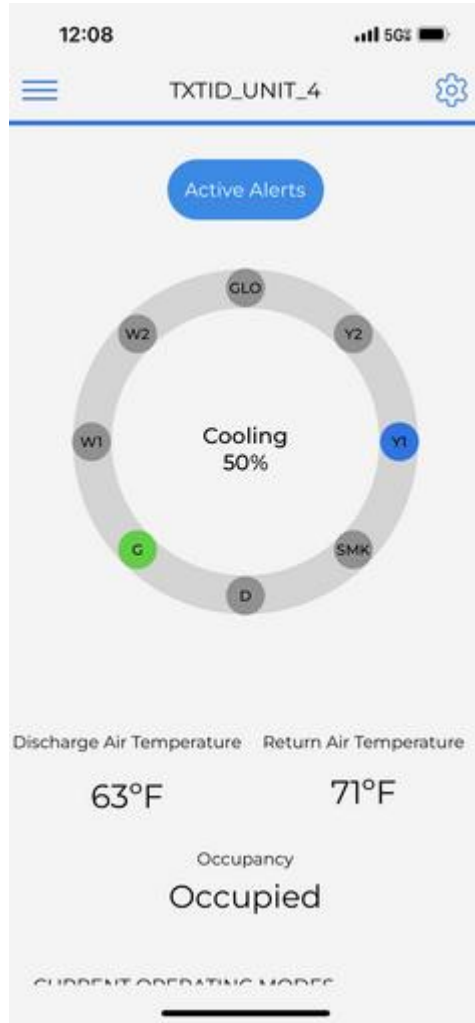
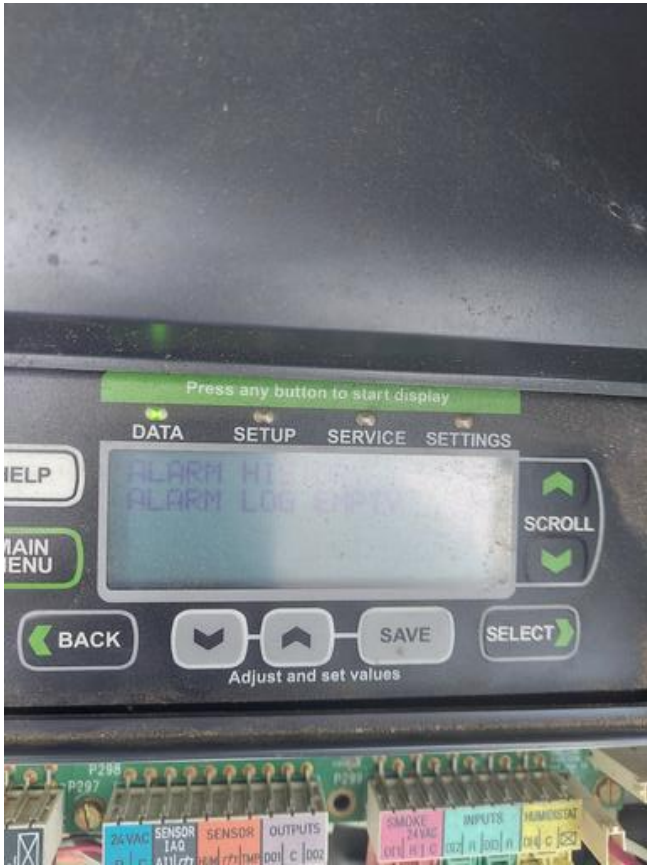
The following alarms were found on the RTUs:  
RTU 3 - Alarm 147 & 137

No active alarms on RTU's 1,3,4

RTU #3 alarming 137 & 147. Economizer functioning correctly and at NTi setpoint.

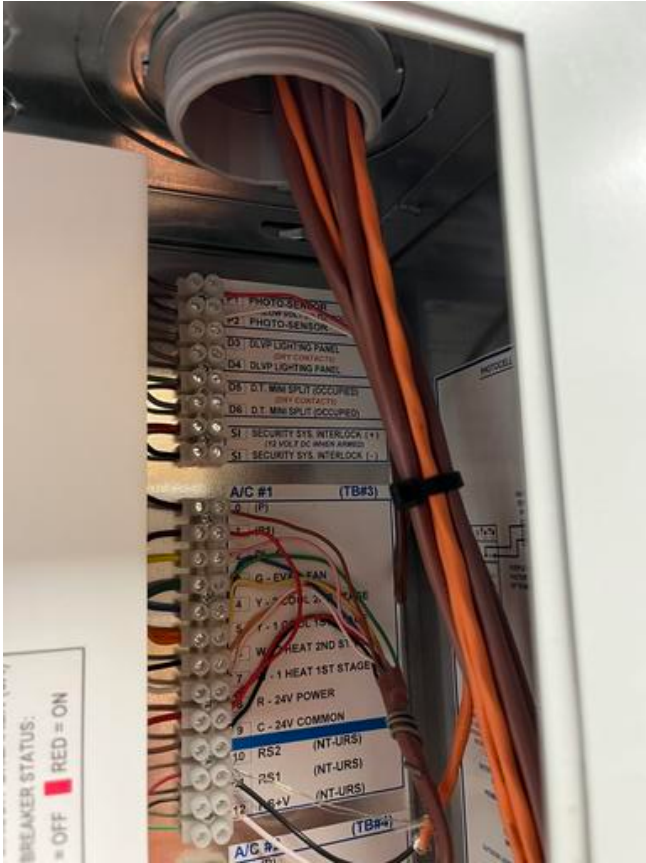
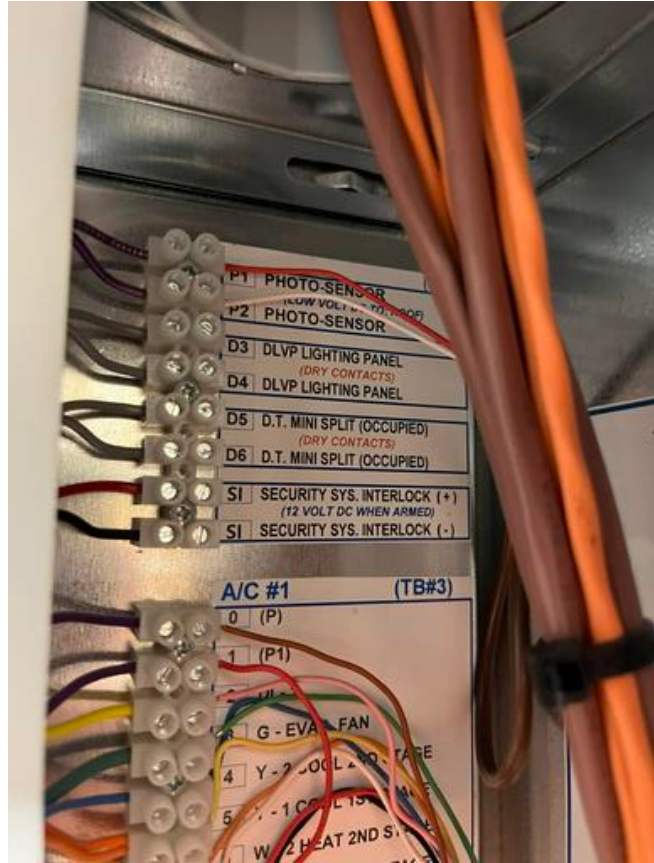
**Description**  
Mini split control wires not landed in suncoast panel.

No wires landed 6/19

No wires landed 9/9

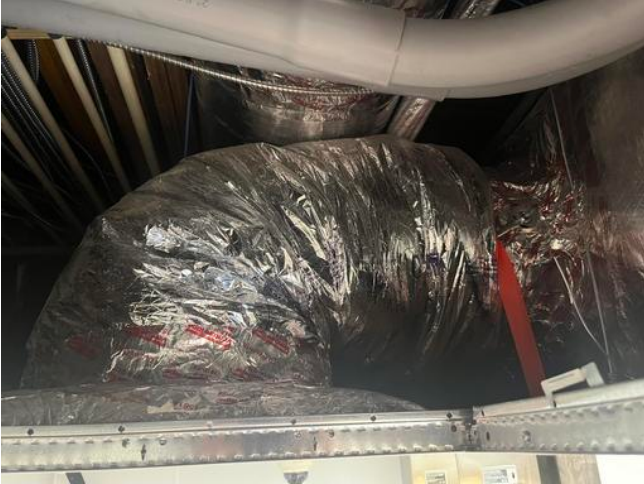
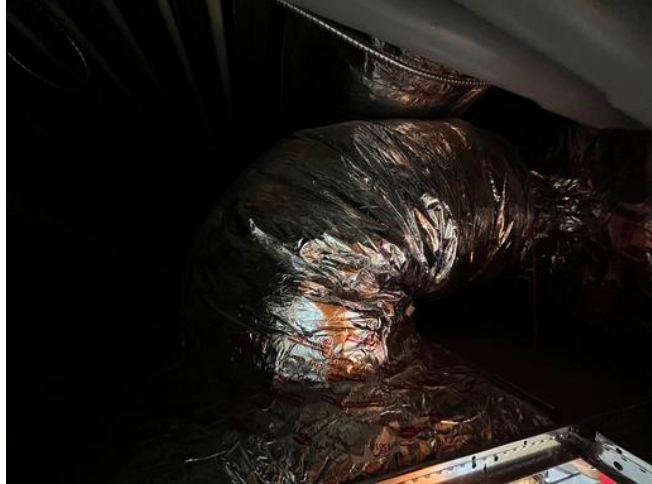
Ensure rigid 90 degree fittings are secured to diffusers, with hard pipe risers adjusted to meet take off height elevation and connected to horizontal flex. No flex in drops allowed per details. Diffuser 2-2 no rigid 90 installed.

Not possible per plan design, grill too close to main duct 5.21

Airflow within design as-is. No changes required to meet airflow requirements.

Recommend seeking EOR approval if rigid 90 fitting cannot be installed.

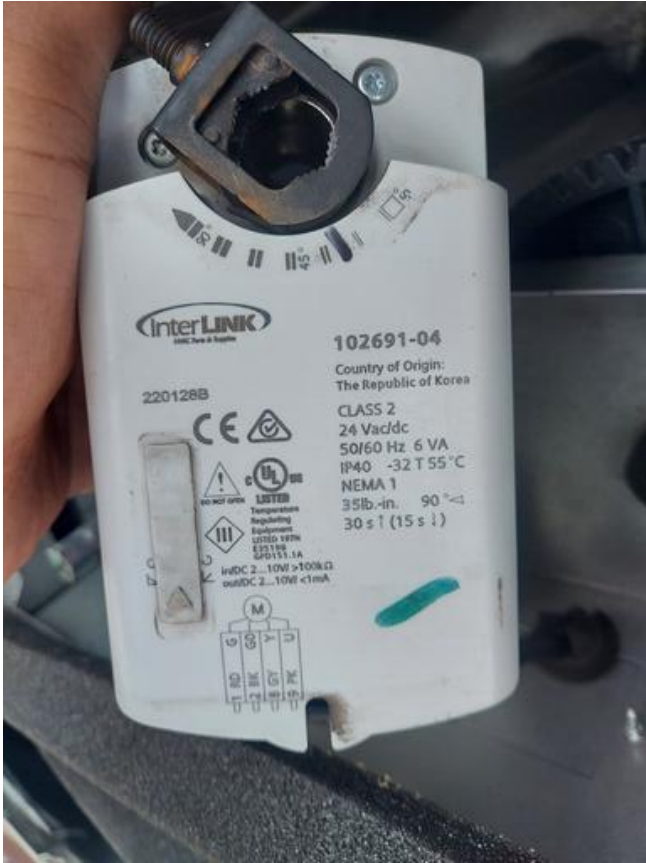
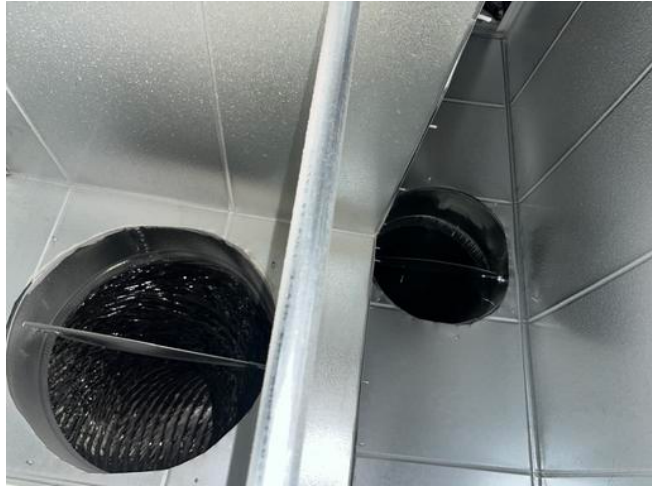
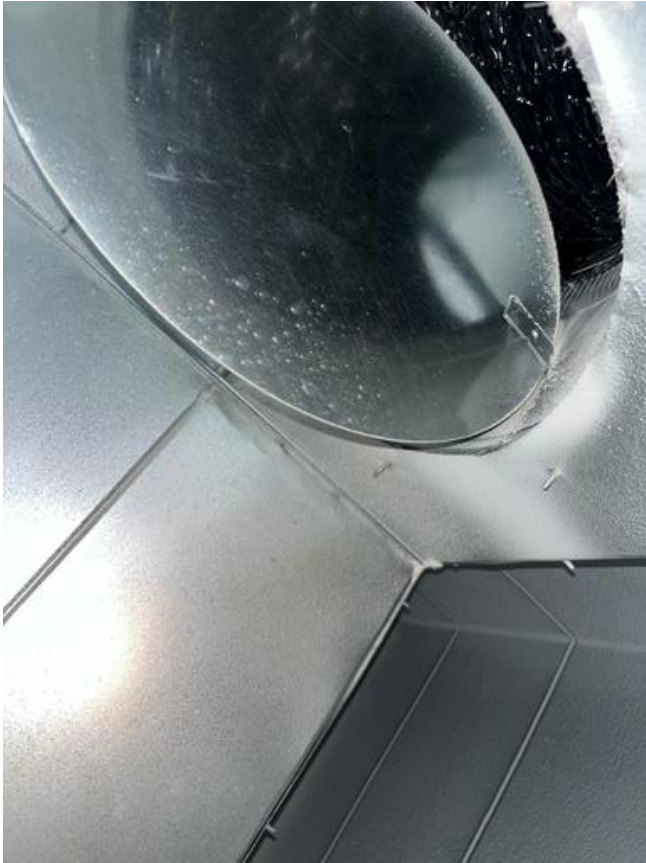
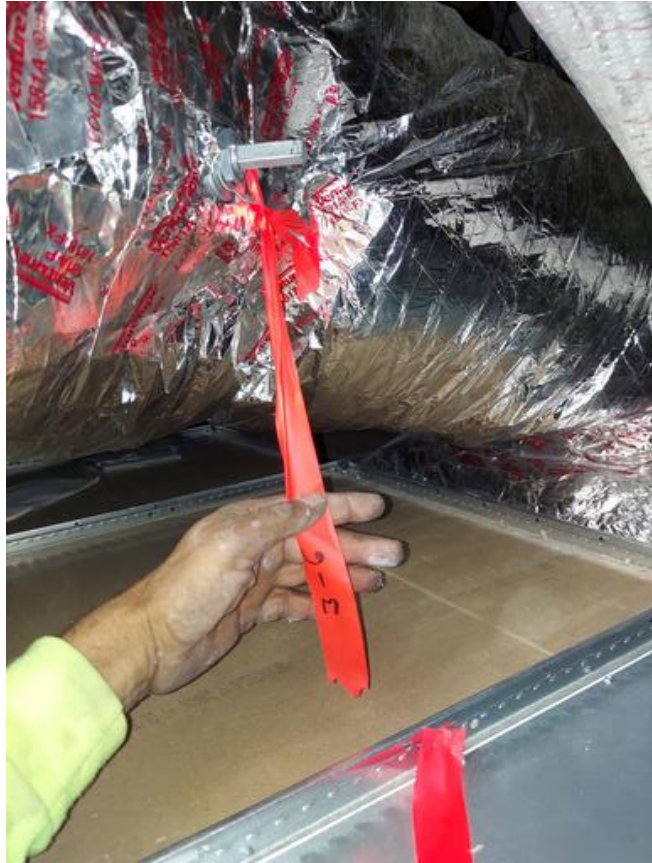
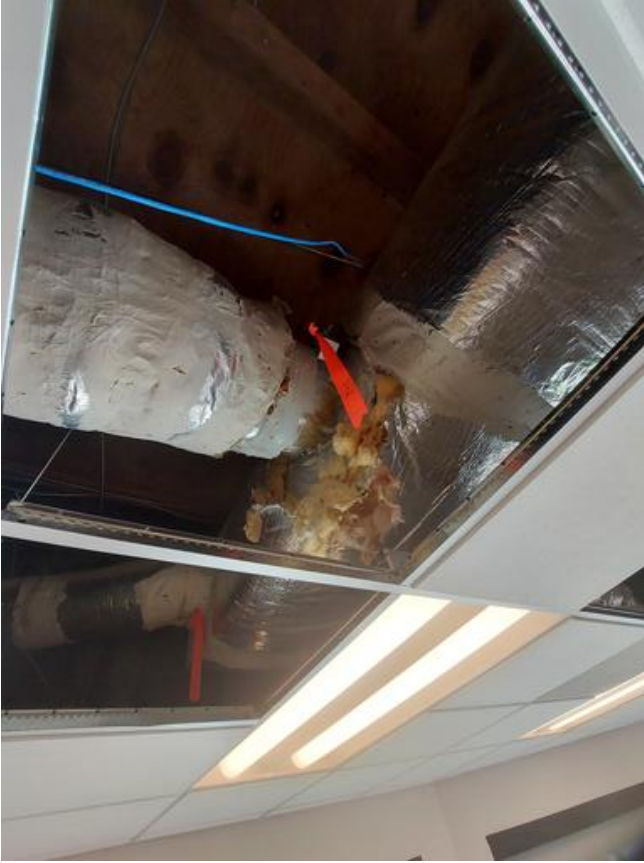
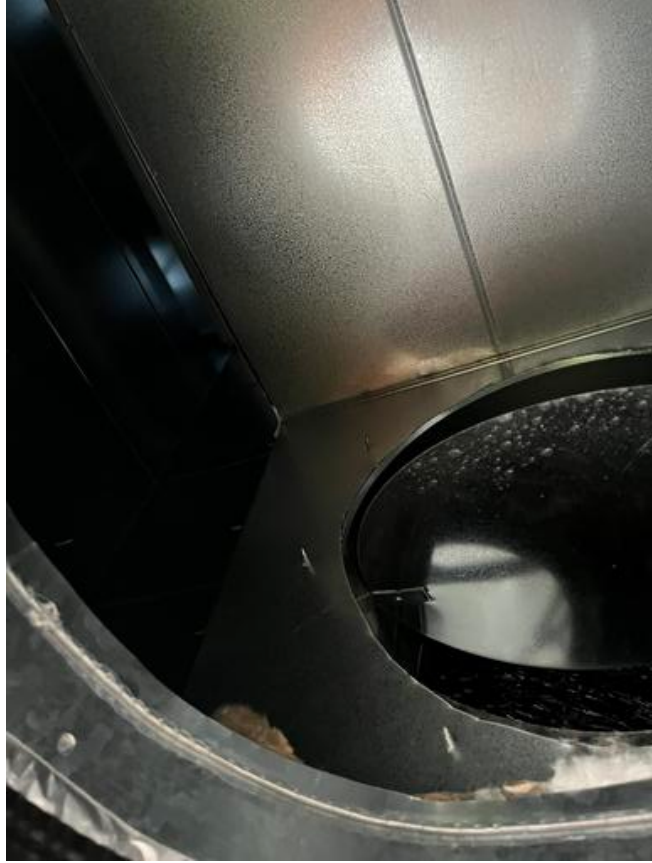
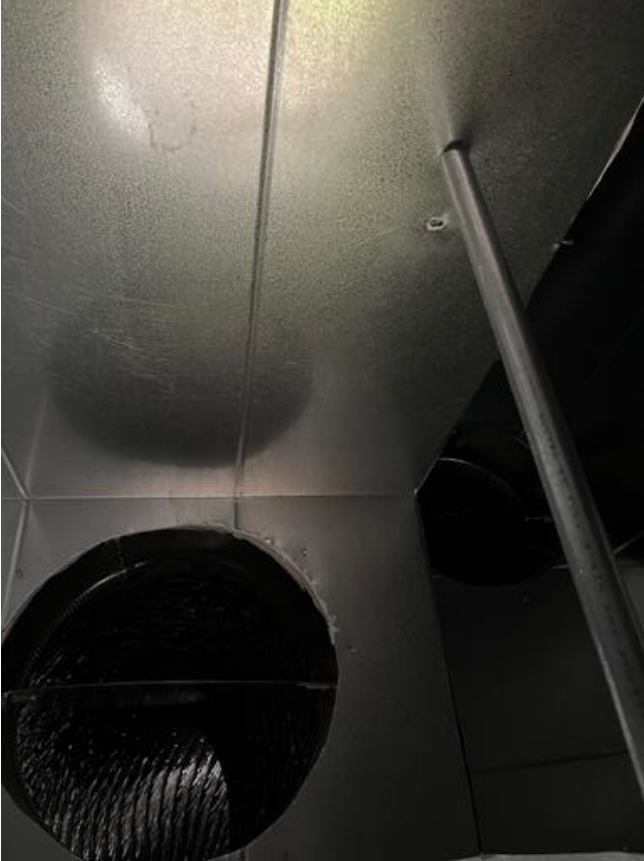
Dampers to be installed parallel to airflow. In horizontal runs, position damper on left or right at 9 or 3 o'clock. On vertical ducts position damper on bottom only (6 o'clock). RTU 2 return dampers incorrect orientation.

No change to return damper orientation on RTU 2

No change to return damper orientation on RTU 2 (Kitchen). Dampers should be in 6 o'clock positions on vertical ducts.

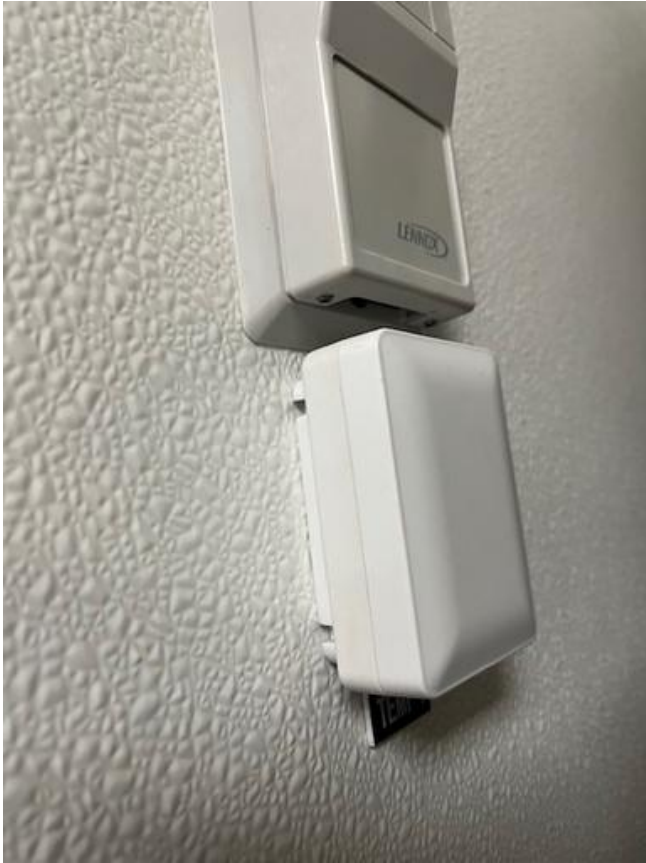
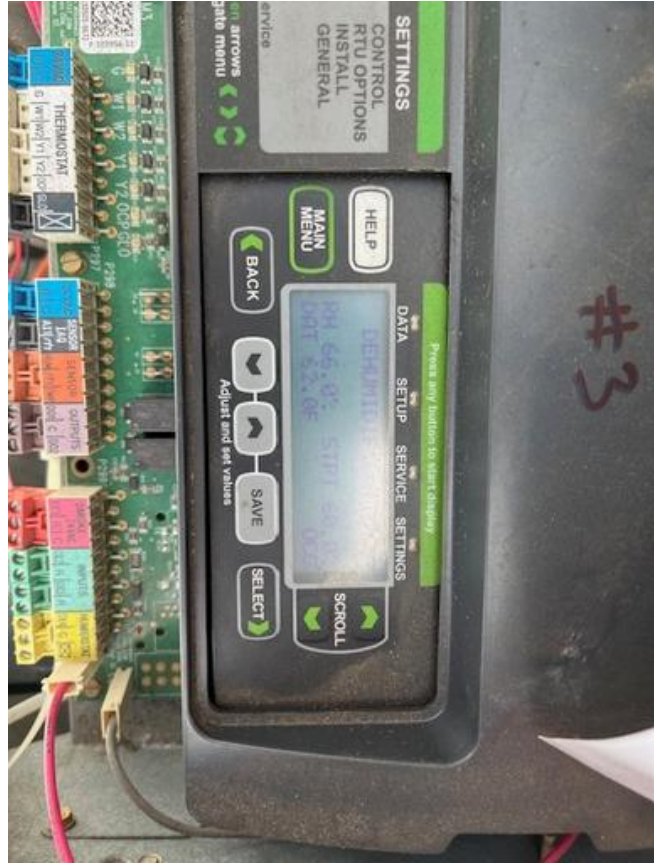
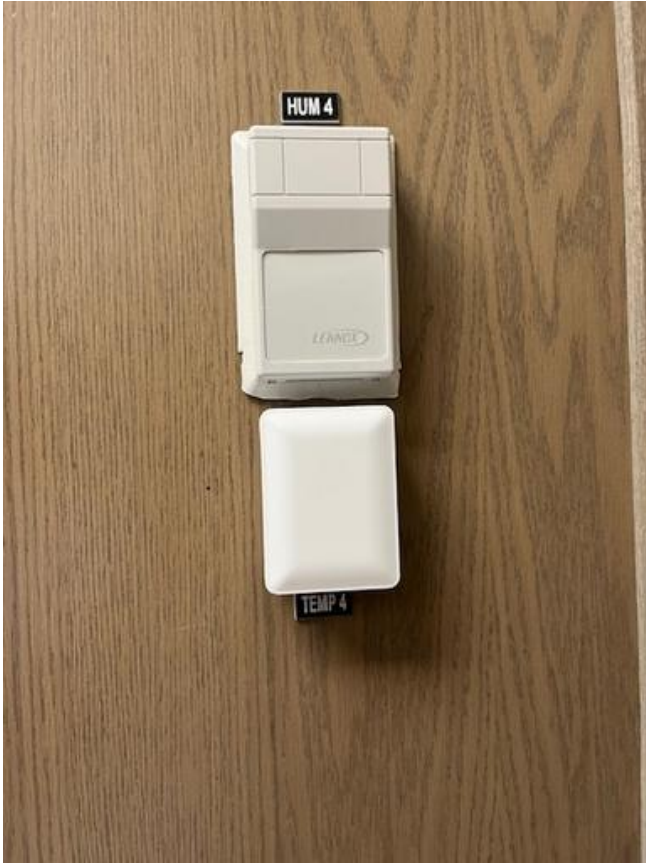
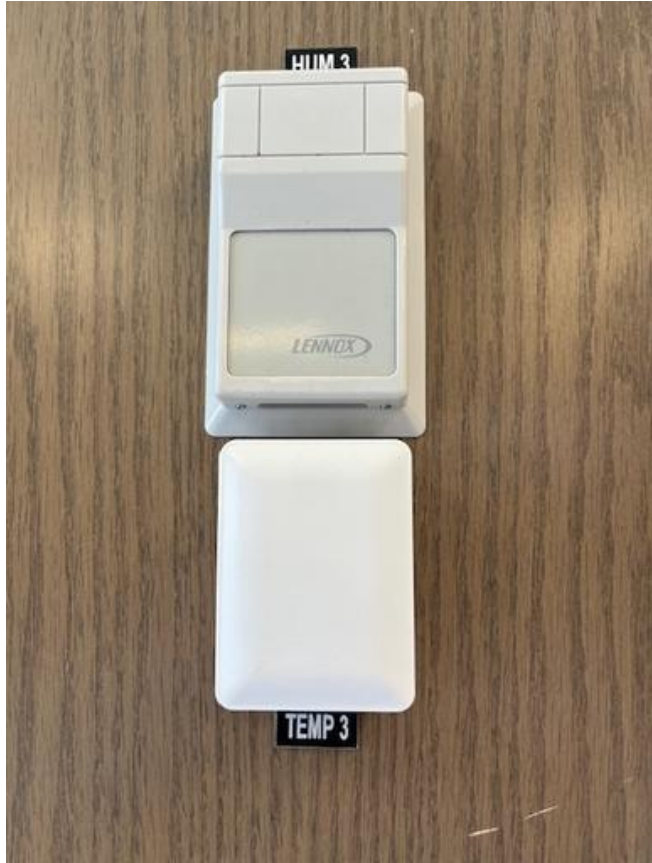
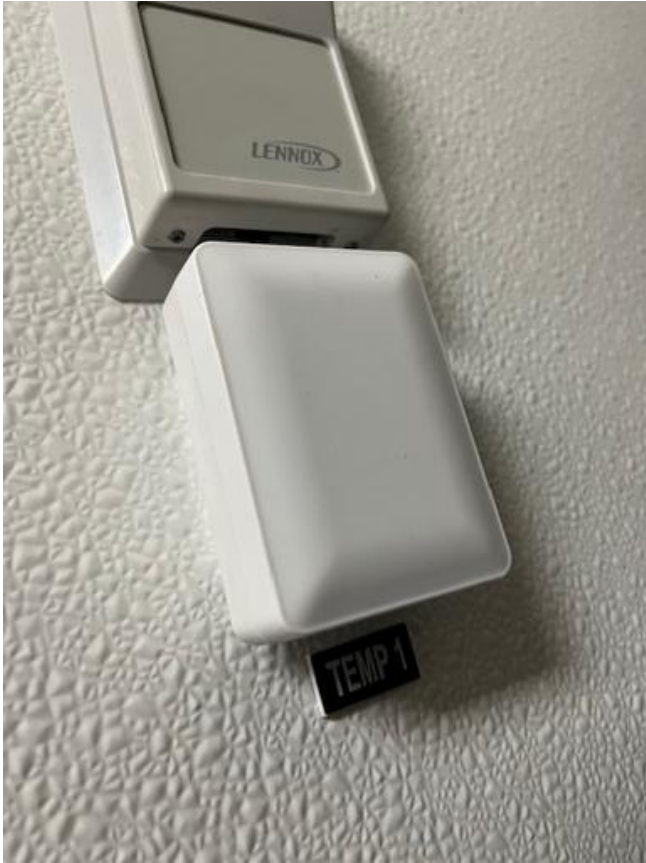
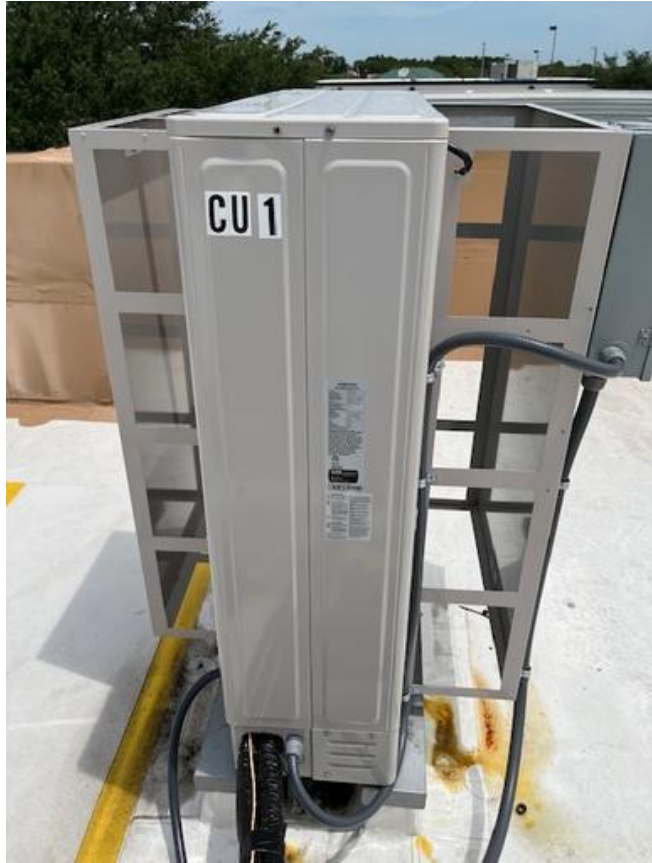
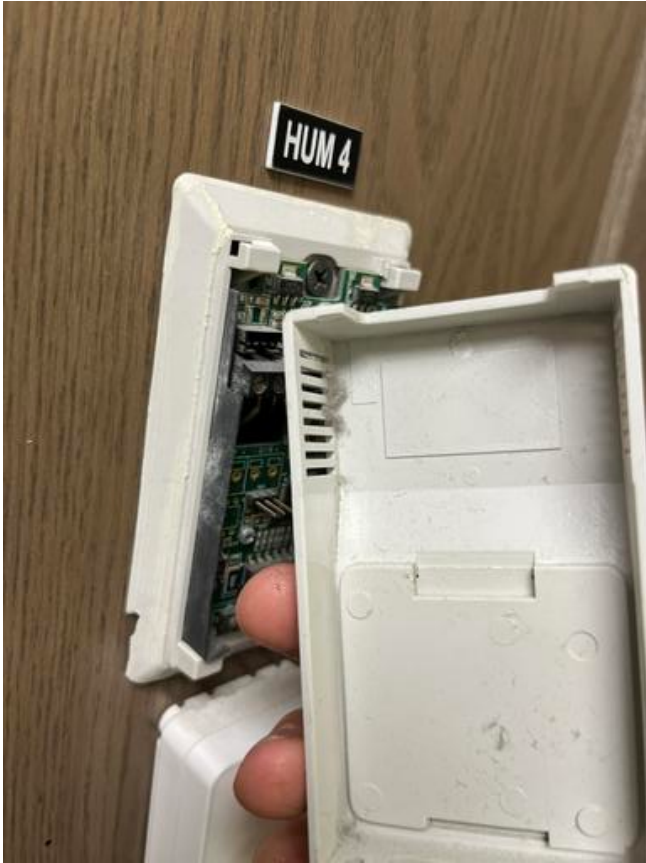
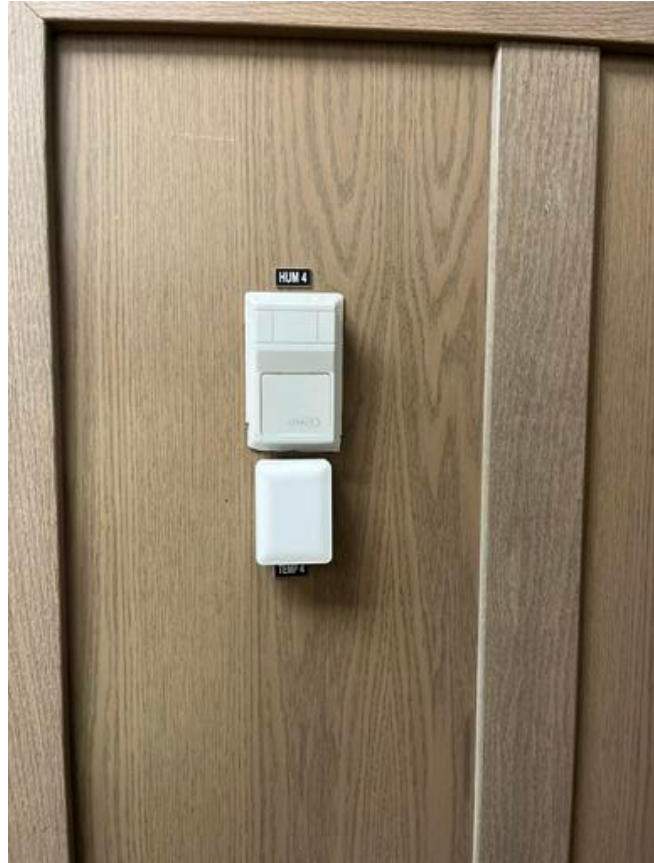
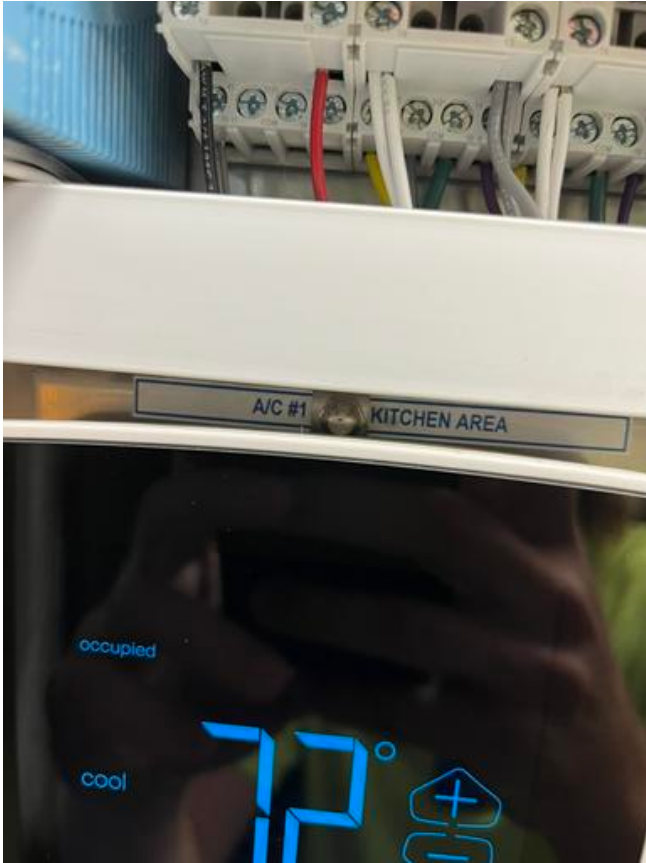
Label all sensors, humidistats, thermostats, smoke annunciators and remote space mounted OADs, MODs, VFD's for which piece of equipment they serve. Remote sensors labeled incorrectly (wrong units). Thermostats 1 and 2 labeled incorrectly (switch labels).

All sensors are now labeled but the label numbering does not match the mechanical plans. Per the mechanical plans: RTU 1 - Side Dining, RTU 2 - Kitchen, RTU 3 - Dining "B", RTU 4 - Dining "B" (where playroom previously existed).

Thermostat labeling not corrected. RTU 1 serves the side dining and RTU 2 serves the kitchen, per the mechanical plans.

See above comments. Sensors are labeled, but labeling does not match the mechanical plans.

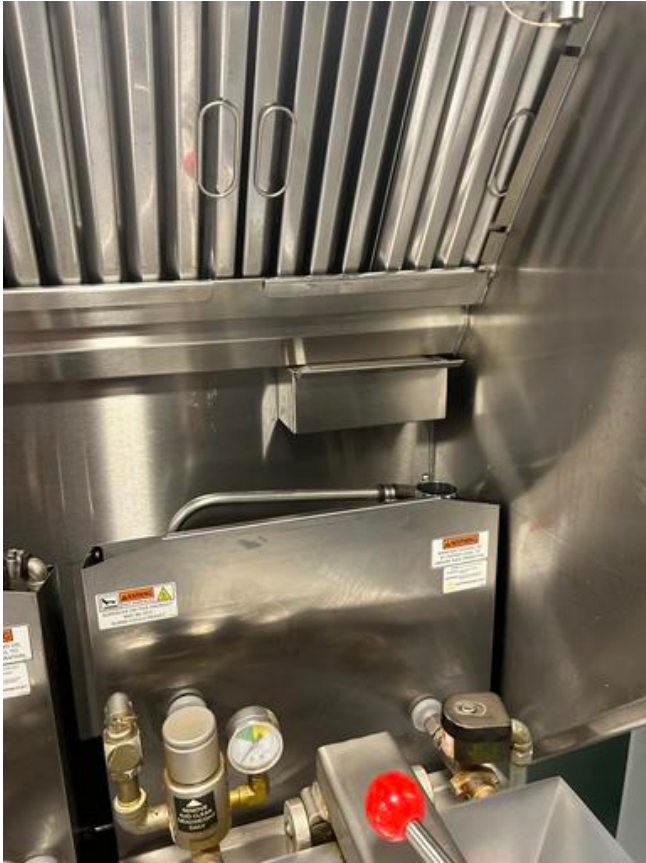
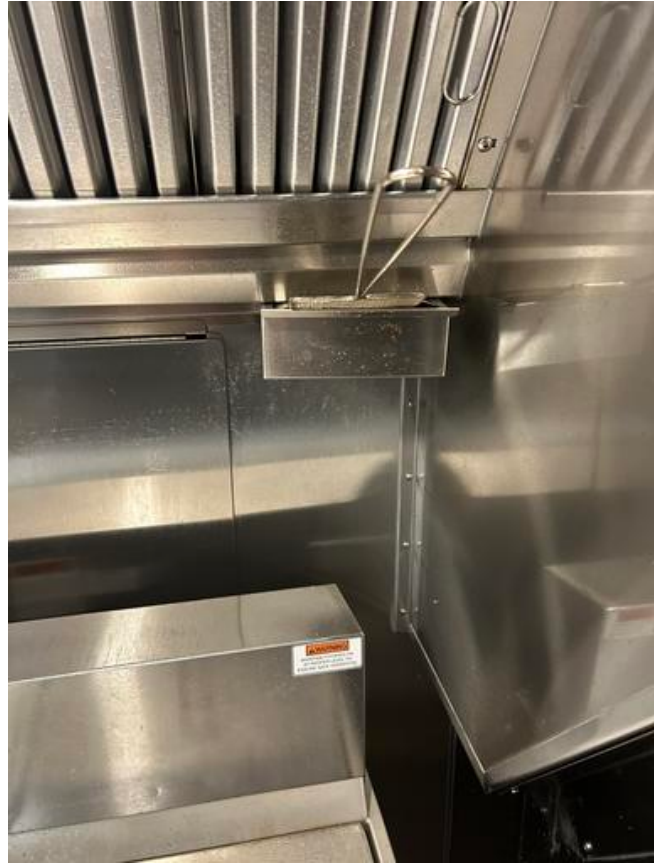
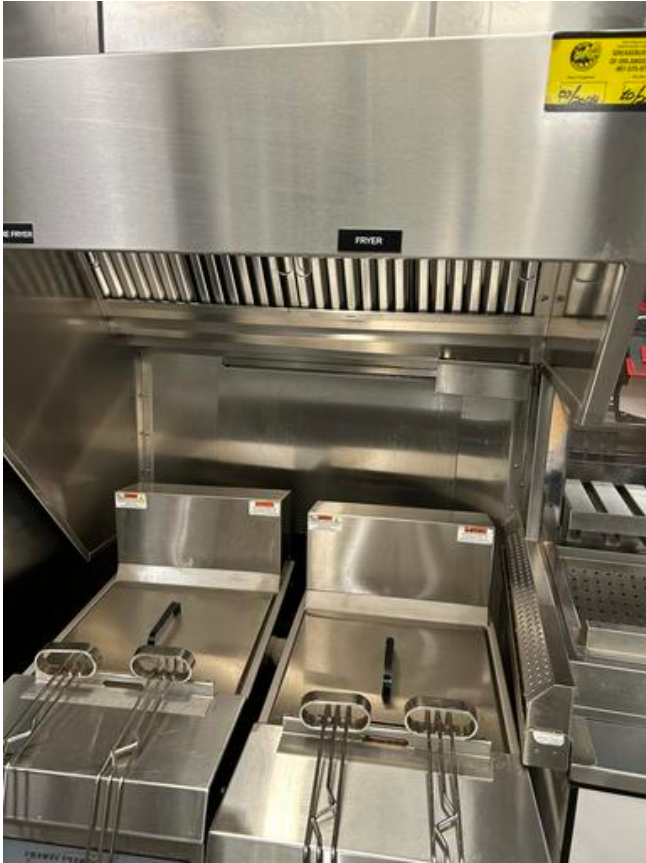
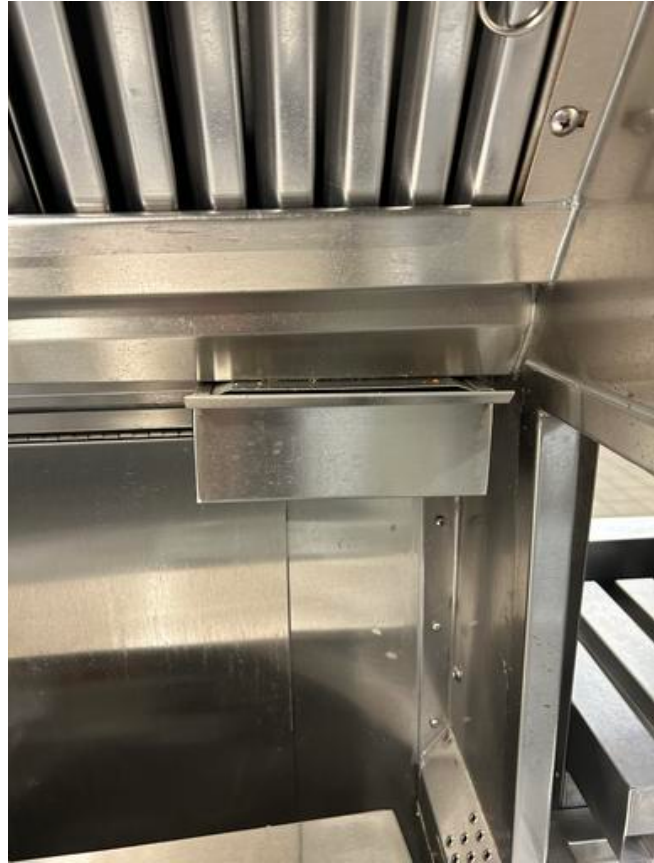
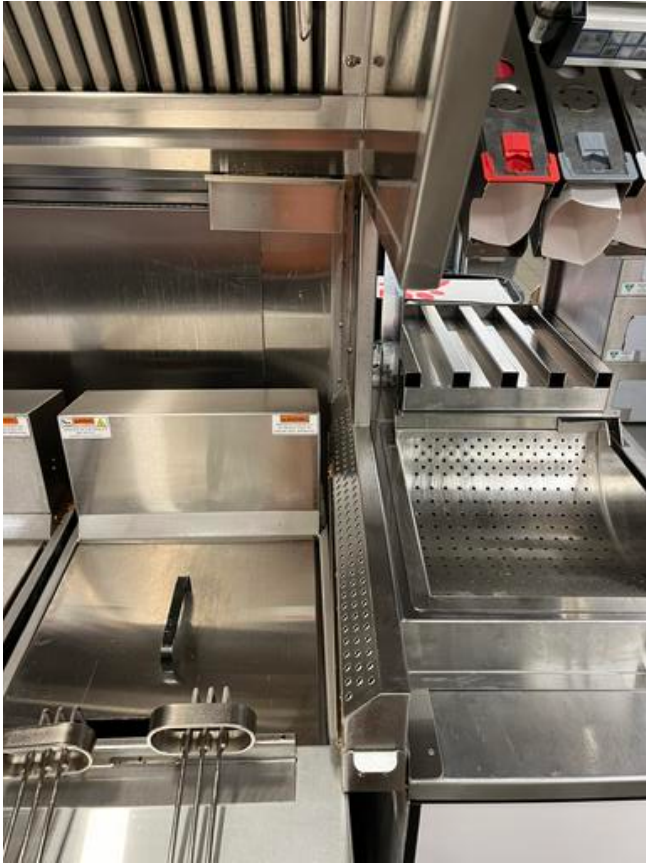
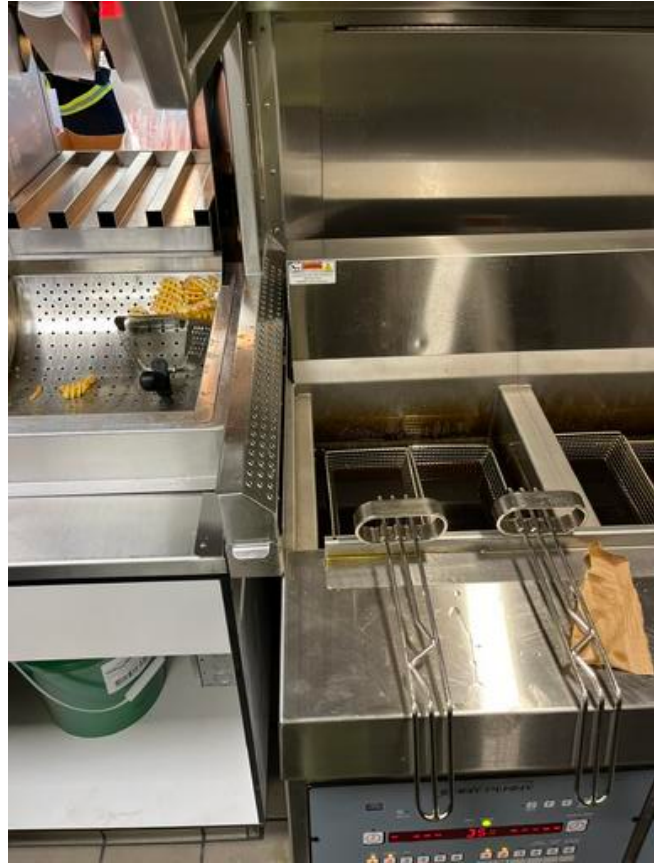
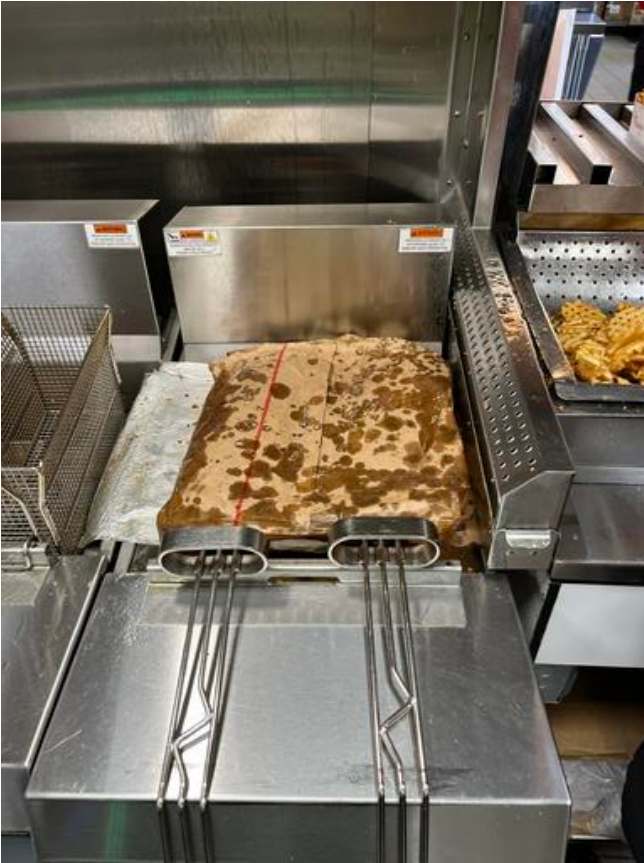
Hood is missing its grease cup and / or fry chute.

Hood 3 missing fry chute. All other fry chutes and grease cups installed.

See above comment, Hood 3 no fry chute

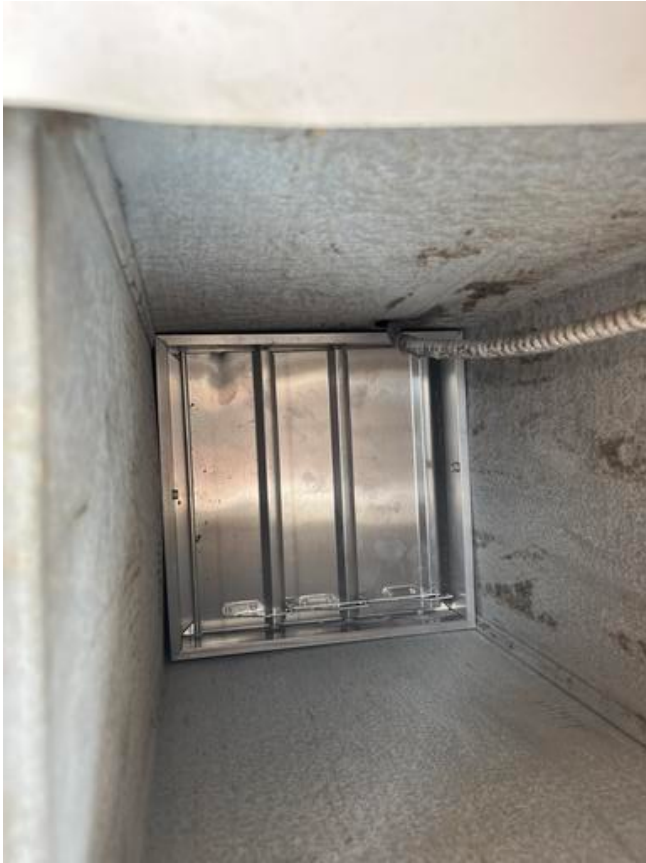
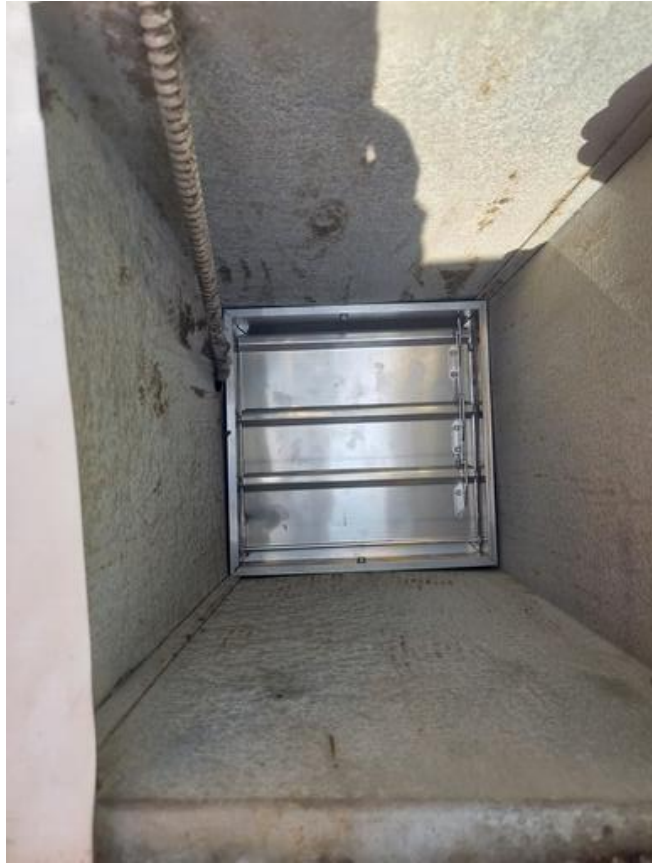
Restroom exhaust rectangular duct riser not correctly lined per specification.

Not complete. However this is an existing duct.

cannot line the duct due to existing and ceiling would need to be removed.

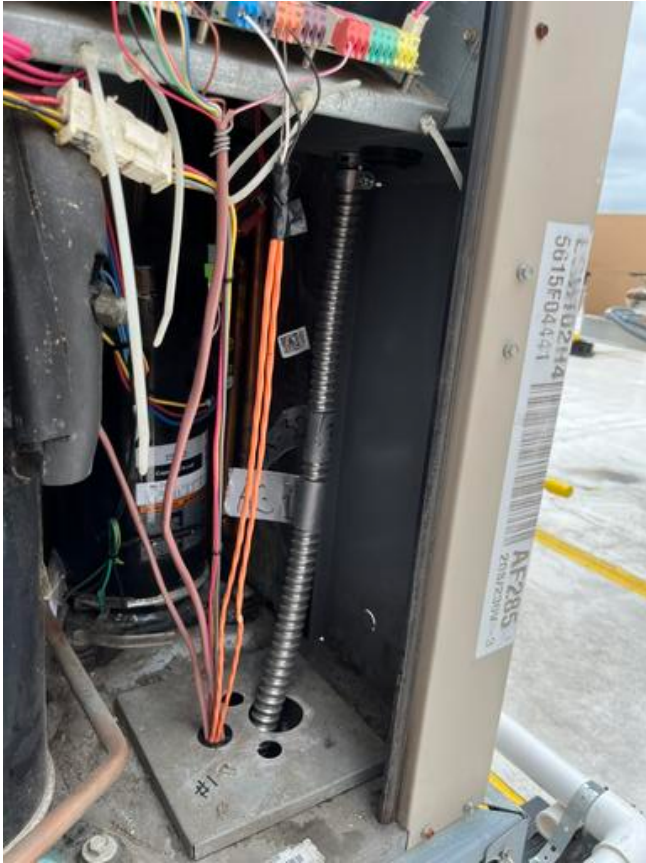
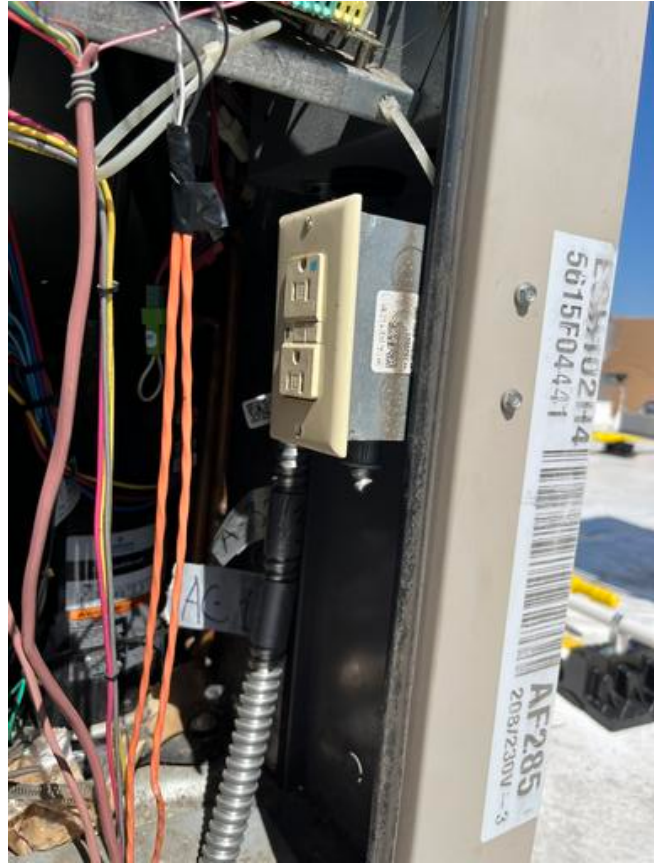
Equipment GFI outlet missing components (GFI itself, din rail with fuses) or not terminated/operational.  
RTU 1

GFCI outlet removed from unit.

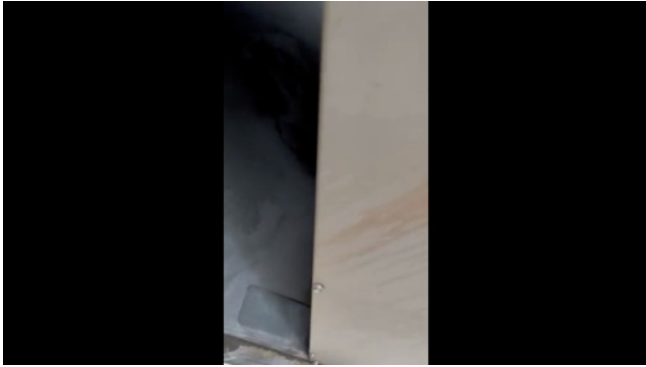
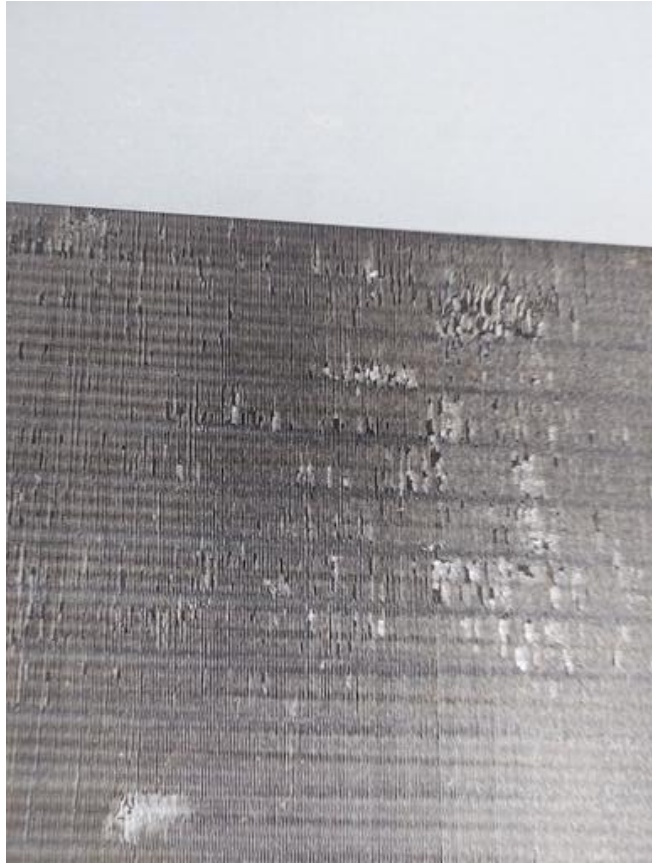
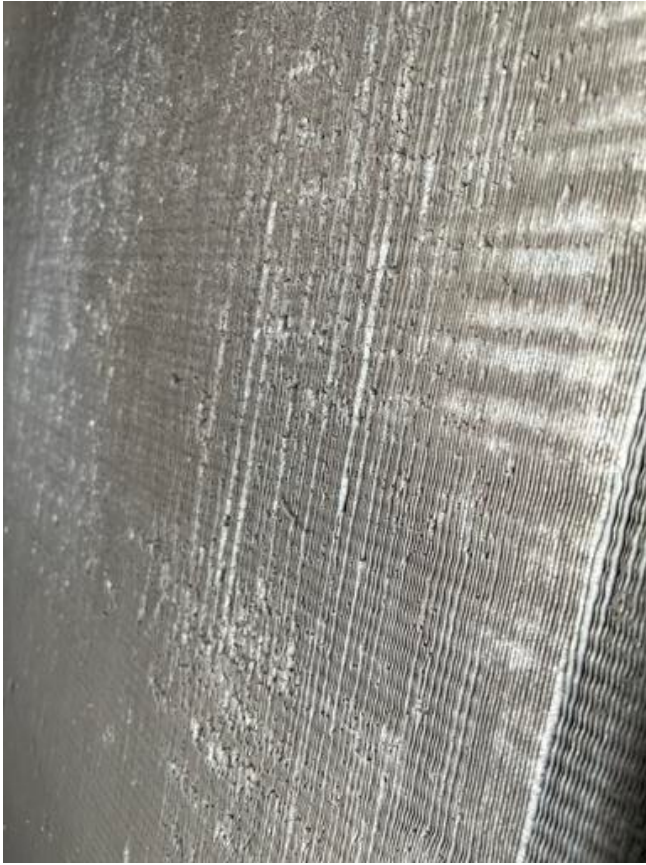
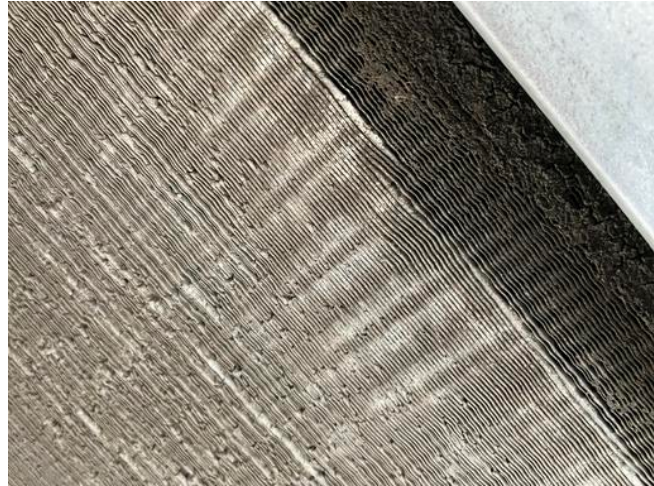
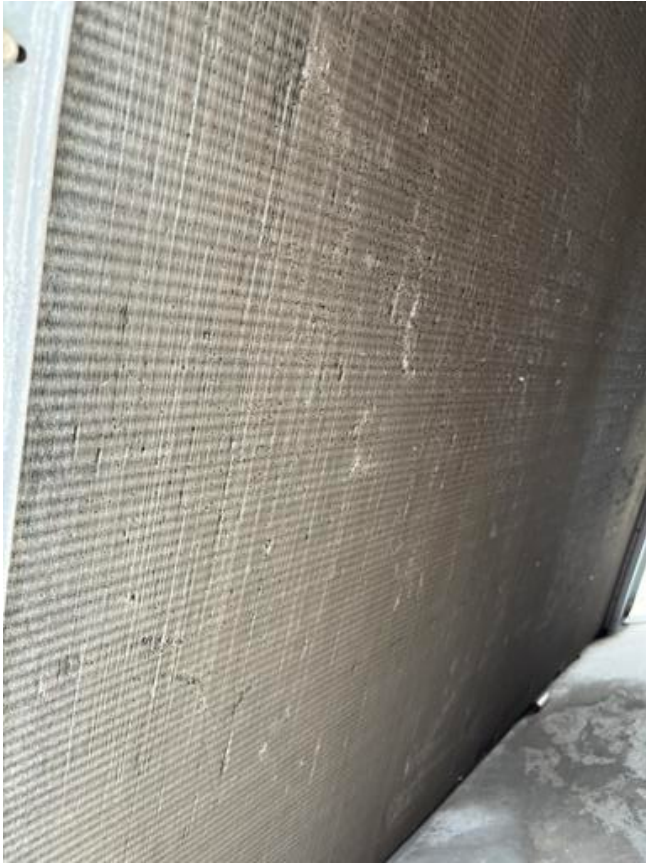
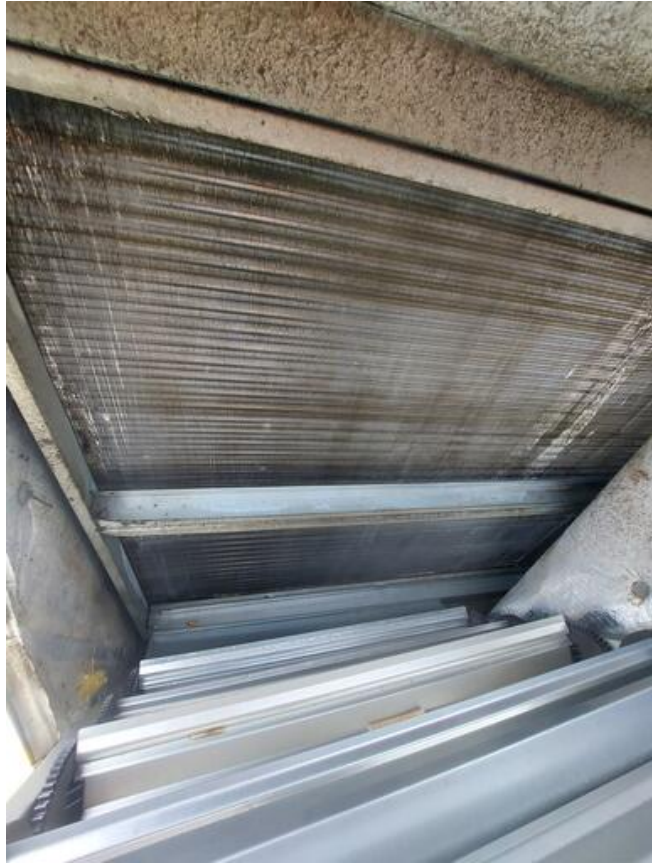
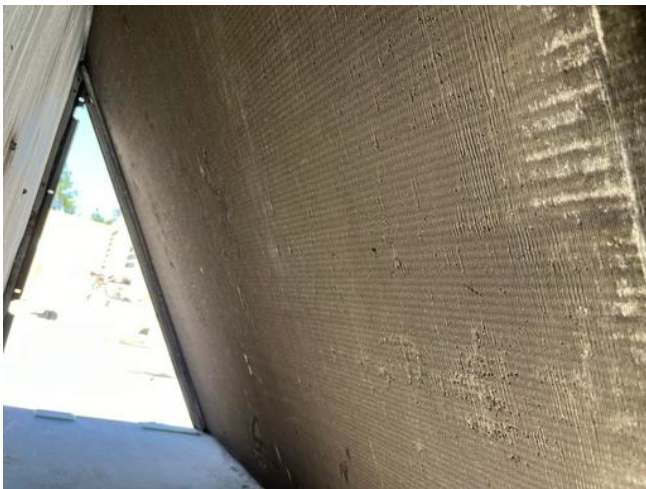
RTU 3 condenser coil is dirty and compacted. Cleaning recommended.

Evaporator coil confirmed to be cleaned. Condenser coil does not appear to have been cleaned.

Coils cannot be cleaned due to the amount of wear on them. suggest replacement. They were cleaned with cool water to avoid breaking or holes.
