PlanGrid Task Report - Sep 9, 2024

Prepared by Stephen Tassinaro

Sep 9, 2024

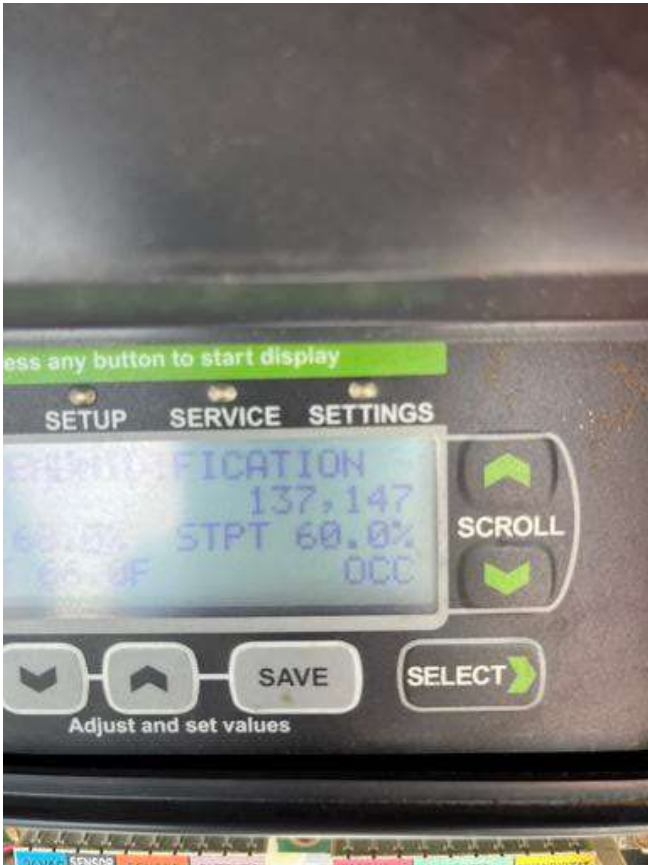
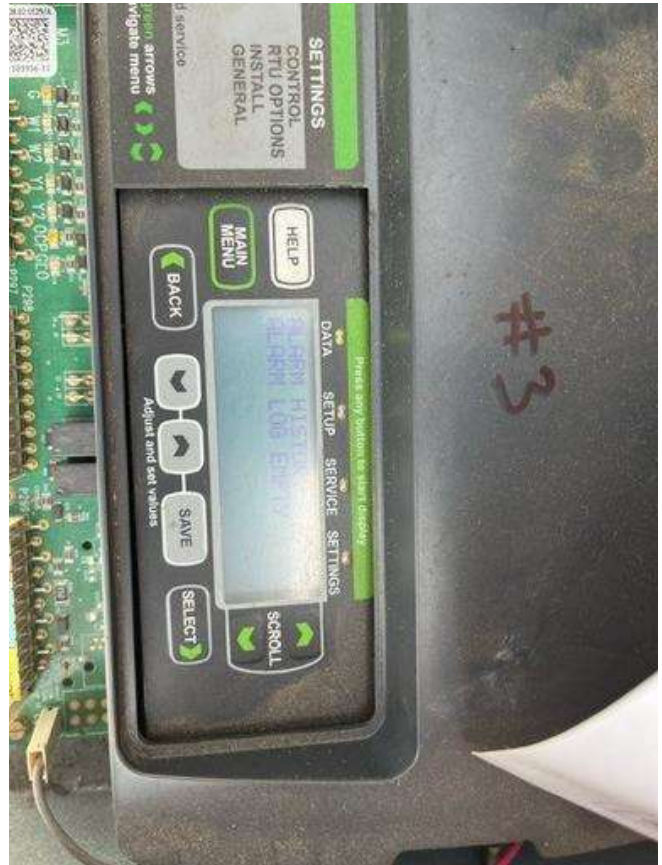
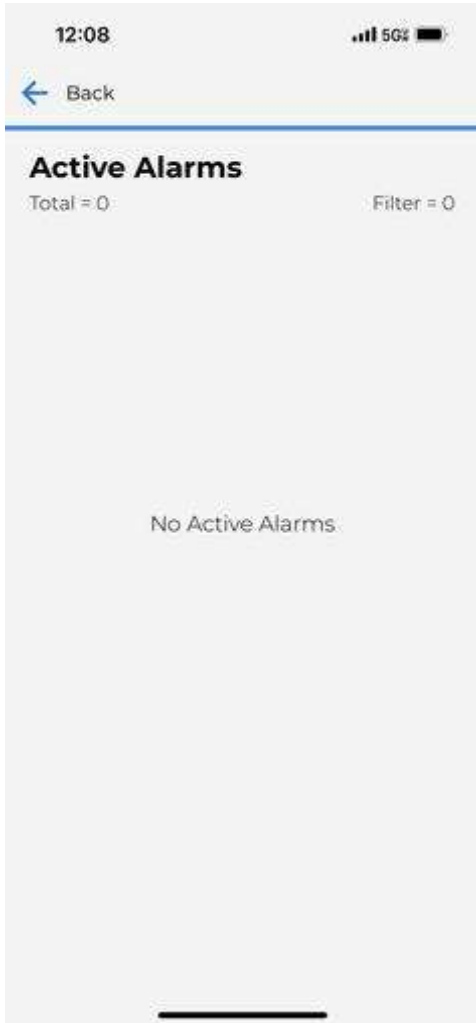
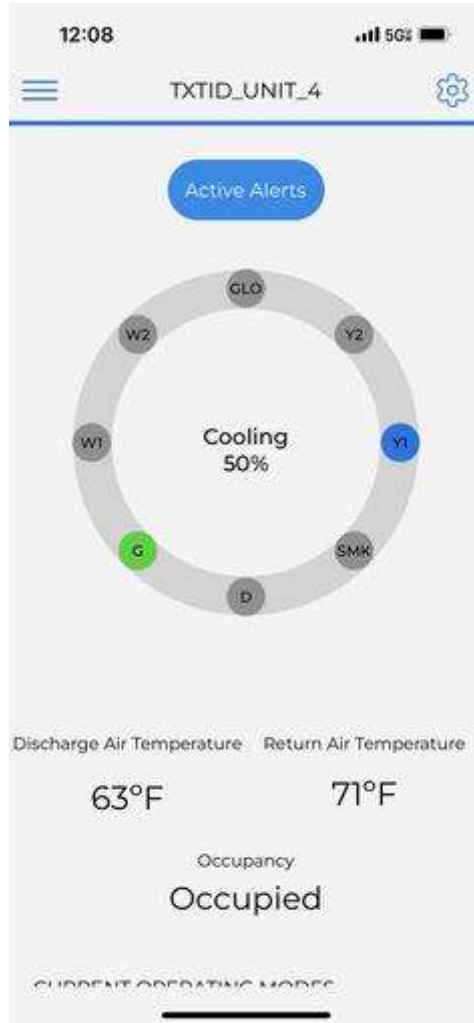
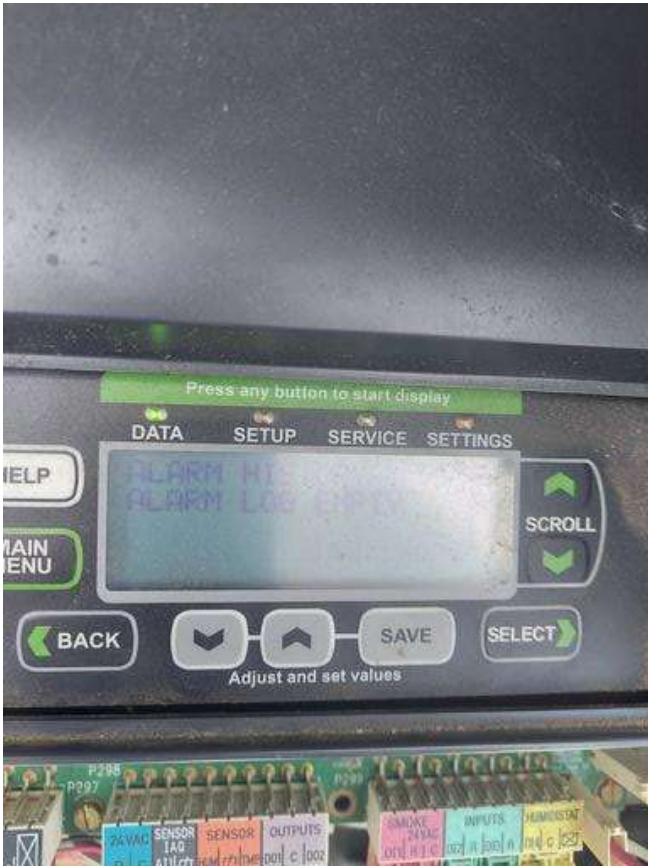
The following alarms were found on the RTUs:
RTU 3 - Alarm 147 & 137

No active alarms on RTU's 1,3,4

RTU #3 alarming 137 & 147. Economizer functioning correctly and at NTi setpoint.

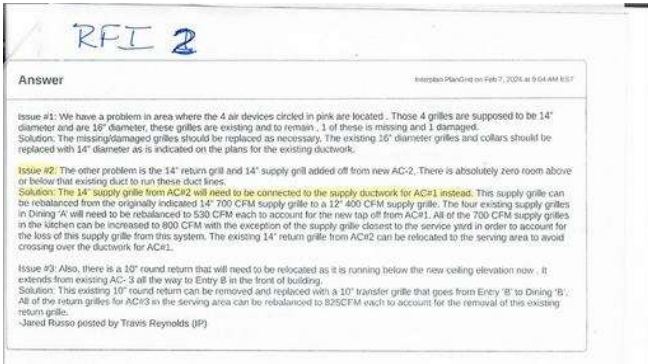
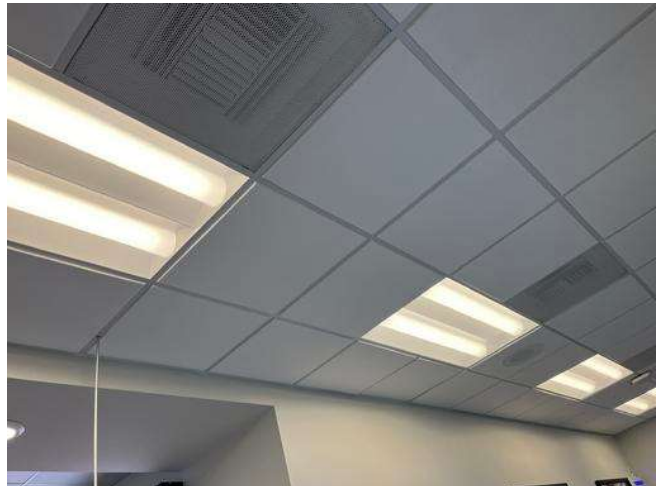
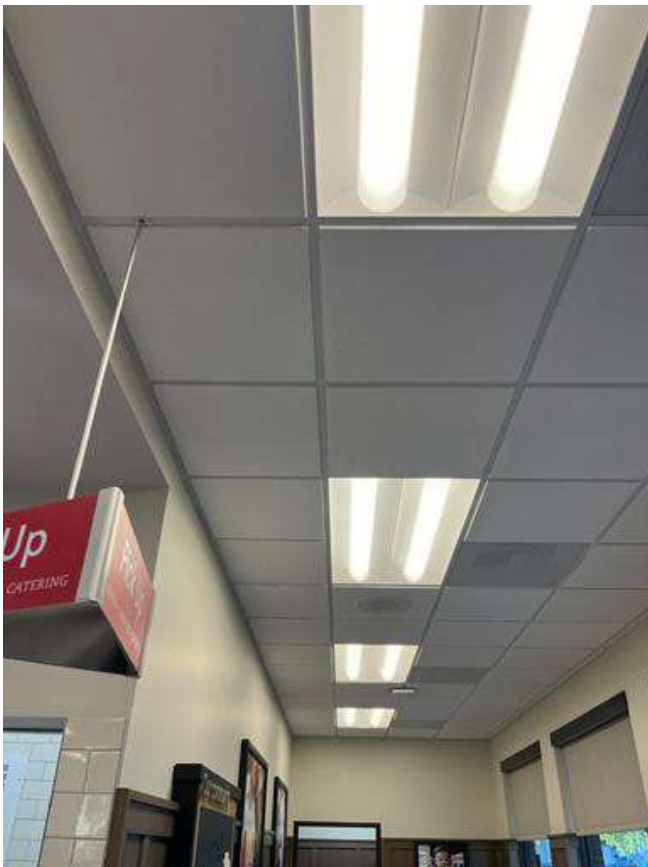
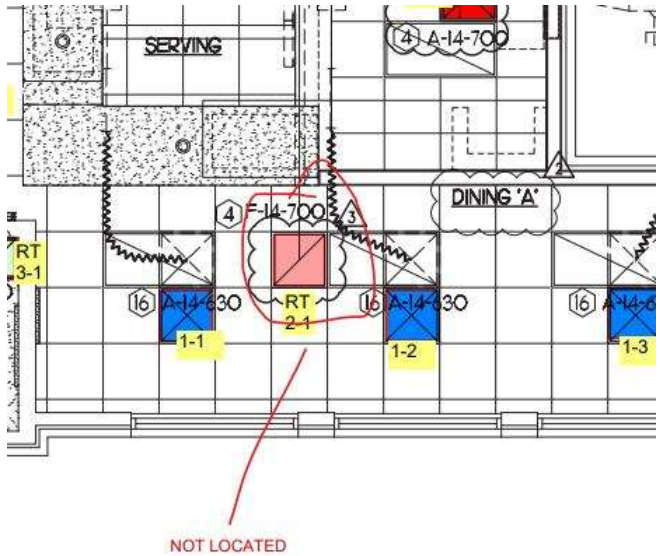
Description
Return Grille 2-1 could not be located in the space. Per M1.1 it should be located adjacent to diffusers 1-1 and 1-2 (side dining area).
*Reference NTi GRD Layout.

No change

NTi diffuser balance satisfies RFI #2 as-is. No changes required.

Satisfies RFI 11 Issue #2

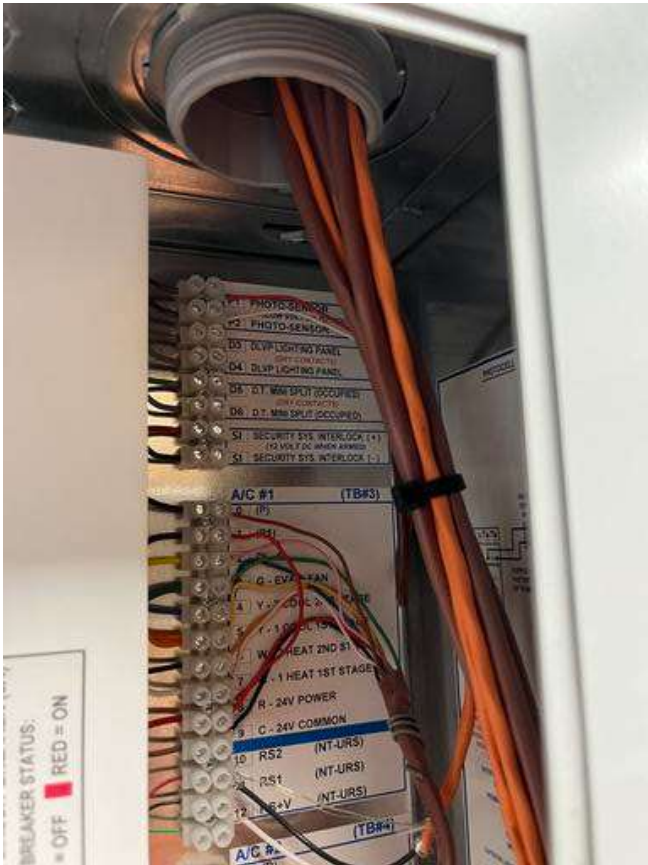
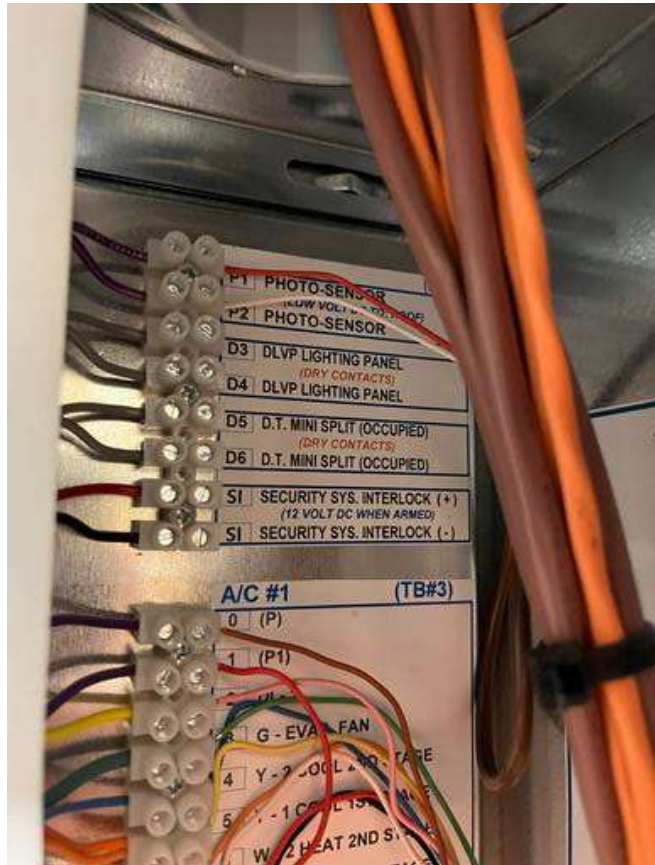
Description
Mini split control wires not landed in suncoast panel.

No wires landed 6/19

No wires landed 9/9

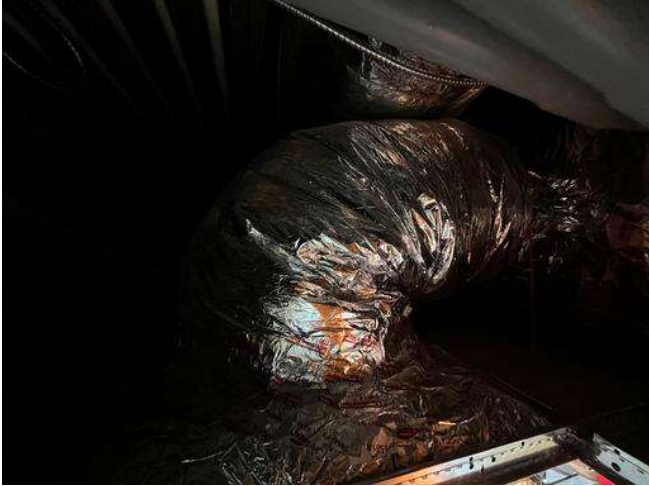
Ensure rigid 90 degree fittings are secured to diffusers, with hard pipe risers adjusted to meet take off height elevation and connected to horizontal flex. No flex in drops allowed per details. Diffuser 2-2 no rigid 90 installed.

Not possible per plan design, grill too close to main duct 5.21

Airflow within design as-is. No changes required to meet airflow requirements.

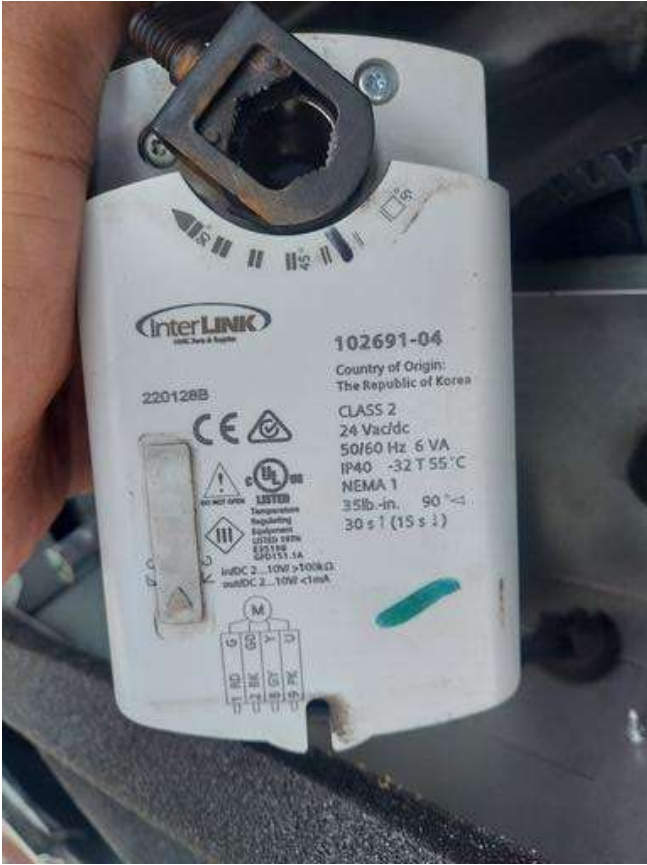
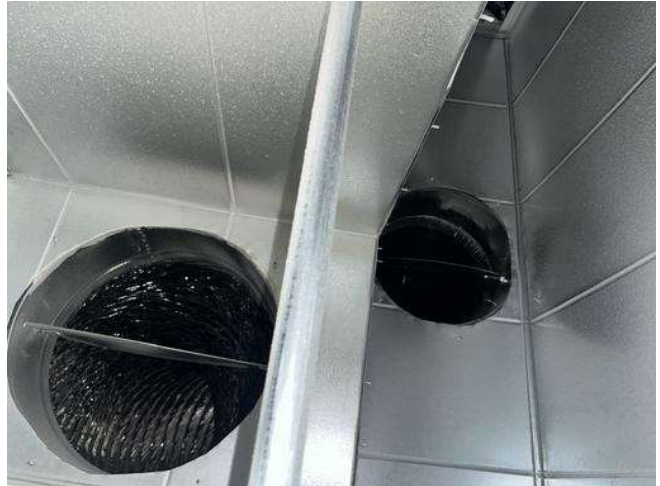
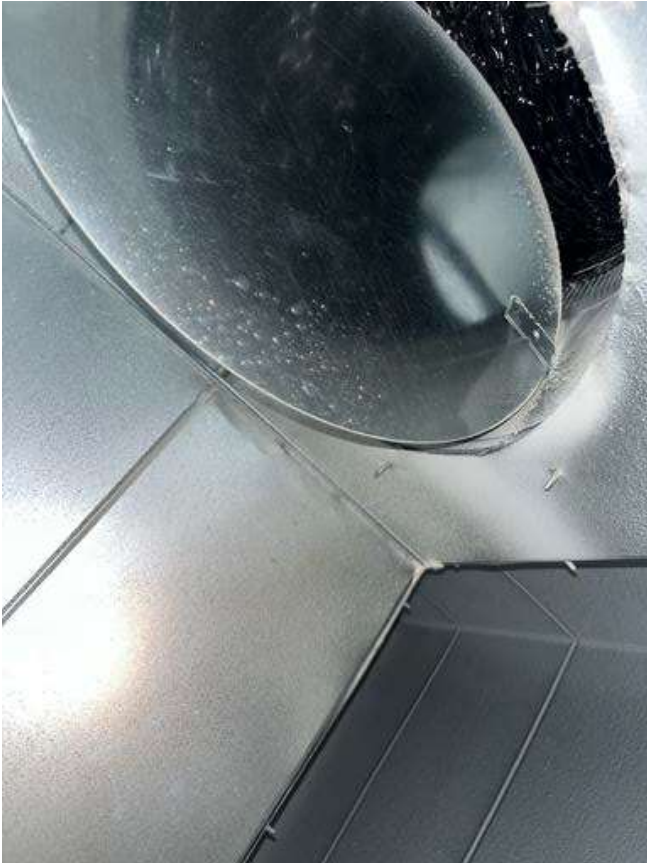
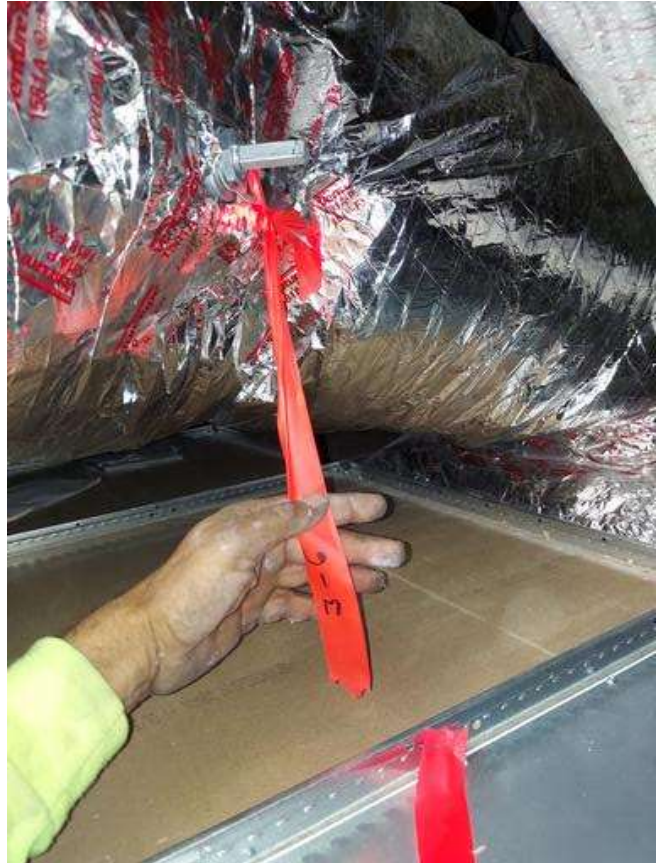
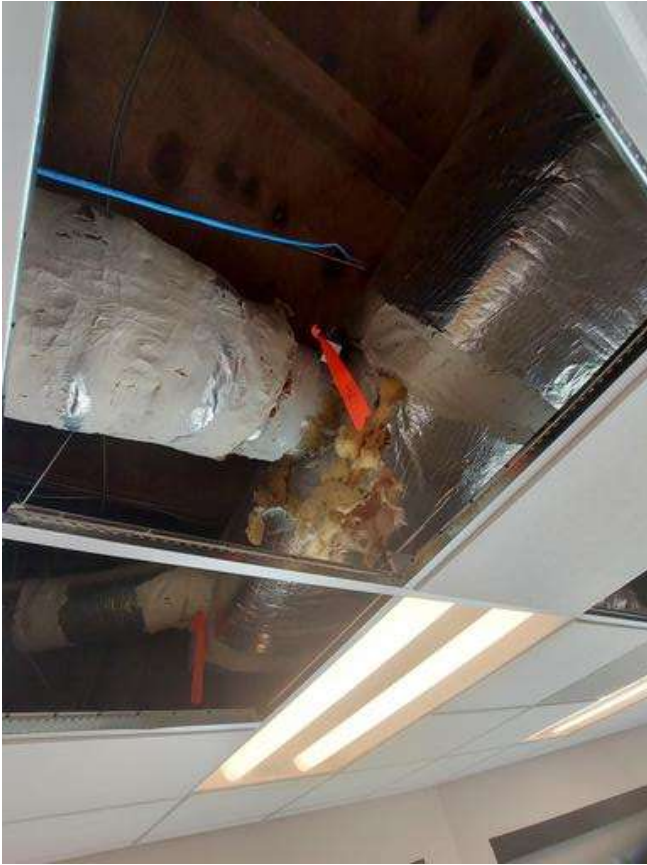
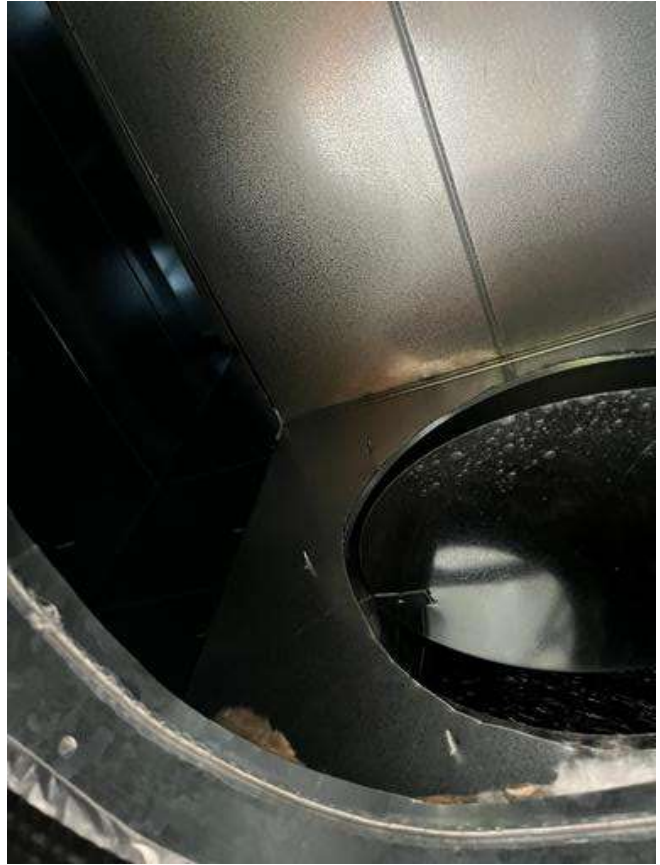
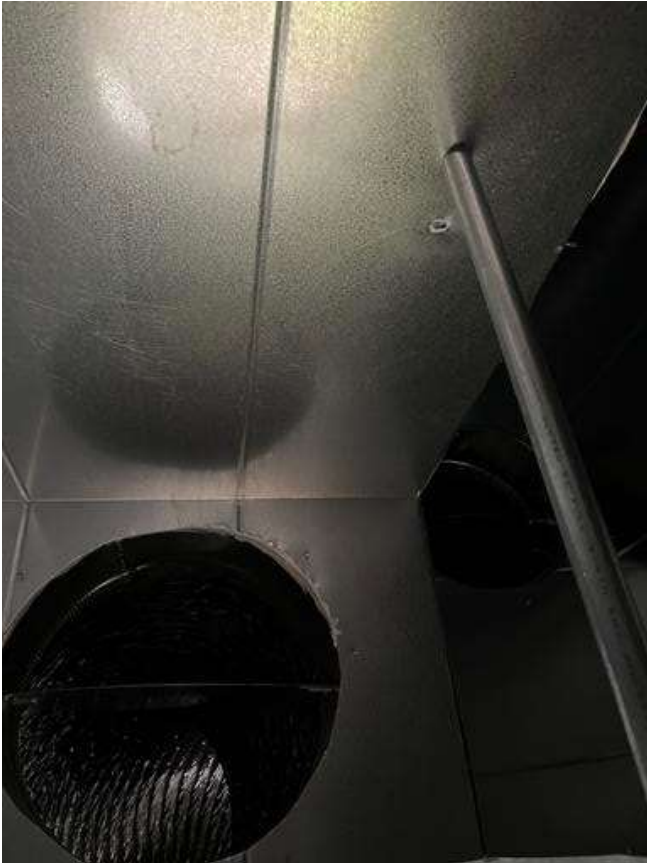
Dampers to be installed parallel to airflow. In horizontal runs, position damper on left or right at 9 or 3 o'clock. On vertical ducts position damper on bottom only (6 o'clock). RTU 2 return dampers incorrect orientation.

No change to return damper orientation on RTU 2

No change to return damper orientation on RTU 2 (Kitchen). Dampers should be in 6 o'clock positions on vertical ducts.

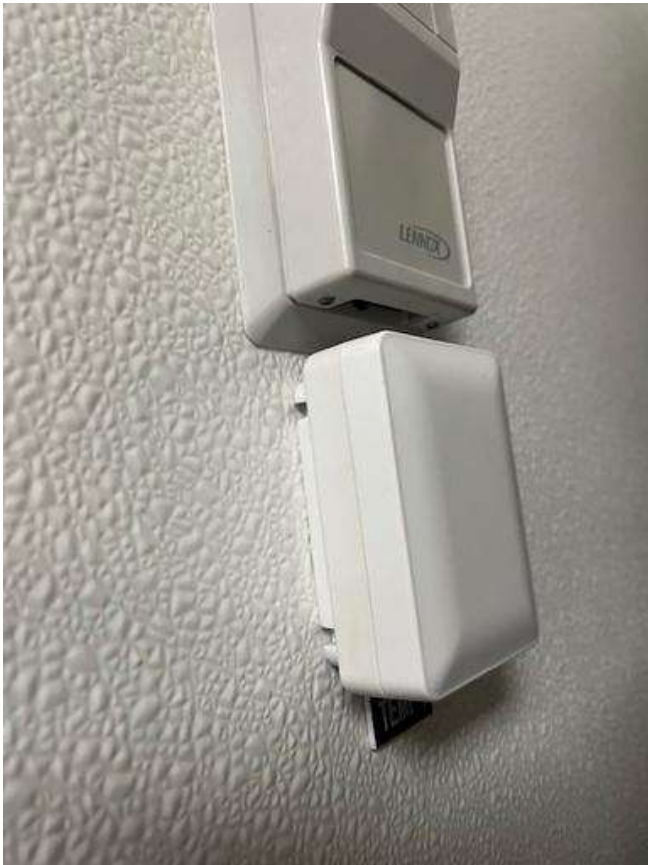
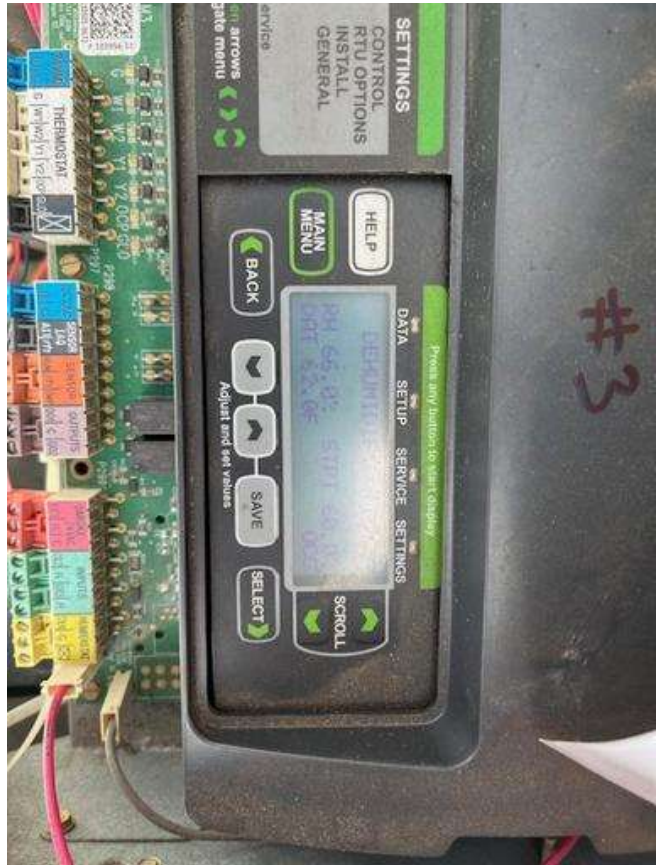
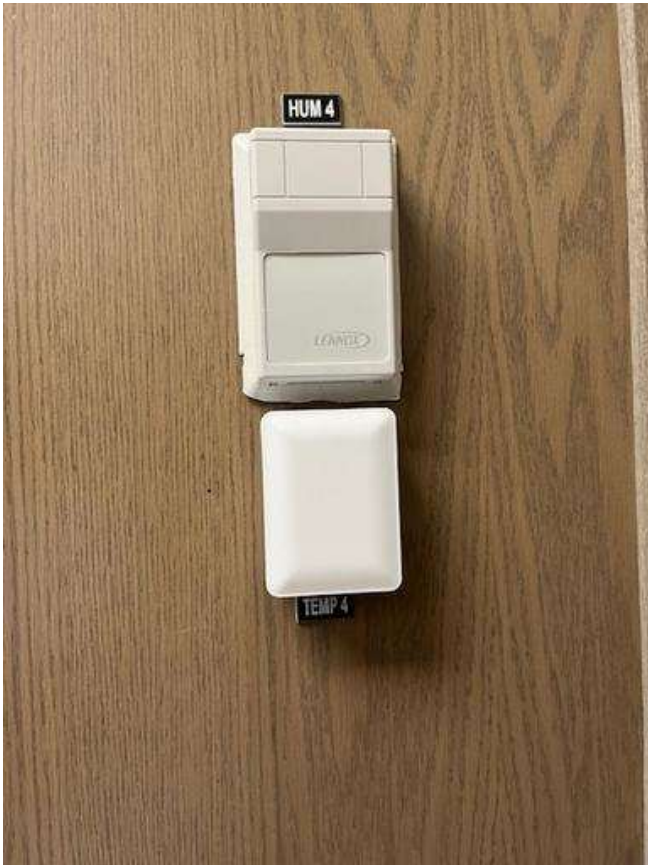
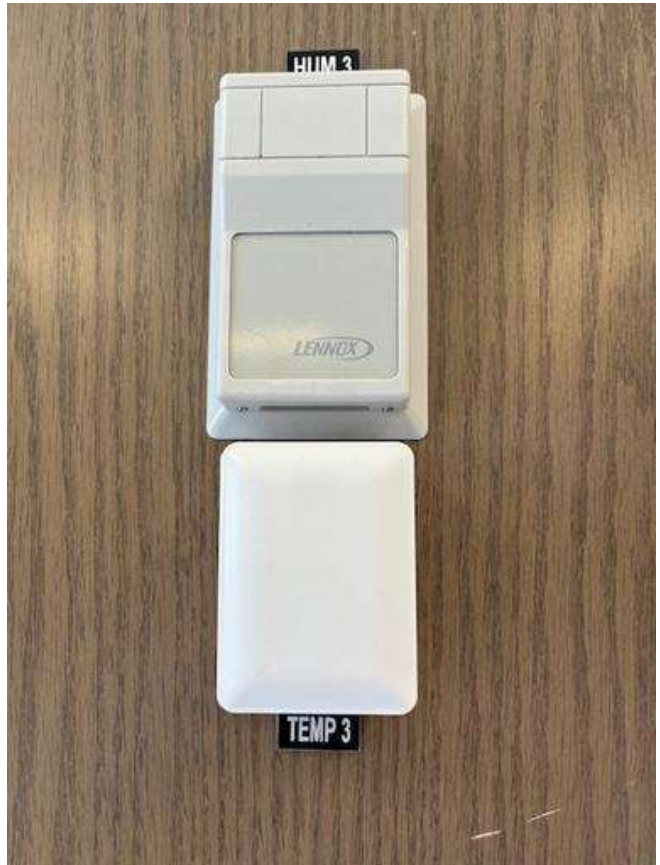
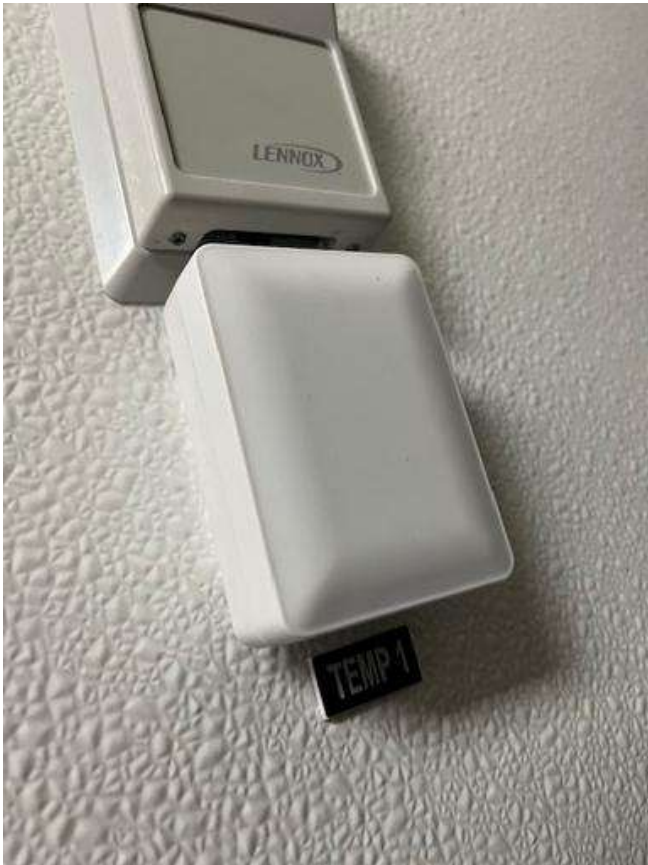
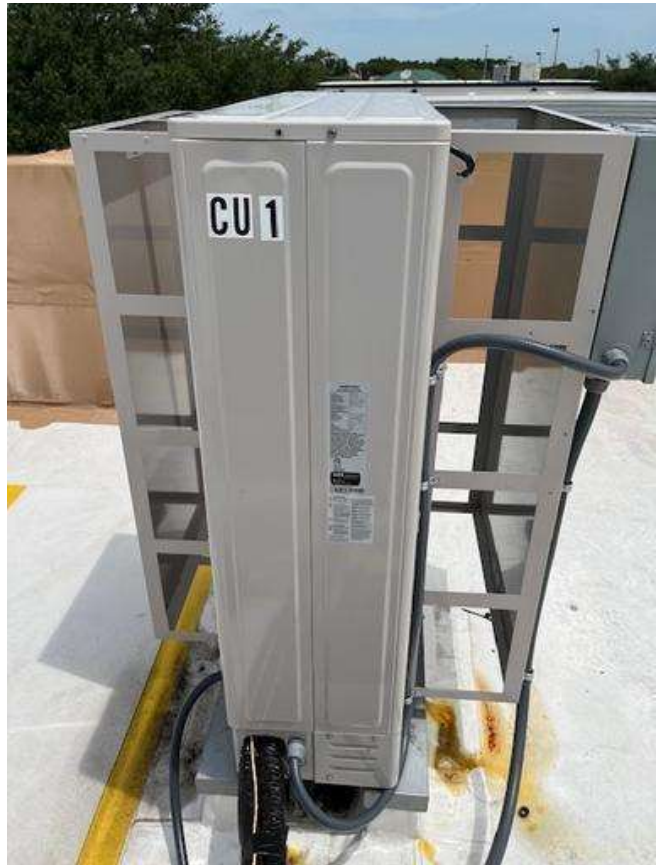
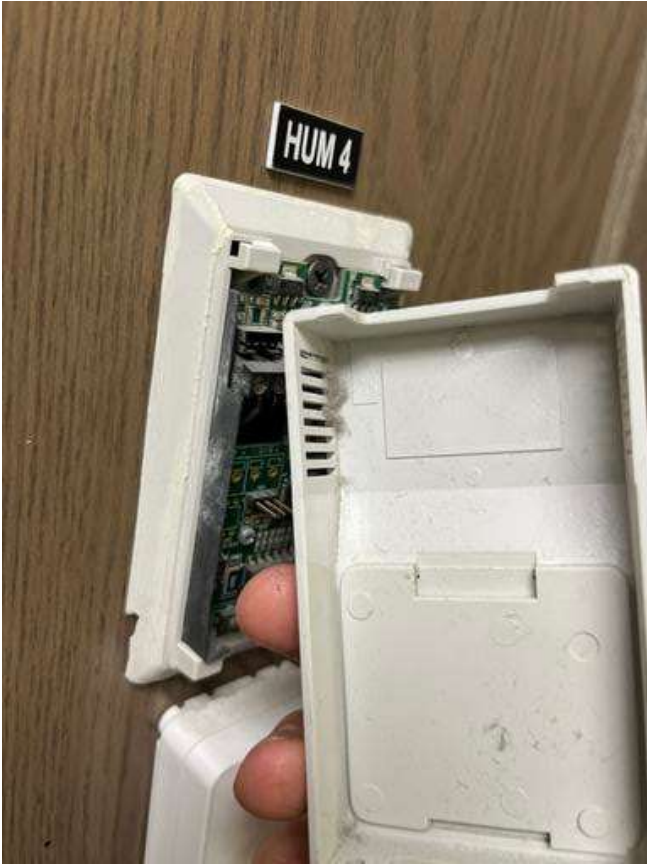
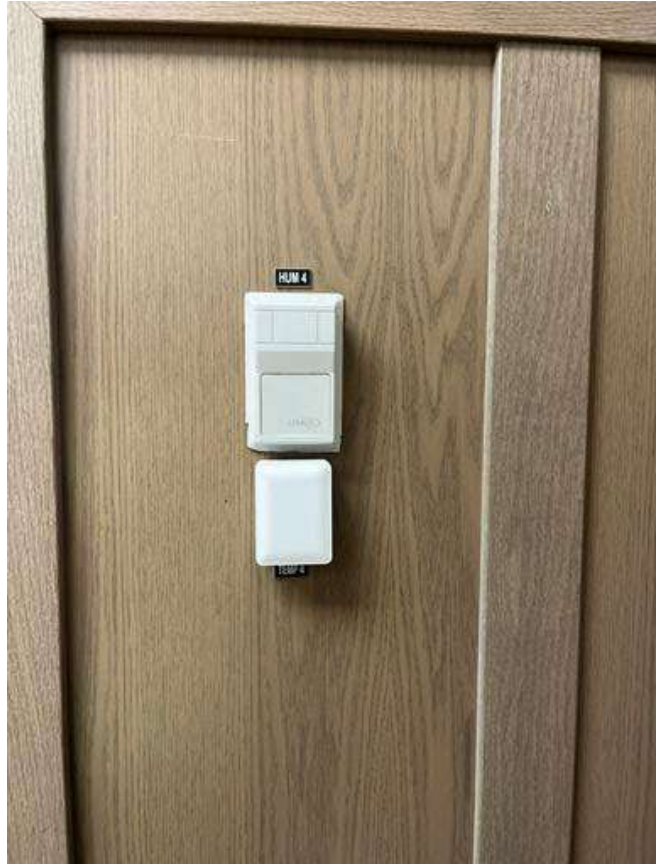
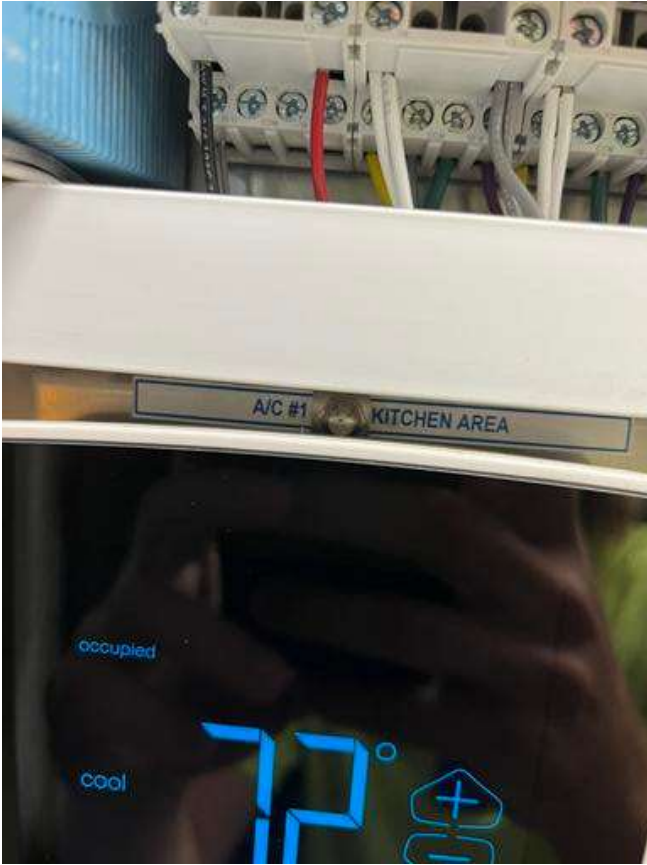
Label all sensors, humidistats, thermostats, smoke annunciators and remote space mounted OADs, MODs, VFD's for which piece of equipment they serve. Remote sensors labeled incorrectly (wrong units). Thermostats 1 and 2 labeled incorrectly (switch labels).

All sensors are now labeled but the label numbering does not match the mechanical plans. Per the mechanical plans: RTU 1 - Side Dining, RTU 2 - Kitchen, RTU 3 - Dining "B", RTU 4 - Dining "B" (where playroom previously existed).

Thermostat labeling not corrected. RTU 1 serves the side dining and RTU 2 serves the kitchen, per the mechanical plans.

See above comments. Sensors are labeled, but labeling does not match the mechanical plans.

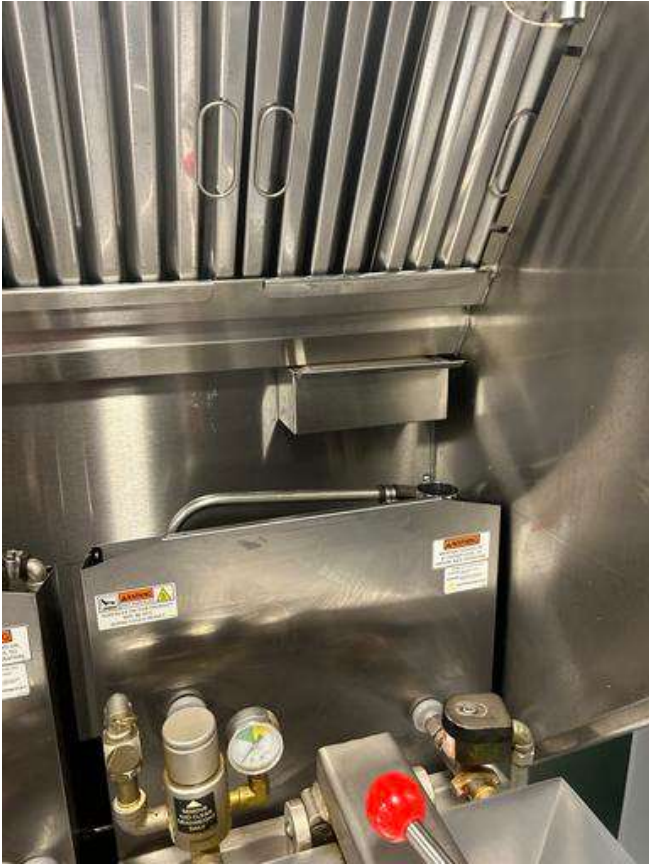
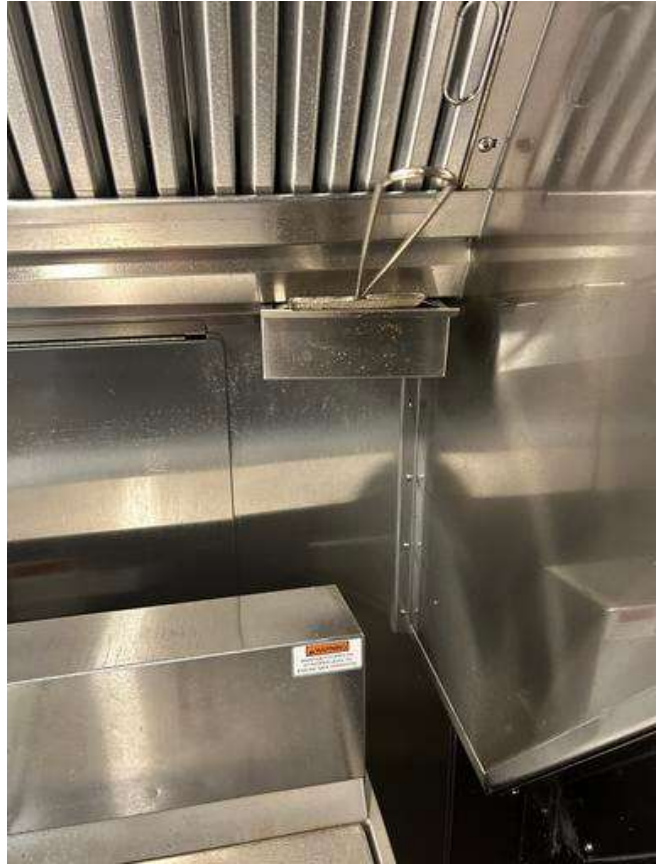
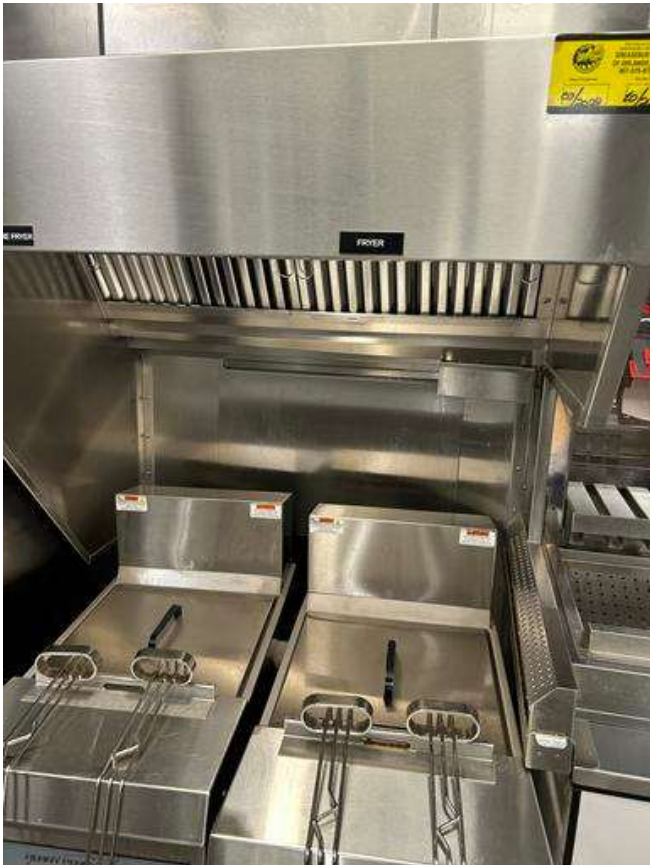
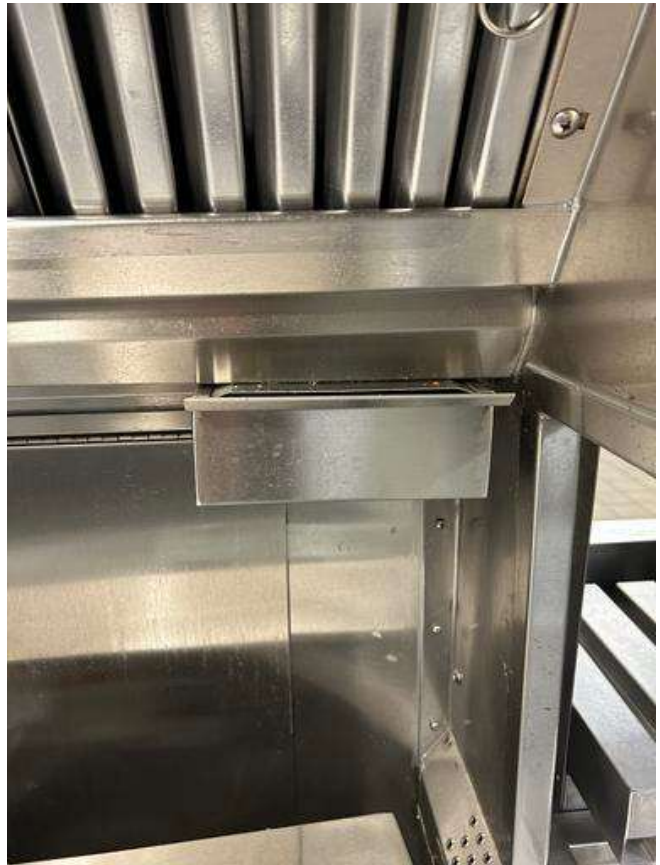
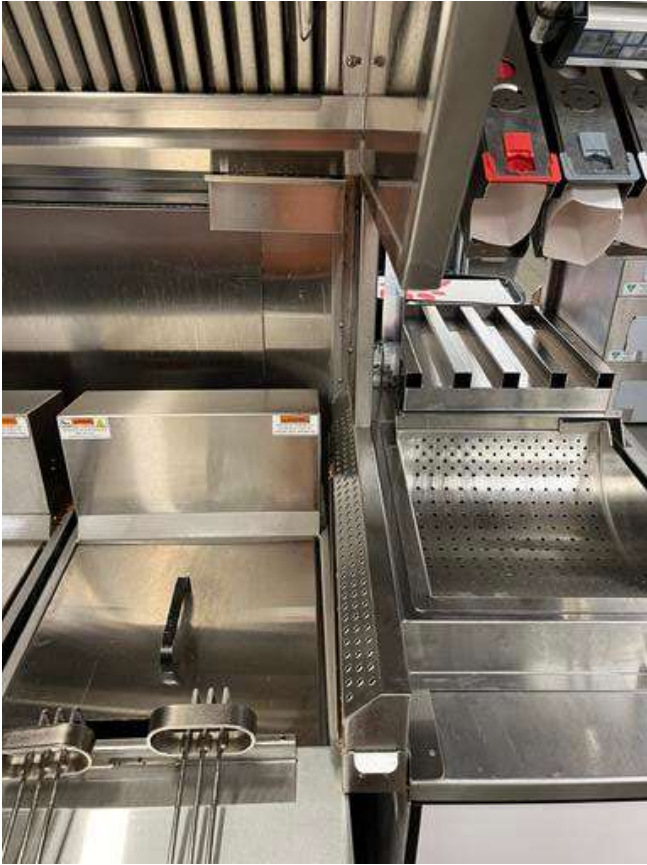
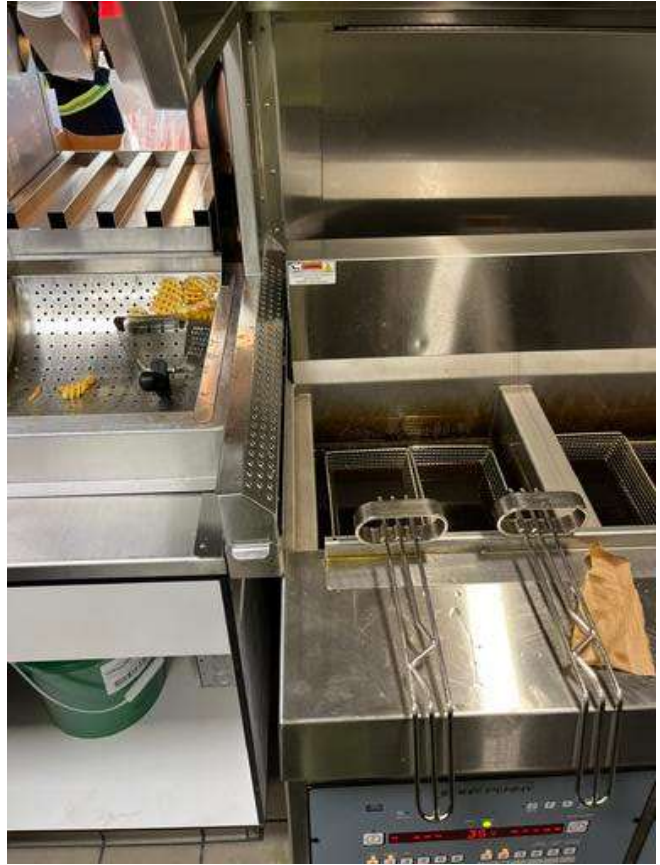
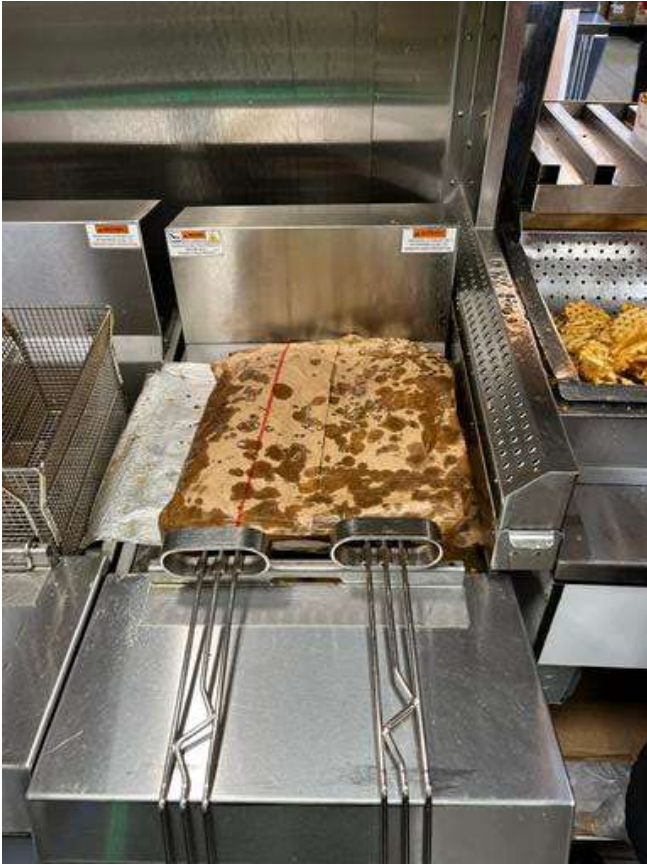
Hood is missing its grease cup and / or fry chute.

Hood 3 missing fry chute. All other fry chutes and grease cups installed.

See above comment, Hood 3 no fry chute

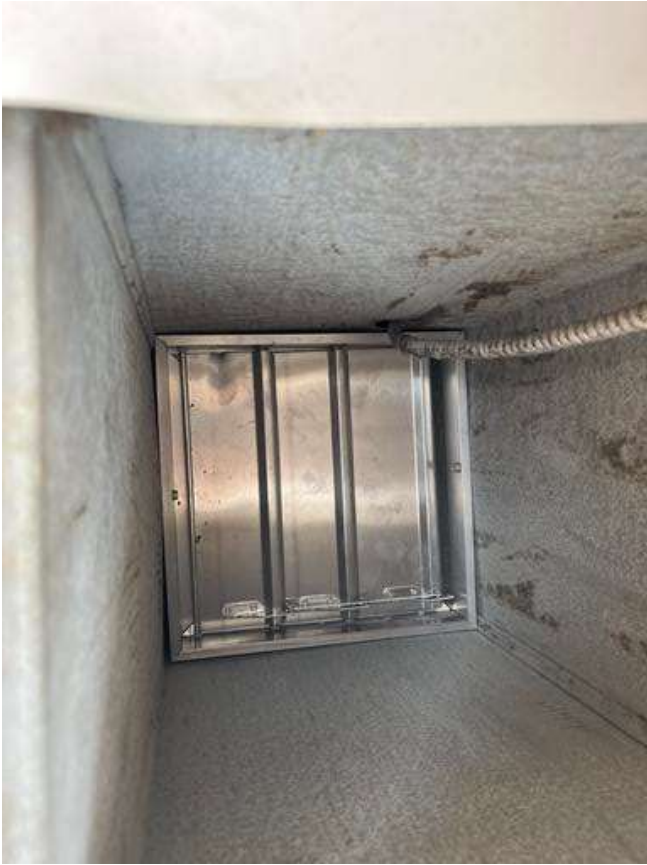
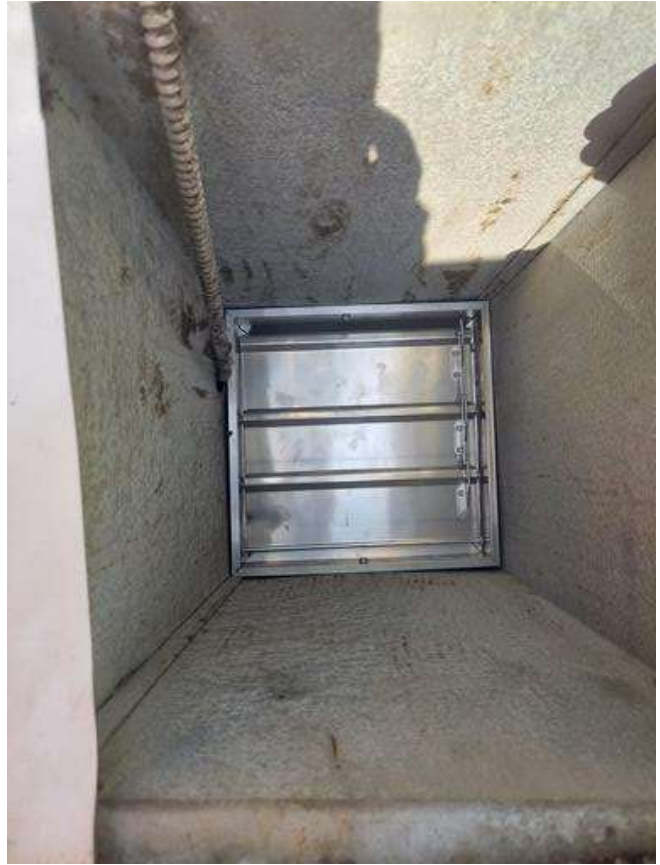
Restroom exhaust rectangular duct riser not correctly lined per specification.

Not complete. However this is an existing duct.

cannot line the duct due to existing and ceiling would need to be removed.

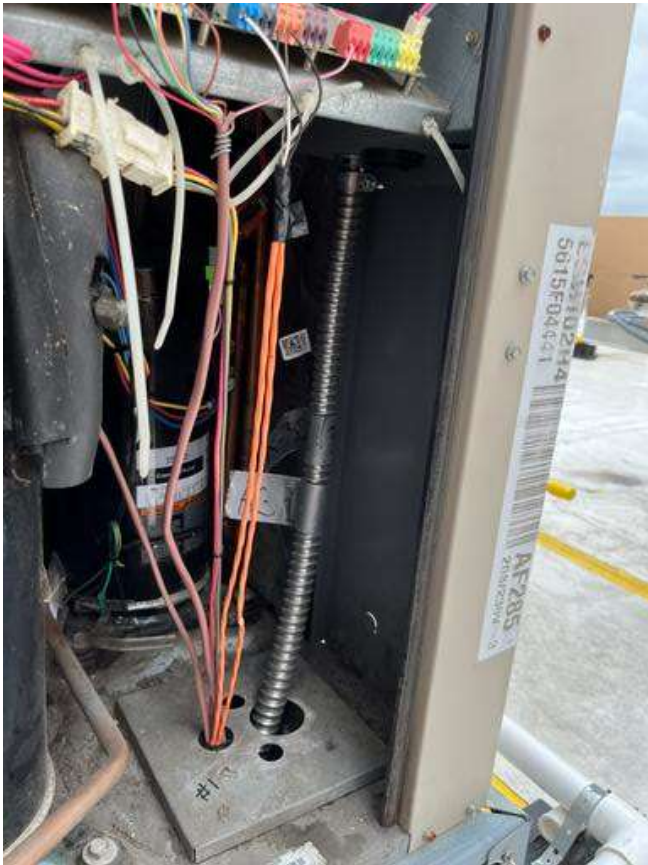
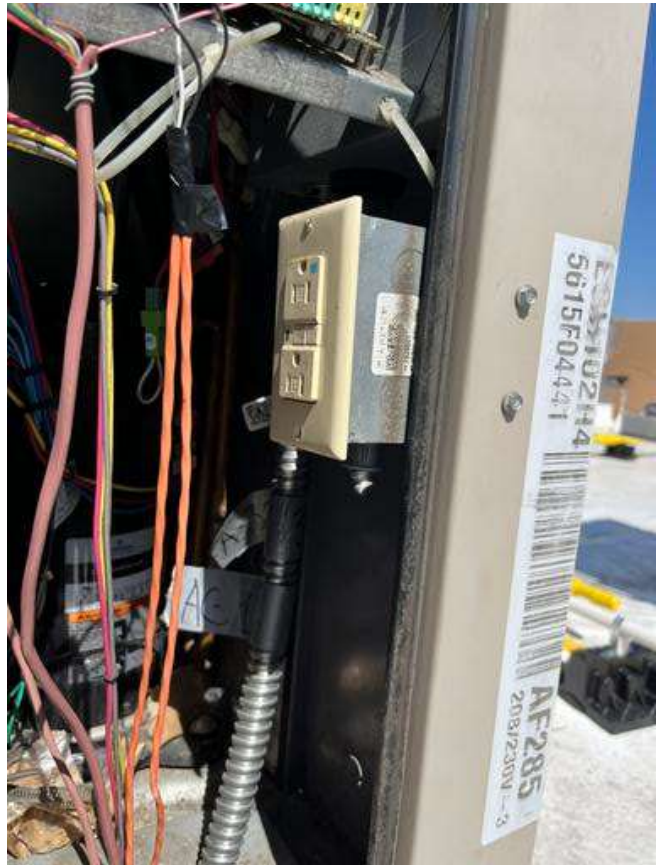
Equipment GFI outlet missing components (GFI itself, din rail with fuses) or not terminated/operational.
RTU 1

GFCI outlet removed from unit.
