PlanGrid Task Report - Sep 9, 2024

Prepared by Stephen Tassinaro

Sep 9, 2024

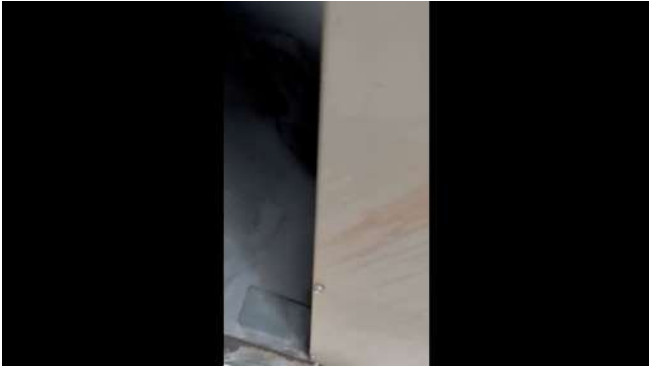
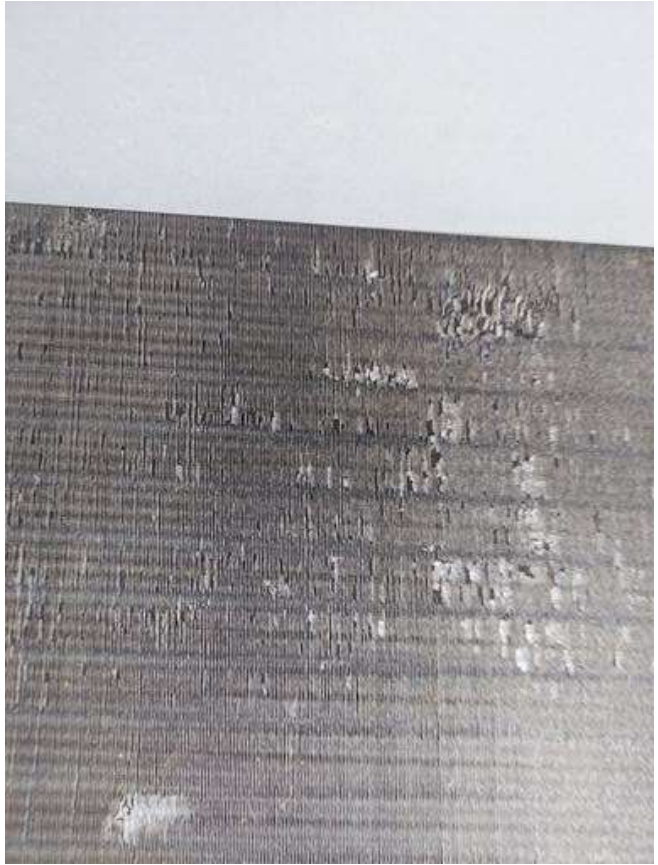
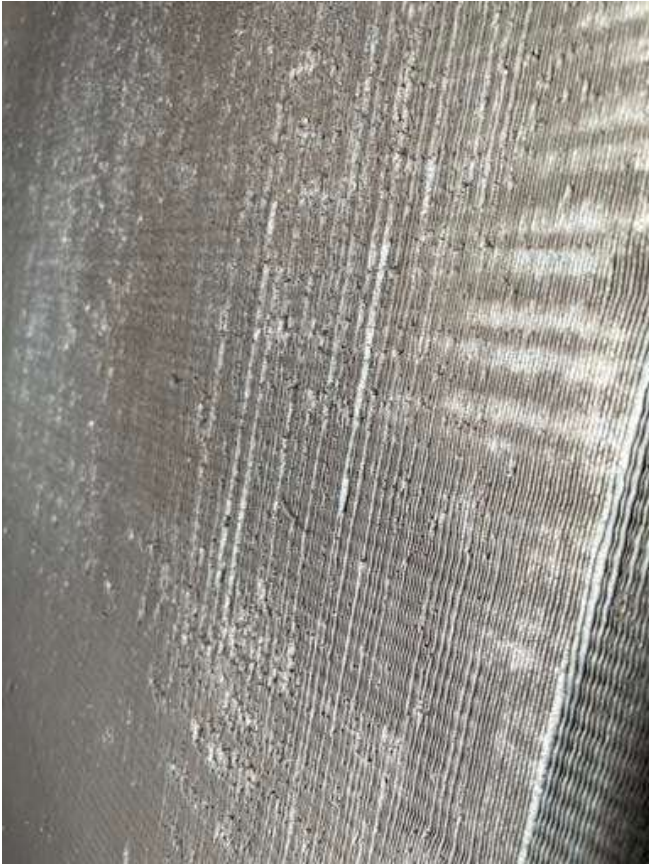
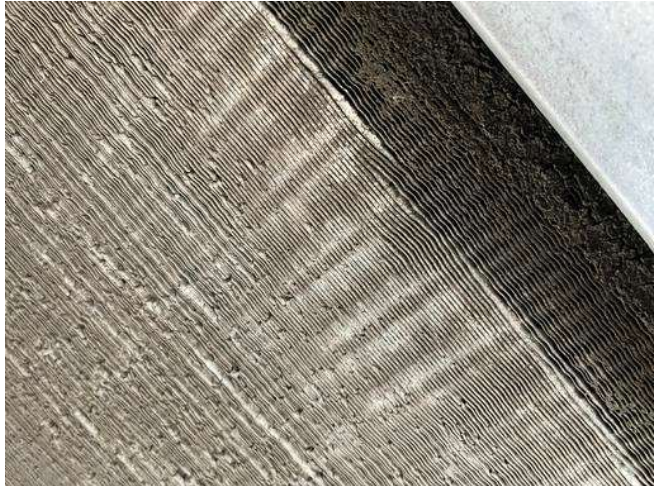
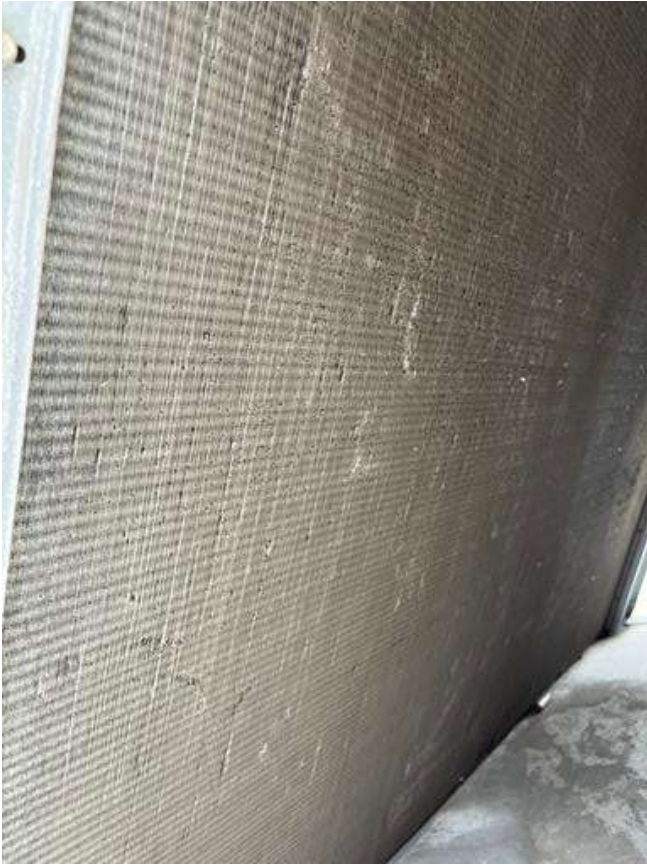
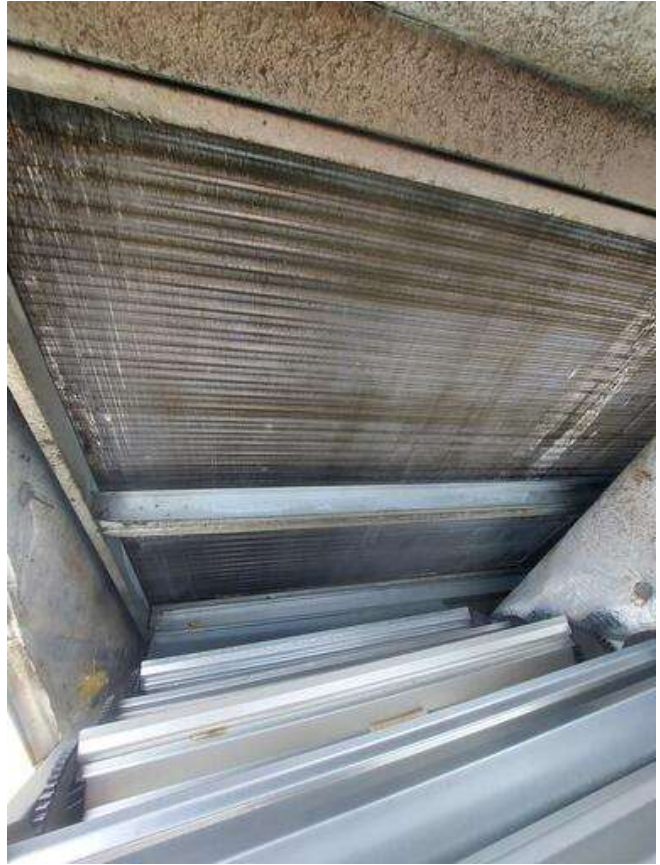
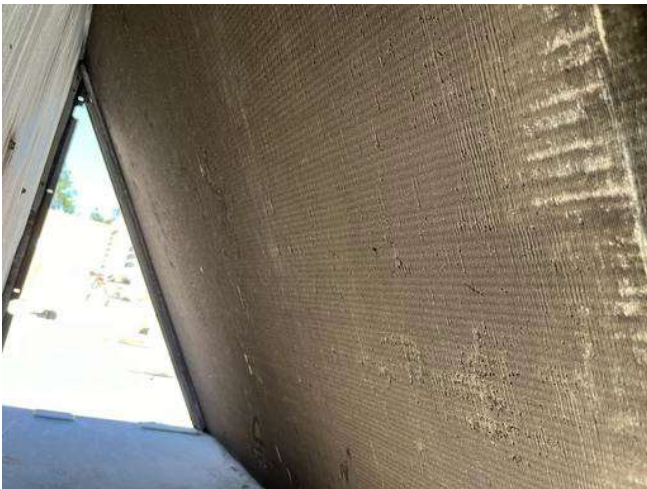
RTU 3 condenser coil is dirty and compacted. Cleaning recommended.

Evaporator coil confirmed to be cleaned. Condenser coil does not appear to have been cleaned.

Coils cannot be cleaned due to the amount of wear on them. suggest replacement. They were cleaned with cool water to avoid breaking or holes.
