# TAB Punch List CFA 05766 Brockport FSU

Prepared by Cody Collett

Oct 9, 2025

**L05766\_Brockport (NY) FSU**

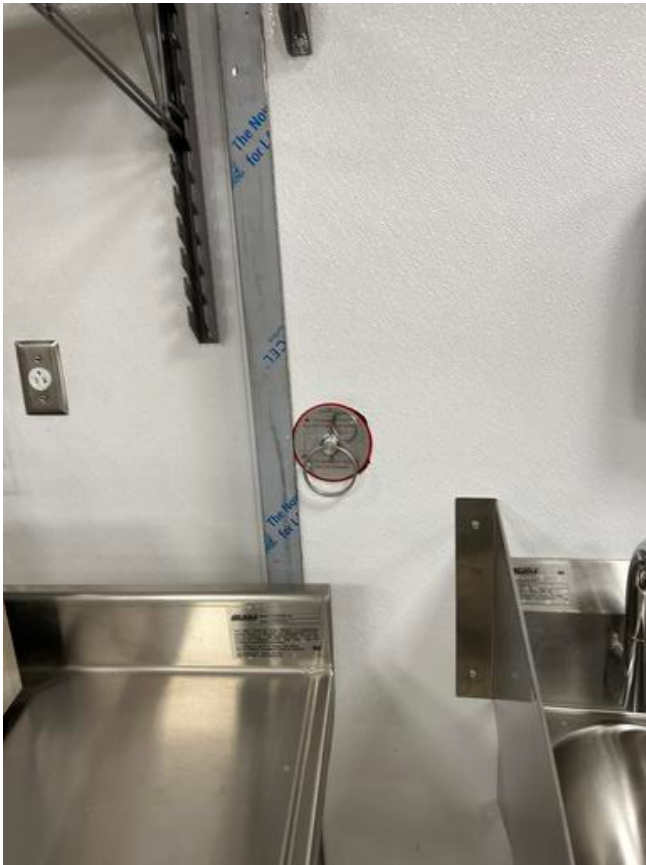
IMG\_1525  
Cody Collett  
Oct 7, 2025 7:47 AM

Label all ansul pull stations  
for which hoods they serve.

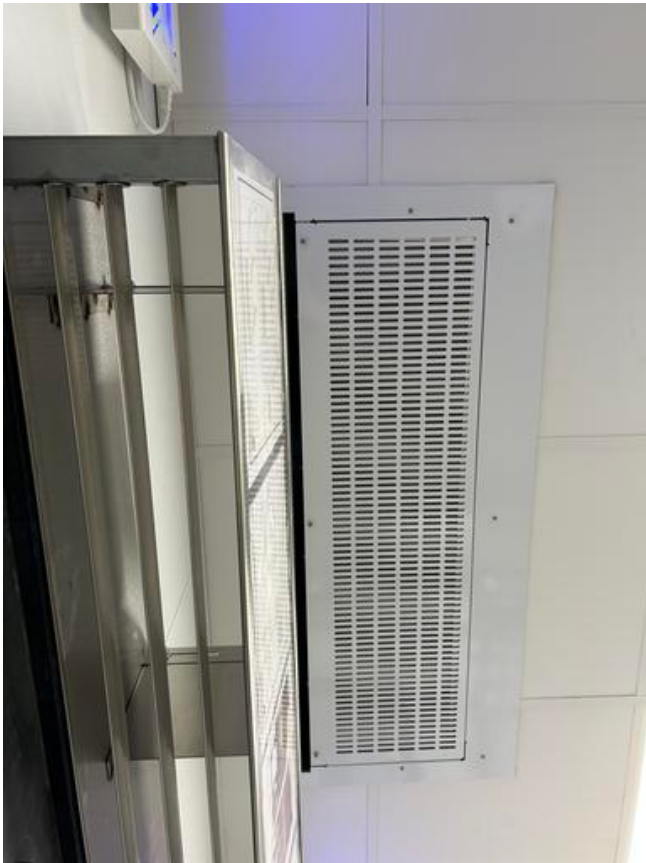
IMG\_1596

Drive through Air curtain diverter box is not installed correctly and should be bolted to wall, slid forward, and flush with door header.
