Report: TAB REPORT
Function: Test, Adjust, & Balance
Date: 02/05/2025
Completed By: National TAB

PROJECT
01-27-25 CAVA FISHERS, IN (116TH ST)

Project: 01-27-25 CAVA FISHERS, IN (116TH ST)

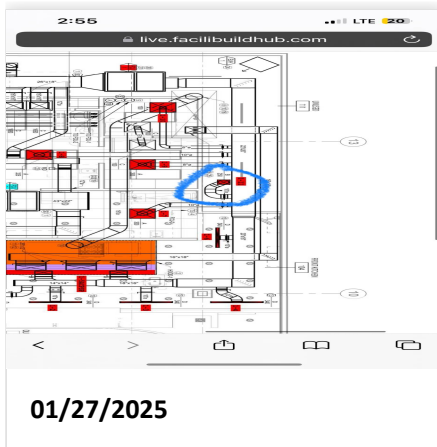
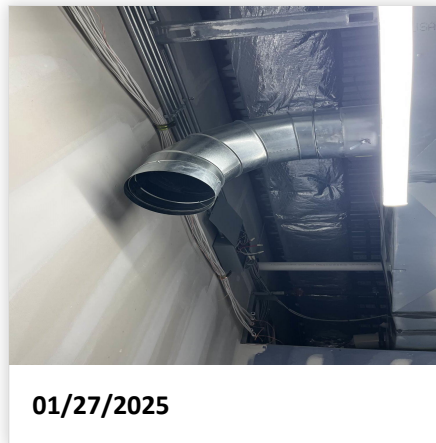
Issue Name : FCU1 missing diffuser 1-11
Description : Missing diffuser on FCU1 in the back labeled 1-11 on the GRD.
Created By : National TAB **Assigned To :** National TAB - Jacob Davidson
Status : Open
Priority : Urgent **Asset Tag :**
Originated Date : 01/27/2025 - Jacob Davidson - National TAB

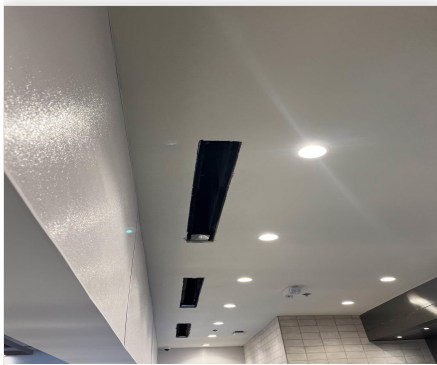
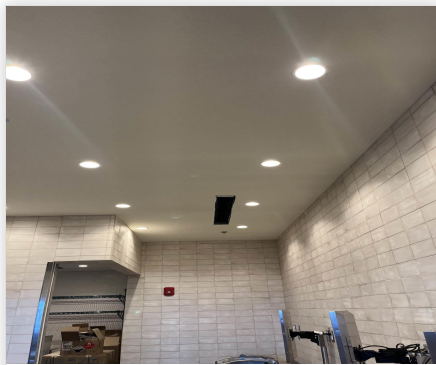
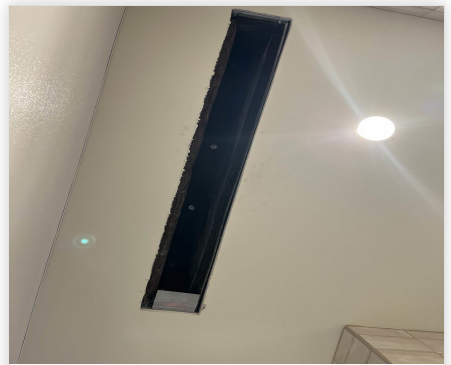
Issue Name : FCU1 missing linear grilles
Description : None of the linear grilles are installed on FCU1. These grilles will control the airflow to these diffusers so airflow cannot be set currently.
Created By : National TAB **Assigned To :** National TAB - Jacob Davidson
Status : Open
Priority : High **Asset Tag :**
Originated Date : 01/27/2025 - Jacob Davidson - National TAB

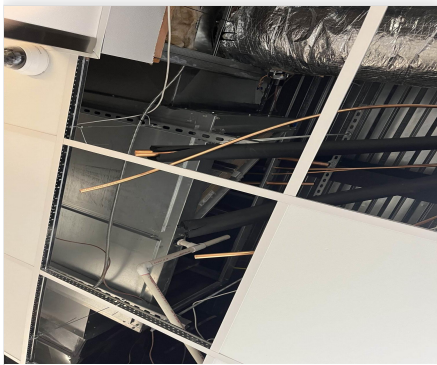
Issue Name : FCU1/FCU2 cooling lines not connected
Description : Cooling lines have not been connected to units so cooling is not active at the time of TAB and cannot be measured.
Created By : National TAB **Assigned To :** National TAB - Jacob Davidson
Status : Open
Priority : Medium **Asset Tag :**
Originated Date : 01/29/2025 - Jacob Davidson - National TAB

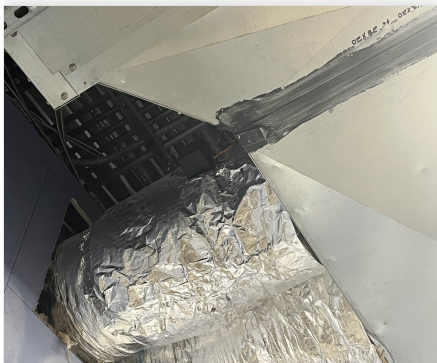
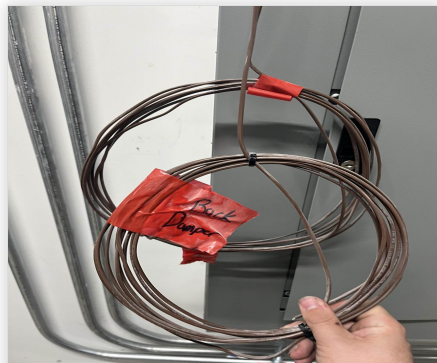
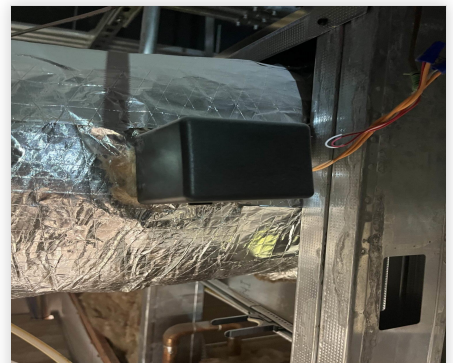
Issue Name : FCU1/FCU2 motorized dampers for OA not operational
Description : Motorized dampers for OA should be connected to 120V and synced with the occupied/unoccupied signal from a time clock. Currently neither OA damper is powered.
Created By : National TAB **Assigned To :** National TAB - Jacob Davidson
Status : Open
Priority : Urgent **Asset Tag :**
Originated Date : 01/28/2025 - Jacob Davidson - National TAB

Both FCU have their OA dampers closed because they were not powered for the duration of the TAB. OA was unable to be set manually.

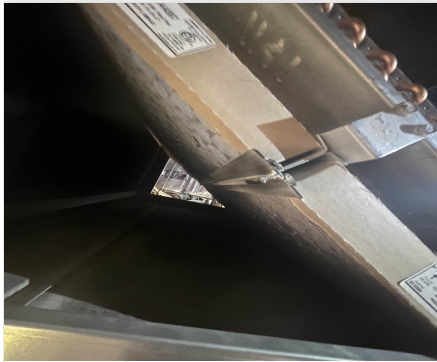
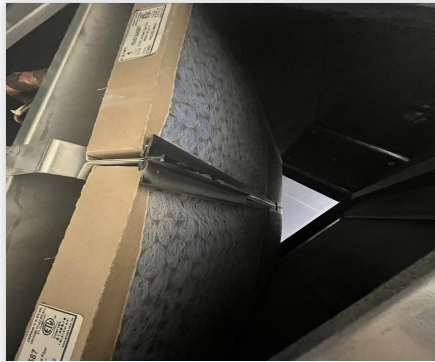
Issue Name : FCU1/FCU2 need new filters
Description : Filters are dirty for both FCU. Recommend replacing. They both take 4 - 16x24X2 filters.
Created By : National TAB **Assigned To :** National TAB - Jacob Davidson
Status : Open
Priority : Low **Asset Tag :**
Originated Date : 01/28/2025 - Jacob Davidson - National TAB

MERV FILTERS ARE NOT CLEAN

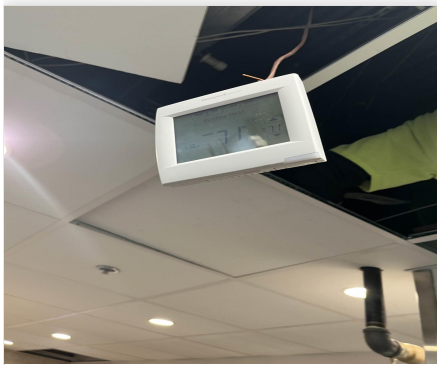
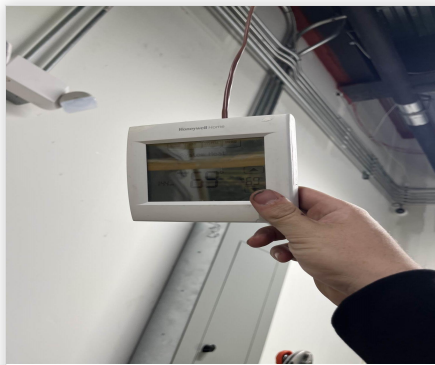
Issue Name : FCU1/FCU2 using temporary thermostats
Description : Both FCU are using temporary stats and setpoints will not be able to be saved.
Created By : National TAB **Assigned To :** National TAB - Jacob Davidson
Status : Open
Priority : High **Asset Tag :**
Originated Date : 01/27/2025 - Jacob Davidson - National TAB

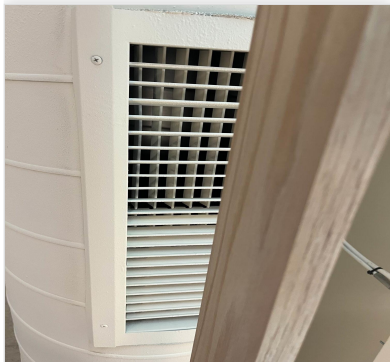
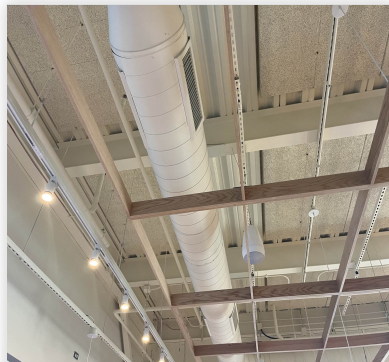
Issue Name : FCU2 all sidewall grilles missing air scoop dampers
Description : All sidewall grilles on FCU2 do not have air scoop dampers per their design on M-501. Tech will not be able to balance air to each diffusers design CFM.
Created By : National TAB **Assigned To :** National TAB - Jacob Davidson
Status : Open
Priority : Urgent **Asset Tag :**
Originated Date : 01/28/2025 - Jacob Davidson - National TAB

MISSING DAMPERS ON FCU2 FRONT DINING ROOM

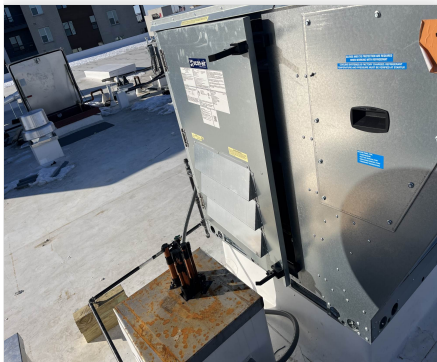
Issue Name : MAU control door cannot open fully
Description : Control door does not maintain minimum 36" clearance.
Created By : National TAB **Assigned To :** National TAB - Jacob Davidson
Status : Open
Priority : Medium **Asset Tag :**
Originated Date : 01/27/2025 - Jacob Davidson - National TAB

CONTROL DOOR DOES NOT MEET CLEARANCE REQUIREMENTS

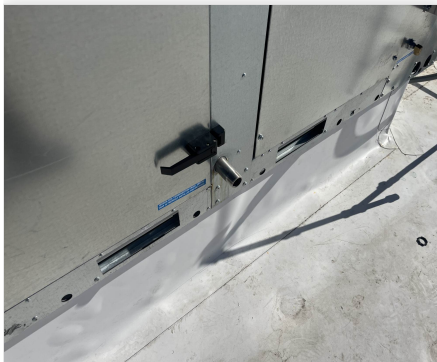
Issue Name : MAU no condensate line installed
Description : Condensate drain is not installed on MAU.
Created By : National TAB **Assigned To :** National TAB - Jacob Davidson
Status : Open
Priority : Low **Asset Tag :**
Originated Date : 01/28/2025 - Jacob Davidson - National TAB

CONDENSATE DRAIN NOT INSTALLED

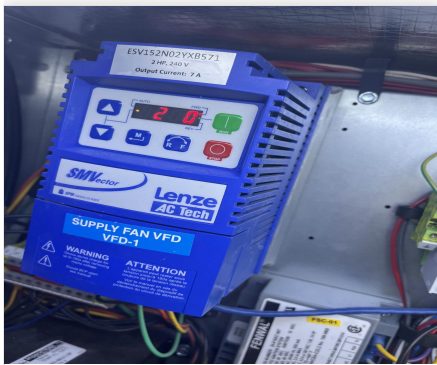
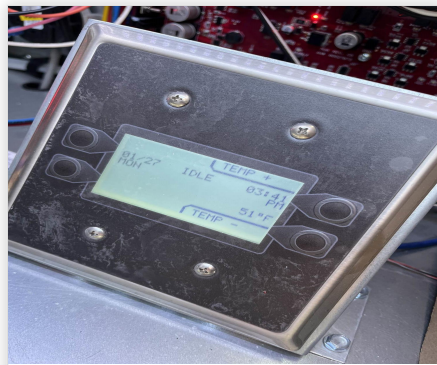
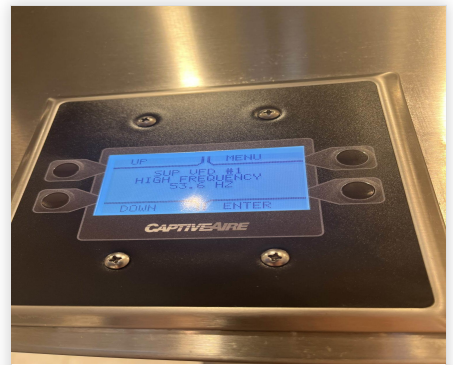
Issue Name : MAU not interlocked with hood
Description : Hood and MAU do not seem to be synchronized. A CAT5 cable was never installed between the VFD and hood panel. Unit was able to be set manually as a freestanding unit.
Created By : National TAB **Assigned To :** National TAB - Jacob Davidson
Status : Open
Priority : Urgent **Asset Tag :**
Originated Date : 01/27/2025 - Jacob Davidson - National TAB

HOOD AND MAU ARE NOT INTERLOCKED.
