Report: TAB REPORT
Function: Test, Adjust, & Balance
Date: 02/05/2025
Completed By: National TAB

PROJECT
01-27-25 CAVA FISHERS, IN (116TH ST)

Project: 01-27-25 CAVA FISHERS, IN (116TH ST)

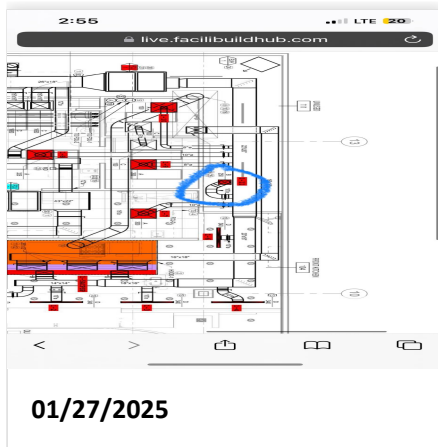
Issue Name : FCU1 missing diffuser 1-11
Description : Missing diffuser on FCU1 in the back labeled 1-11 on the GRD.
Created By : National TAB **Assigned To :** National TAB - Jacob Davidson
Status : Open
Priority : Urgent **Asset Tag :**
Originated Date : 01/27/2025 - Jacob Davidson - National TAB

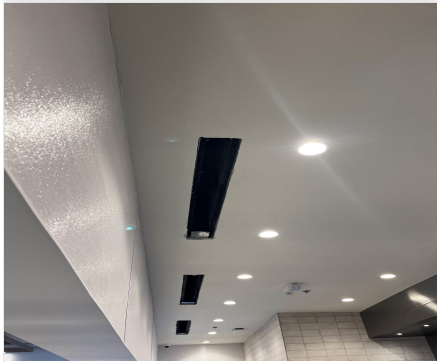
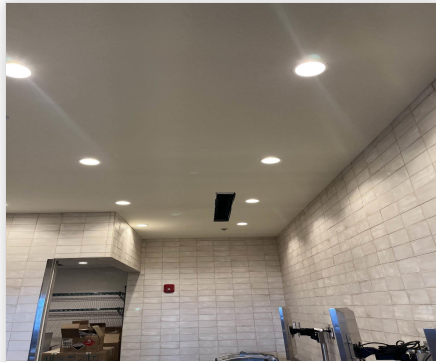
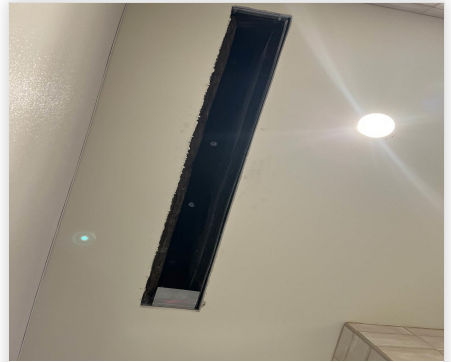
Issue Name : FCU1 missing linear grilles
Description : None of the linear grilles are installed on FCU1. These grilles will control the airflow to these diffusers so airflow cannot be set currently.
Created By : National TAB **Assigned To :** National TAB - Jacob Davidson
Status : Open
Priority : High **Asset Tag :**
Originated Date : 01/27/2025 - Jacob Davidson - National TAB

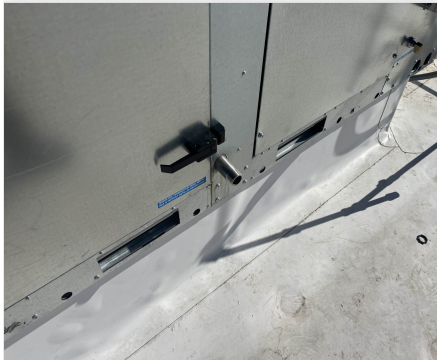
Issue Name : MAU no condensate line installed
Description : Condensate drain is not installed on MAU.
Created By : National TAB **Assigned To :** National TAB - Jacob Davidson
Status : Open
Priority : Low **Asset Tag :**
Originated Date : 01/28/2025 - Jacob Davidson - National TAB

CONDENSATE DRAIN NOT INSTALLED
