# PlanGrid Task Report - Jul 15, 2025

Prepared by Michael McDonnell

Jul 15, 2025

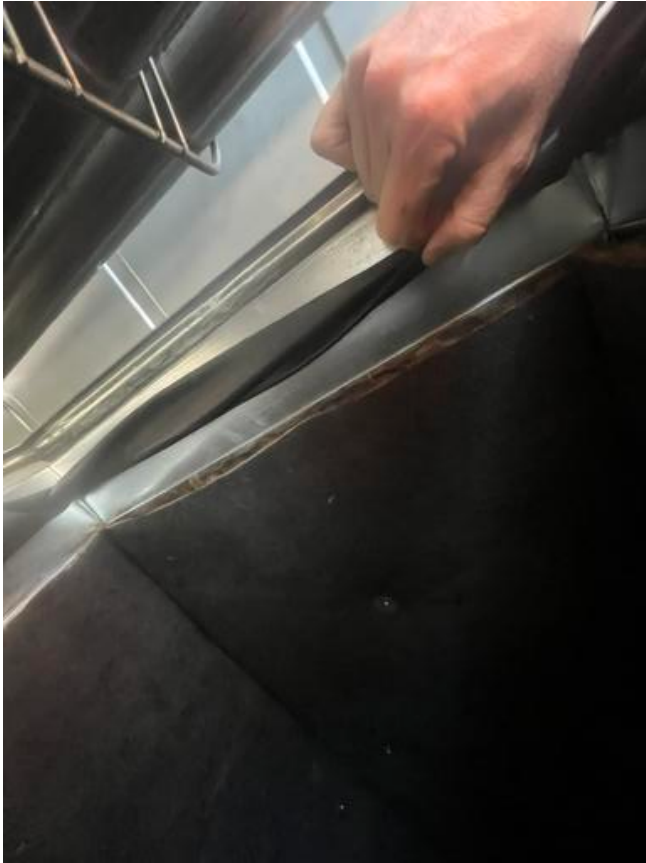
IMG\_9638

Canvas connections are installed but are not serving their purpose. The canvas is pinched and metal from the top and the bottom is making contact, failing to isolate the ductwork from the unit. Recommend all AC canvas connectors are reviewed.

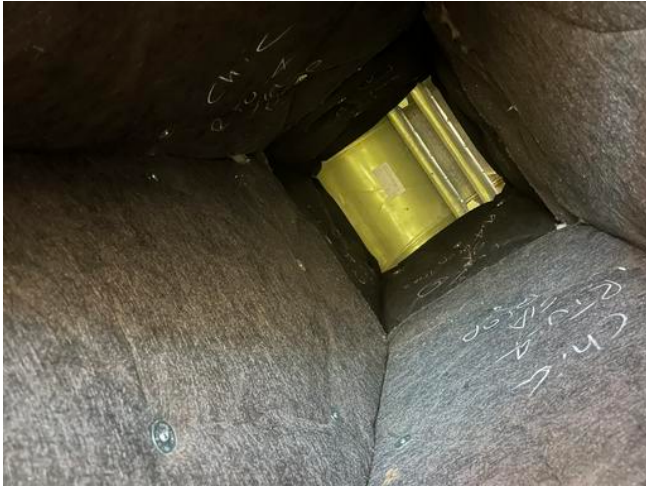
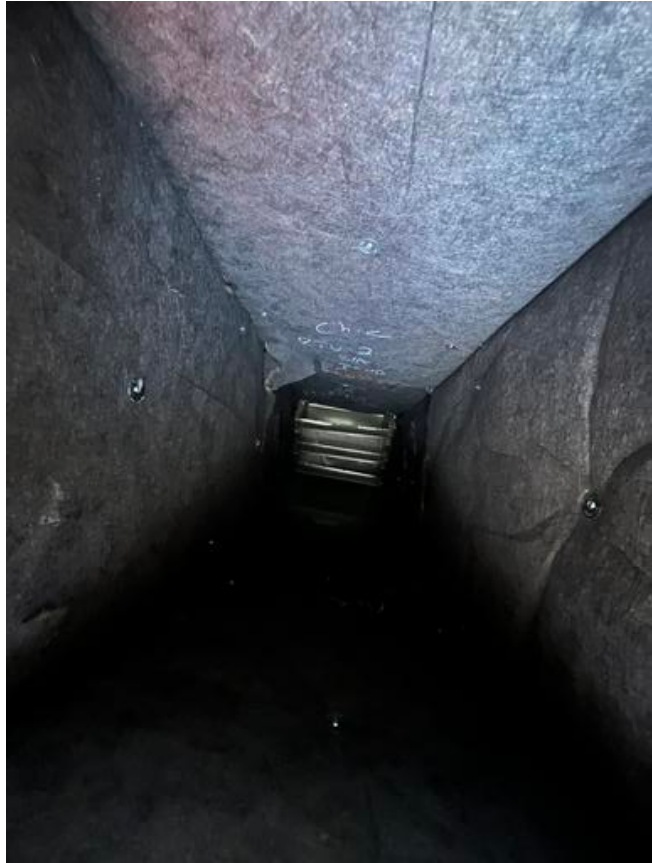
Double thickness turning vanes are present in the system. Per specification only single thickness are to be installed in 90 degree turns where any dimension is greater than 12". Duct is not designed to accommodate the static drop across double thickness vanes. Remove and replace. Unable to balance system until corrected.

Vanes have crimp marks, indicating they are double thickness.

Recommend verifying these are single thickness.

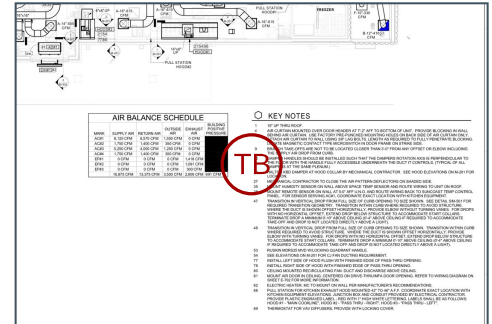
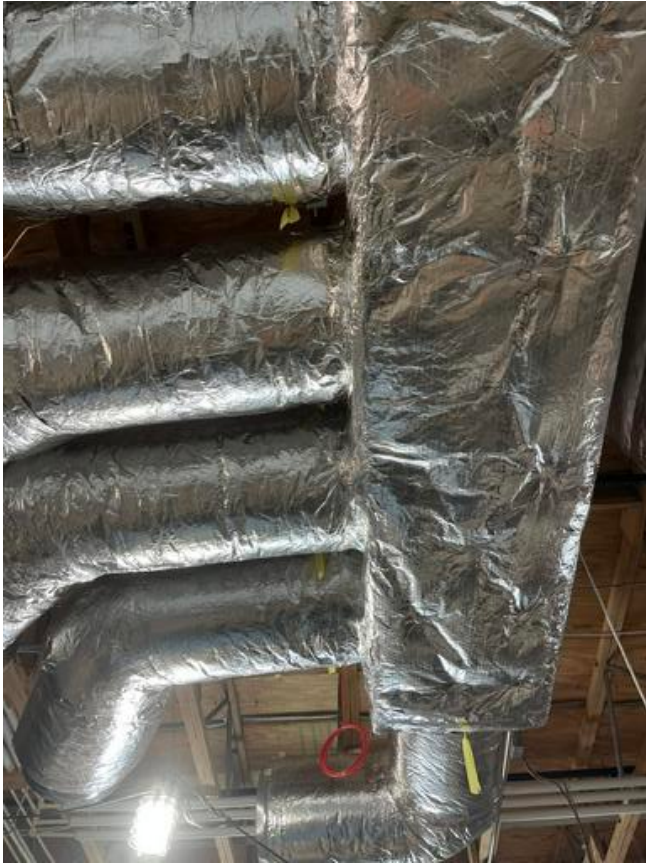
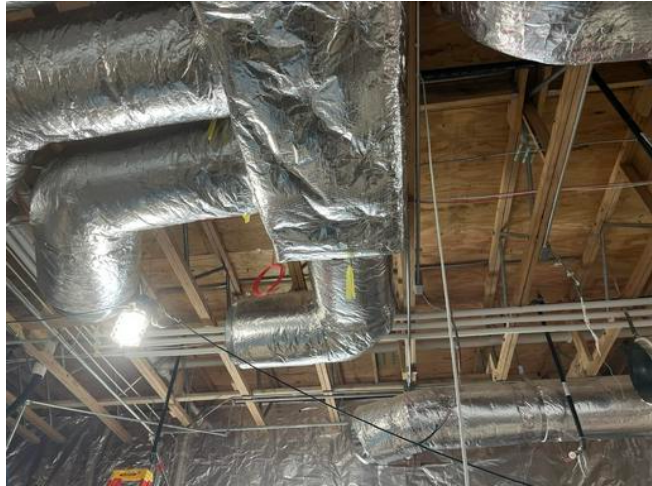
**Sheet**  
M-101L

Dampers to be installed parallel to airflow. In horizontal runs, position damper on left or right at 9 or 3 o'clock. On vertical ducts position damper on bottom only (6 o'clock).

AC-1 Return dampers need to be reoriented. Note 12 pertains to all returns on that plenum. Note lacks clarity as plans show noted damper on bottom, but all others on plenum on the side. Recommend plans are reviewed.

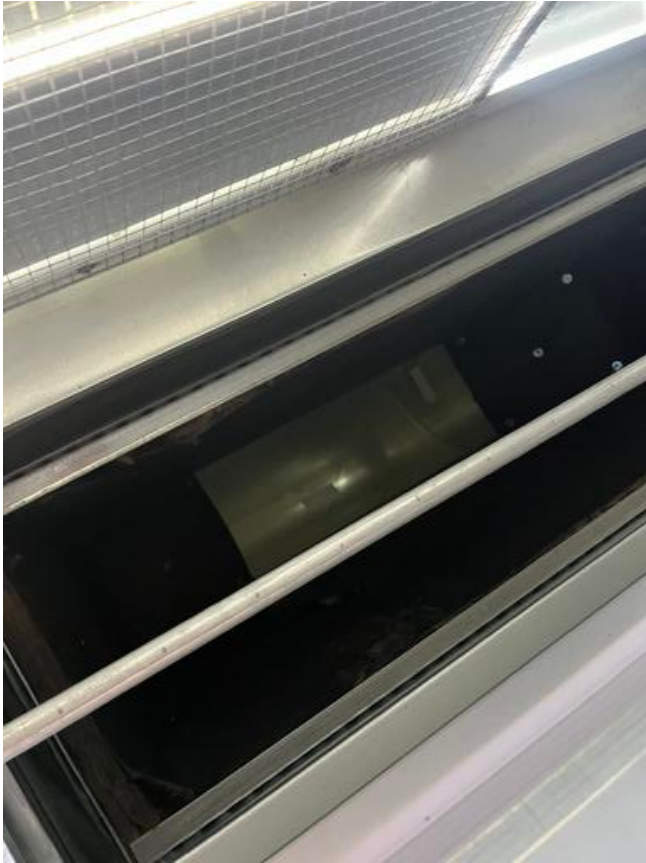
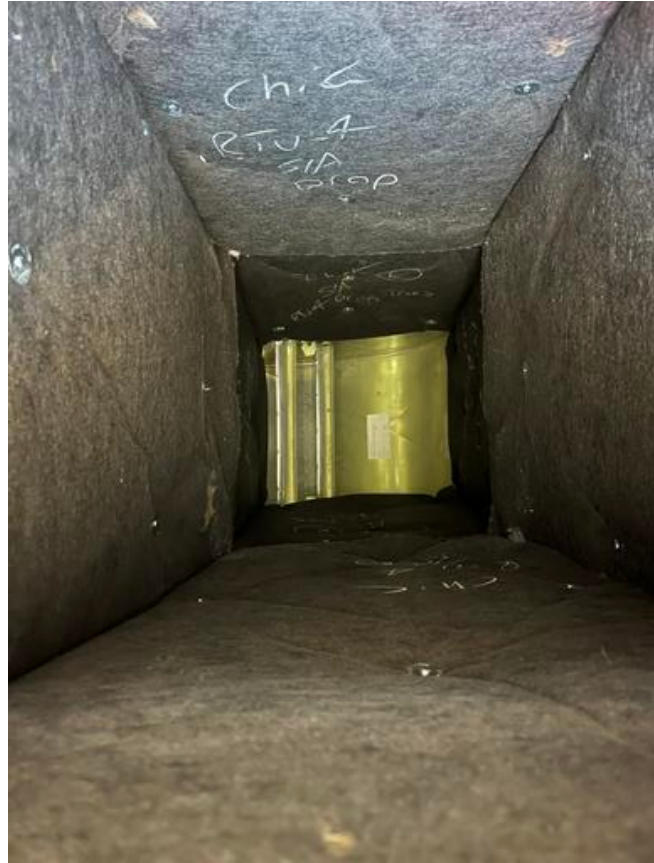
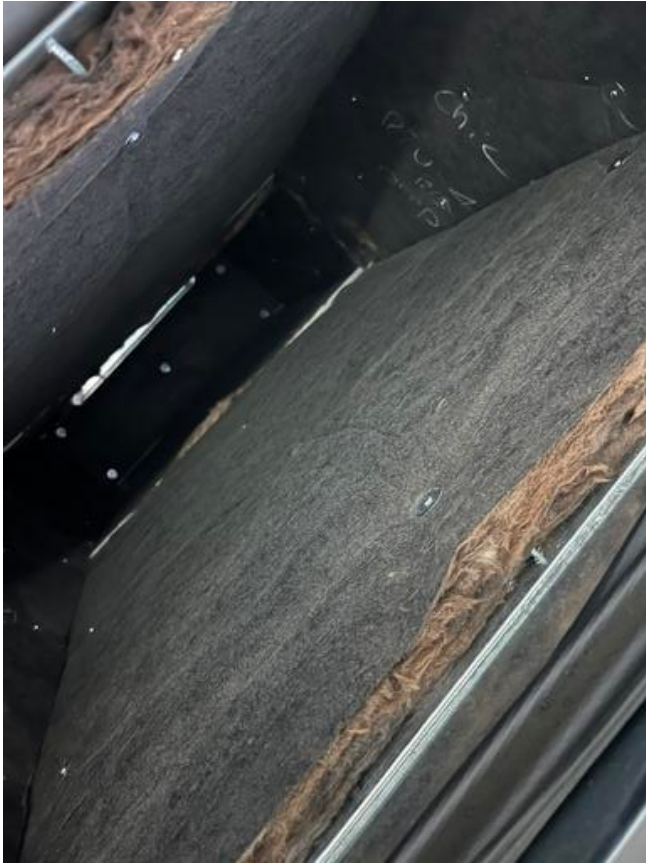
Duct is lined and restricts inside clear dimensions, remove and externally insulate. Only restroom rectangular duct is to be lined.

On all AC units, both the Supply and Return Drops are internally lined and externally insulated. Remove internal liner.

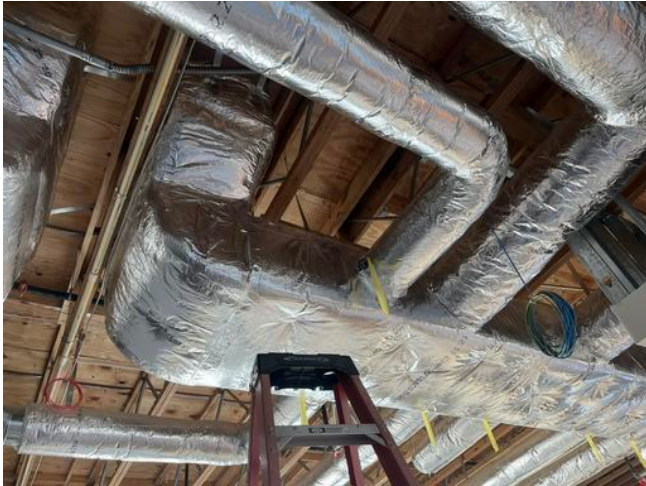
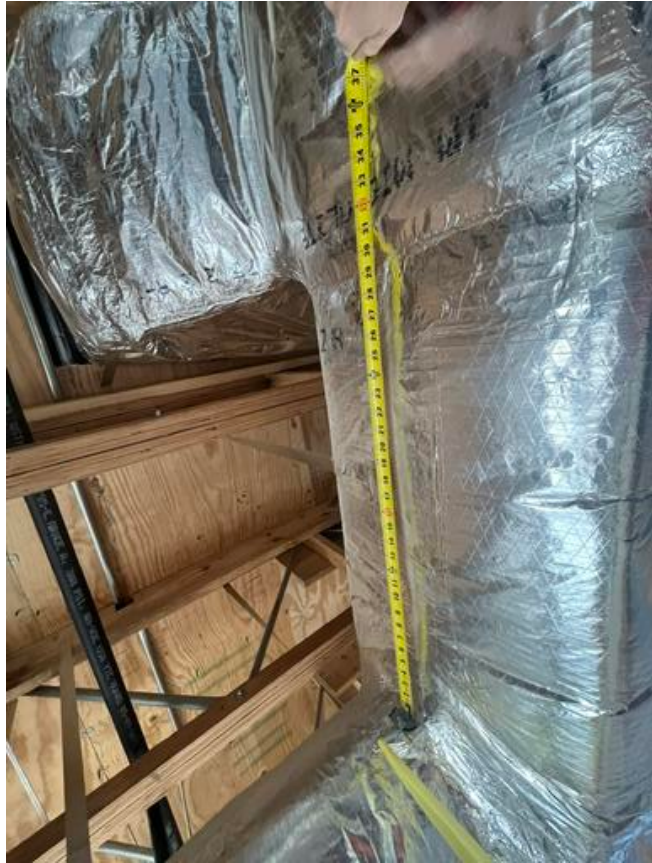
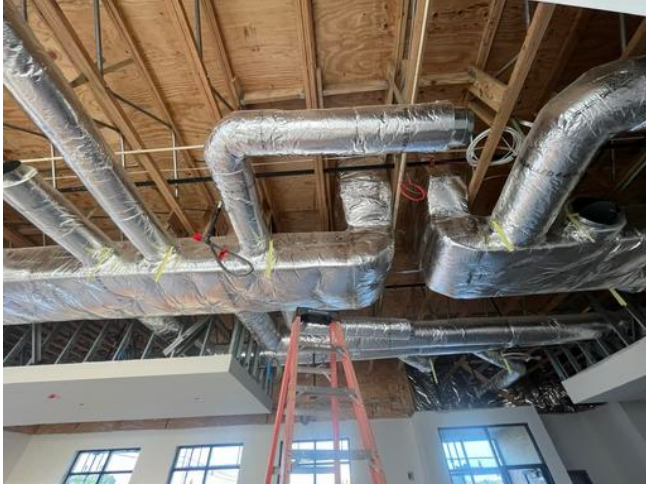
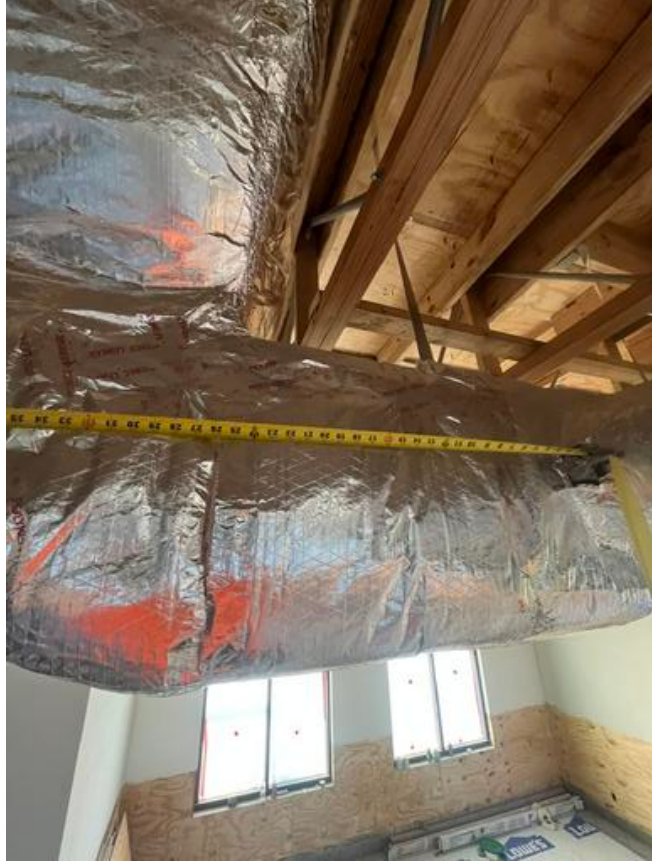
Takeoff does not maintain 3'0" from offset or drop transition per specification. Recommend moving takeoffs away from drop to avoid potential low airflow issue.

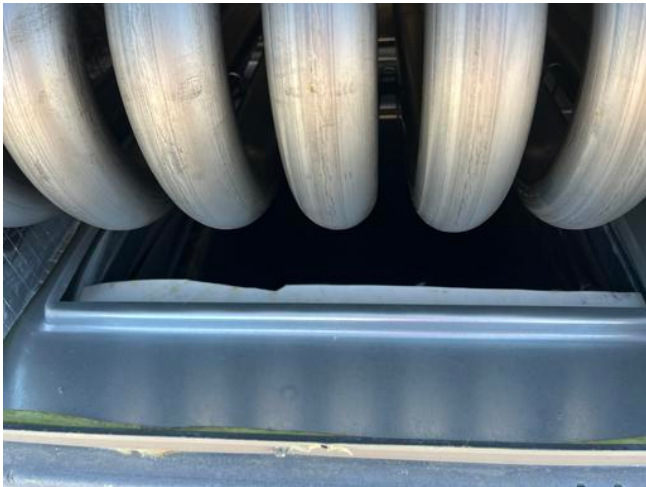
IMG\_9636

Recommend Roofing material in supply discharge is cut away.

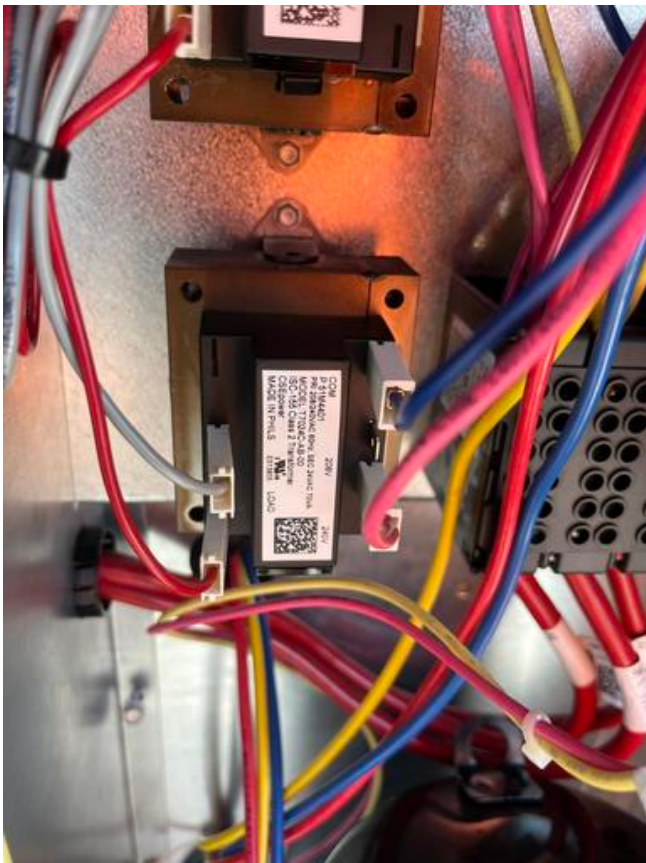
IMG\_9678

The transformer voltage is not swapped to the correct input voltage.

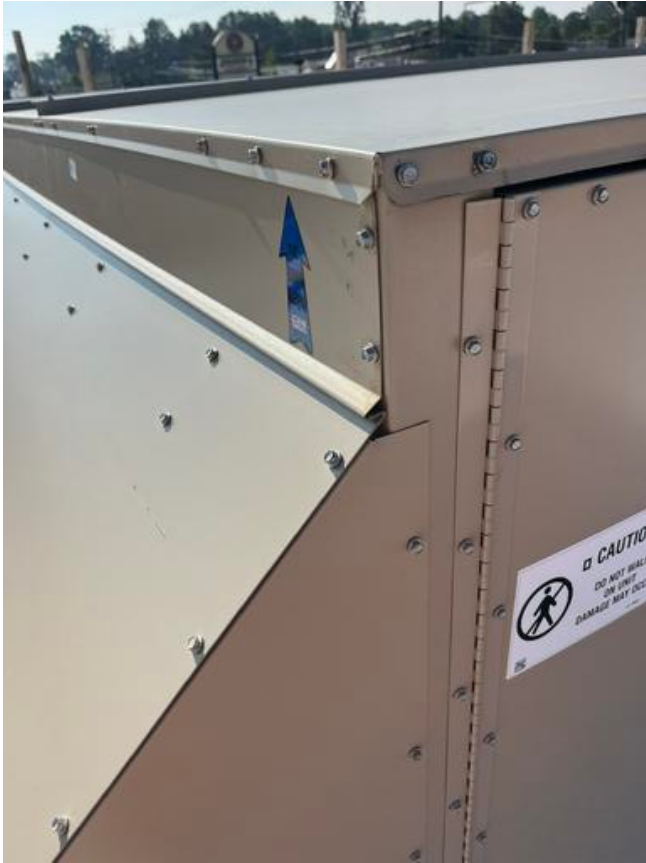
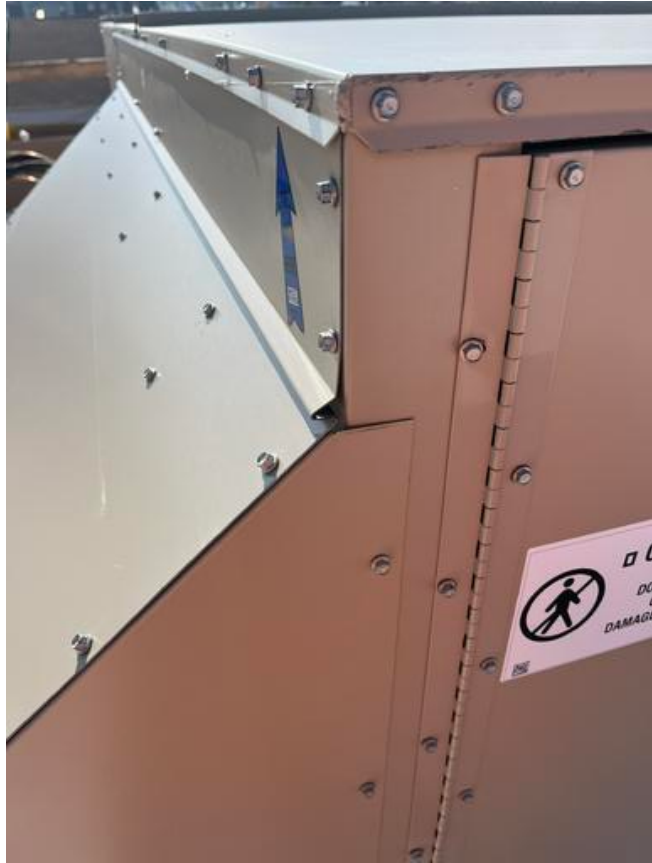
OAs must be caulked/  
gasketed to prevent water  
infiltration.

Caulk OA hoods

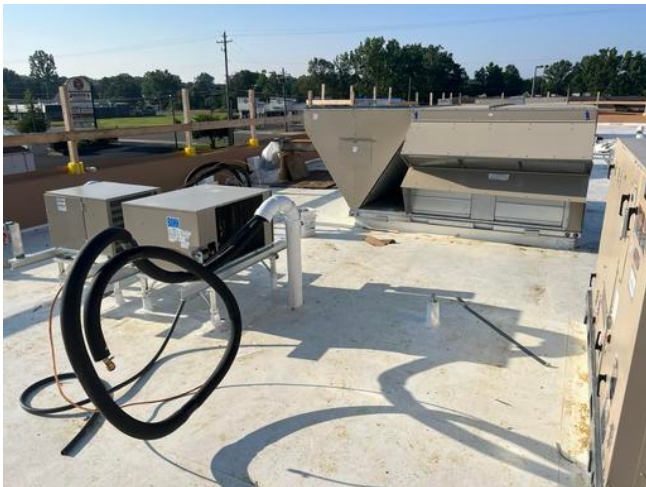
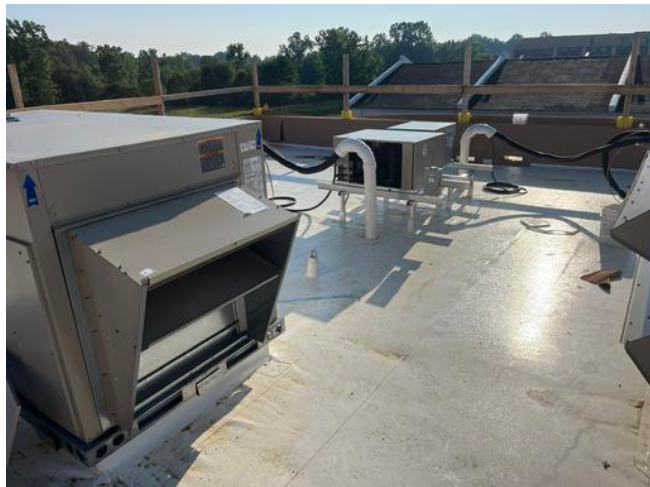
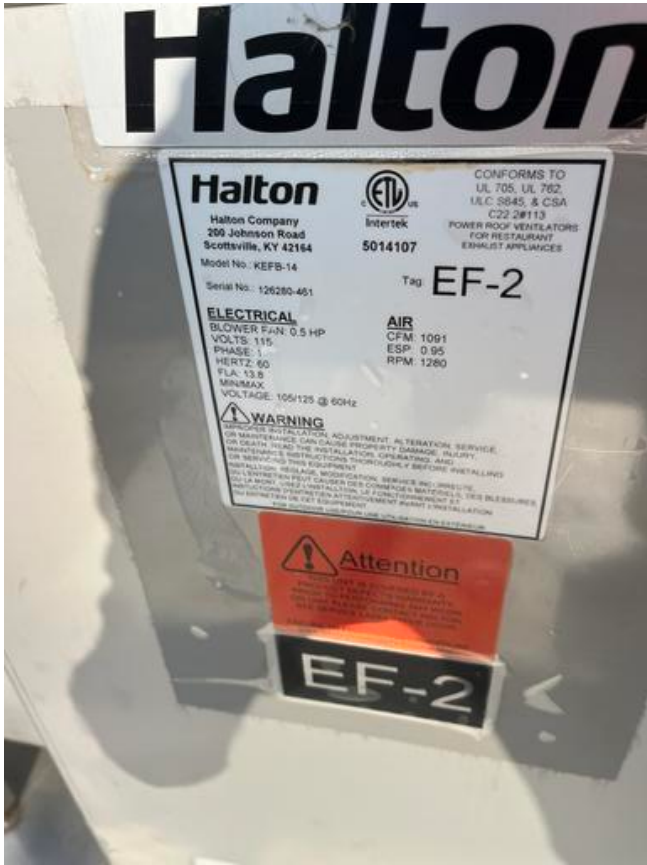
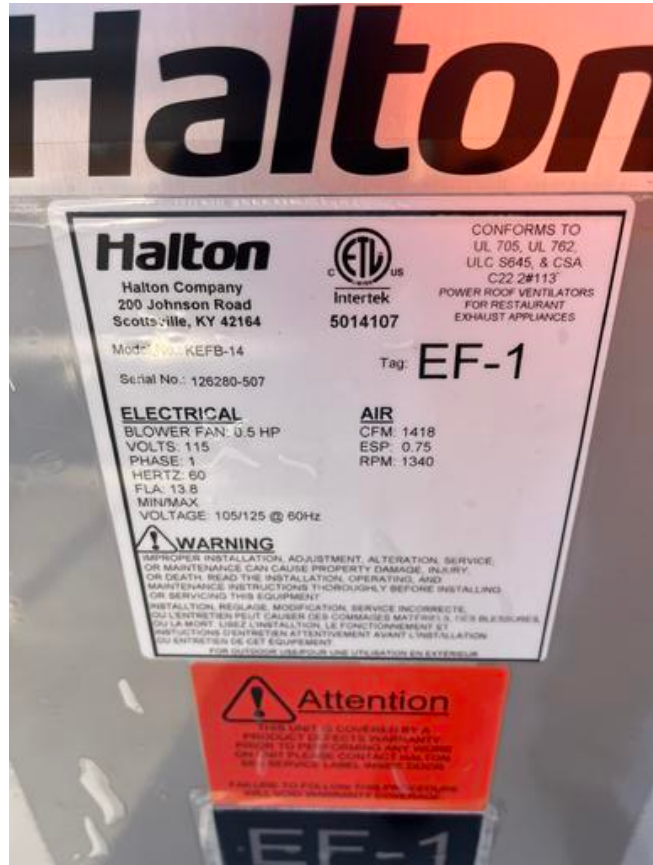
Recommend orientation of Condensers is reviewed. WIF condenser is discharging in general direction of AC-1 and AC-4 Outdoor air intakes.

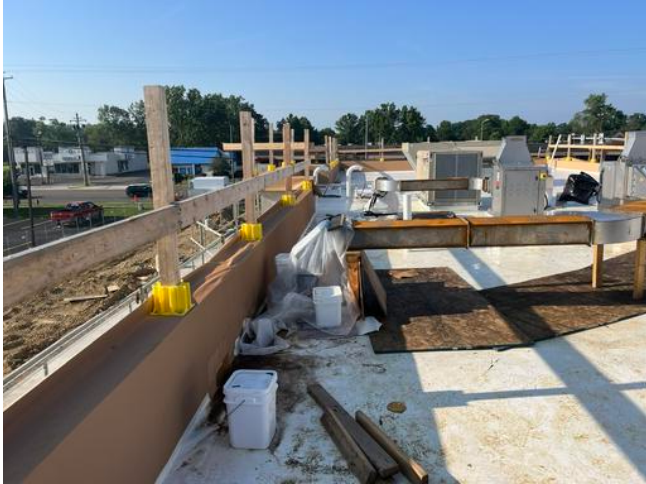
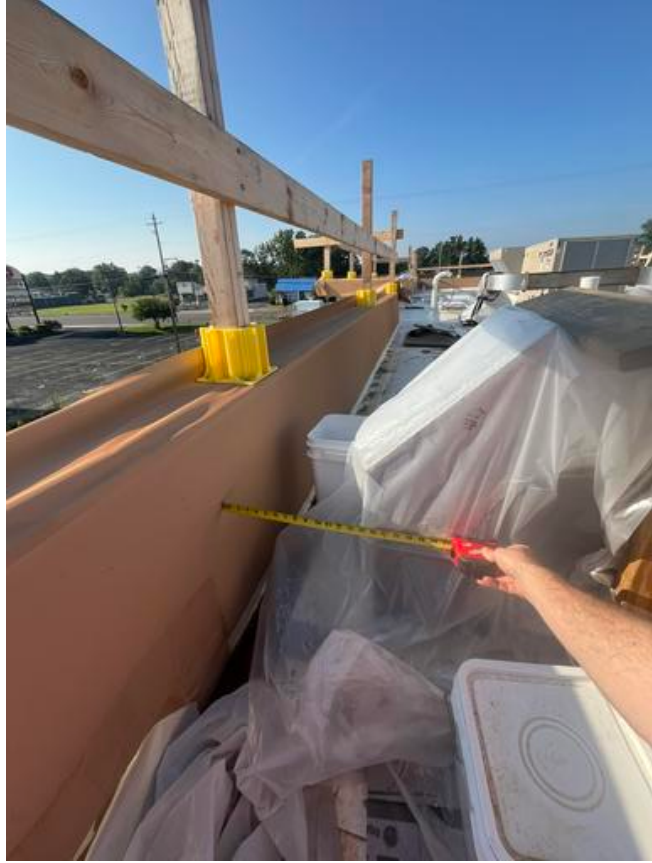
Key Note 87 on M-102L indicates all duct penetrations on roof must be at least 18" from parapet. EF-1 duct penetration does not comply. Recommend Review.

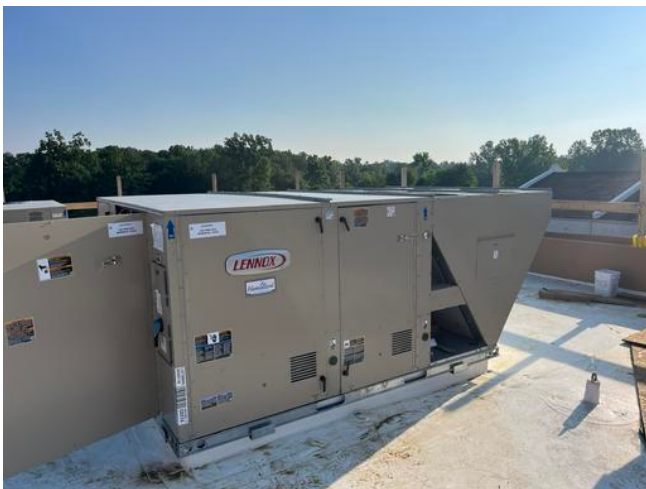
IMG\_9641

RTU Schedule indicates AC-1 (kitchen) is to have power exhaust installed. Forgot to verify, but do not remember seeing power exhaust fans installed below OA intake at relief. Please verify AC-1 has Power Exhaust option installed and it is operational once powered.

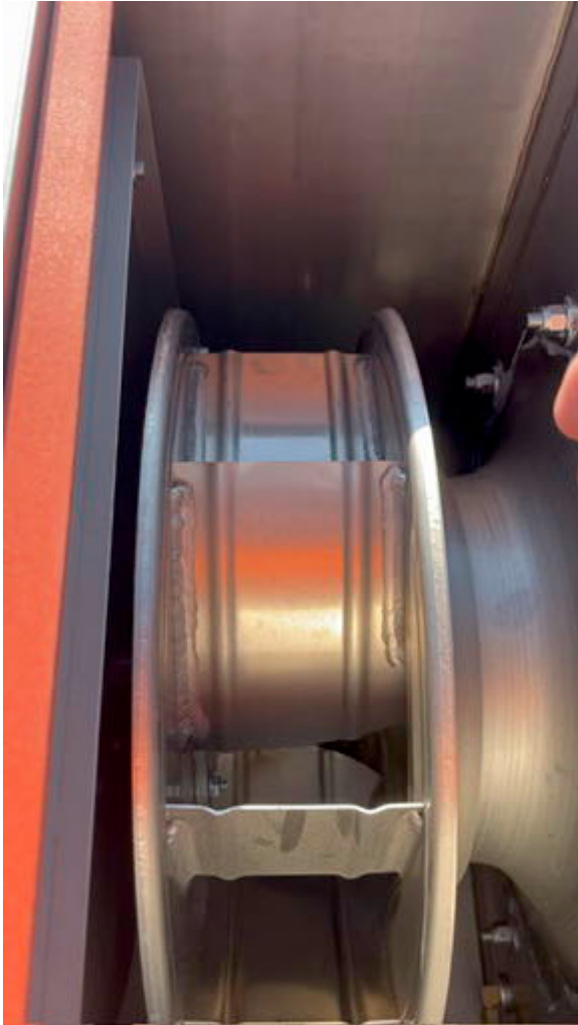
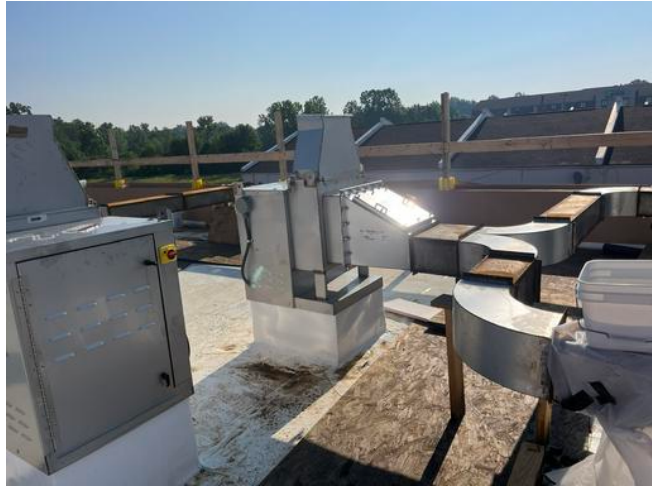
EF-2 blower wheel needs adjustment. The fan rubs when it is spun. Typically, the fan needs to be moved further in, towards the duct
