TAB Punch List CFA #05811 (Alliance FSU)

Prepared by Ben Searles

Sep 12, 2025

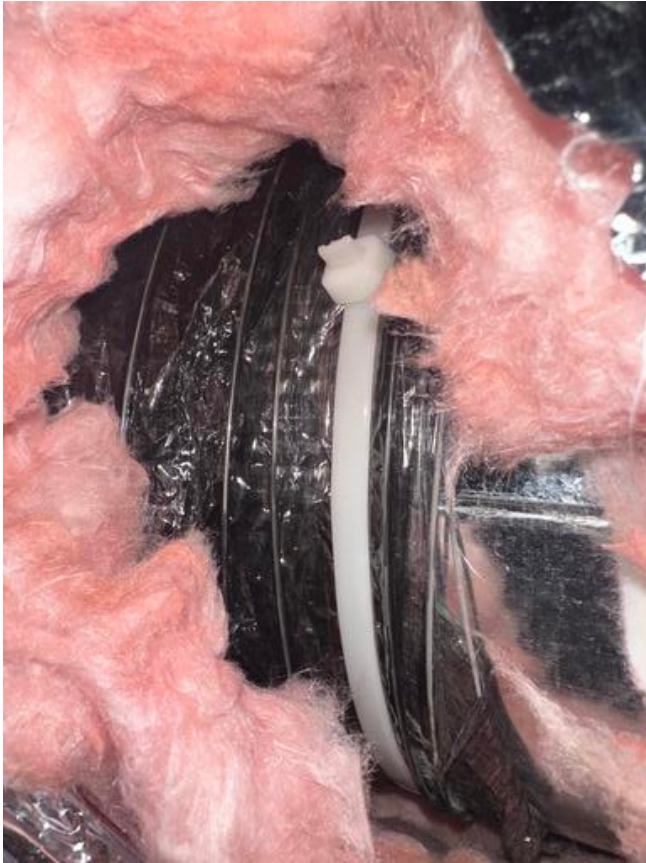
IMG_2867

#95 [DUCT 006] [NEW] CRITICAL – Flex duct installation.

Ensure flex inner core is taped and banded, along with tape or banding on outer insulation jacket. Flex is to be ran in lengths no greater than 4'0" in horizontal positions only.

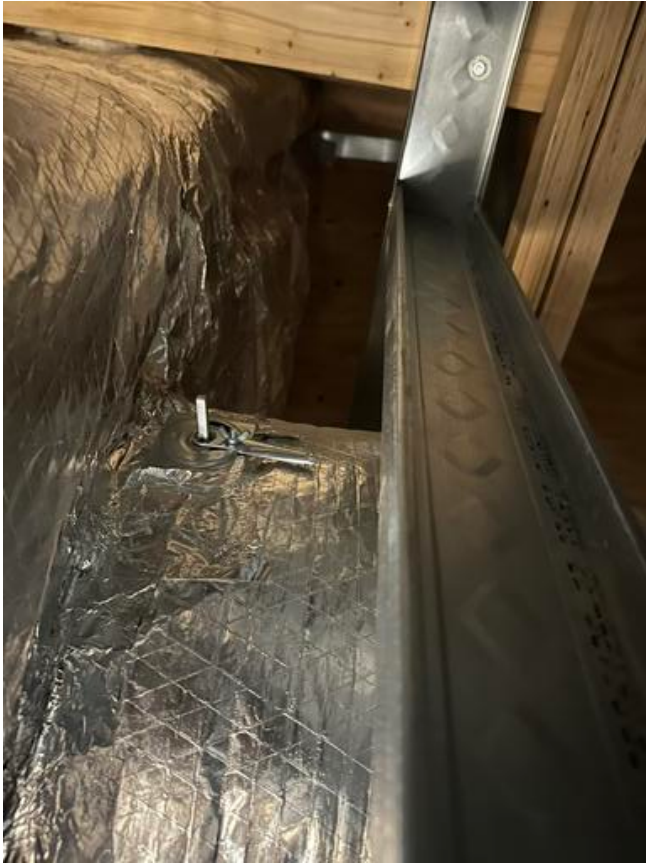
IMG_2837

#94 [DUCT 008] [NEW] CRITICAL – Start collar damper orientation.

Dampers to be installed parallel to airflow. In horizontal runs, position damper on left or right at 9 or 3 o'clock. On vertical ducts position damper on bottom only (6 o'clock). Plans are incorrect and call for the damper to be on the side. Recommend putting the damper to the bottom of the duct and ensuring the damper is fully open.

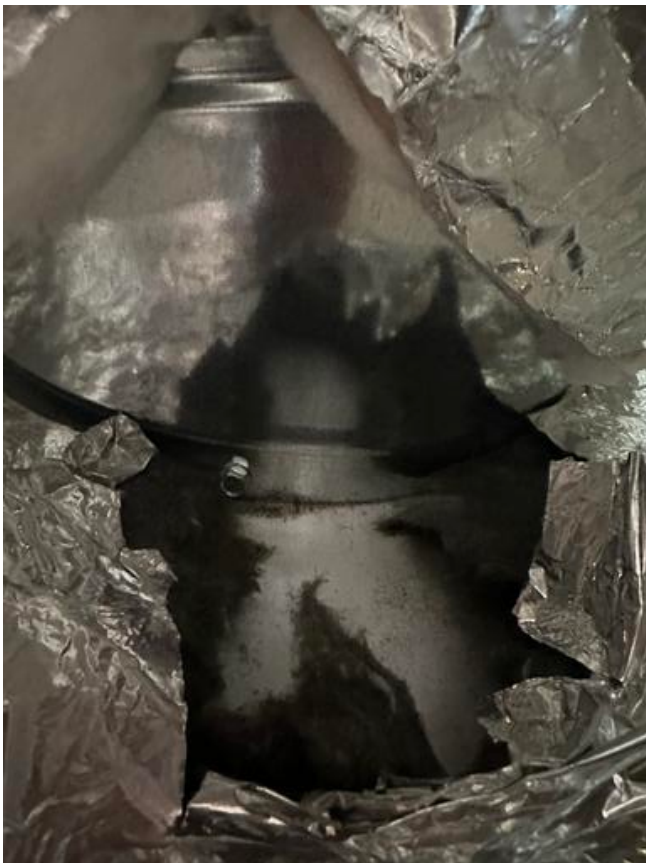
IMG_2866

#93 [DUCT 499] [NEW] CRITICAL (MISC) – Diffuser Connections

Ensure there is mastic at the hard pipe connection to diffusers

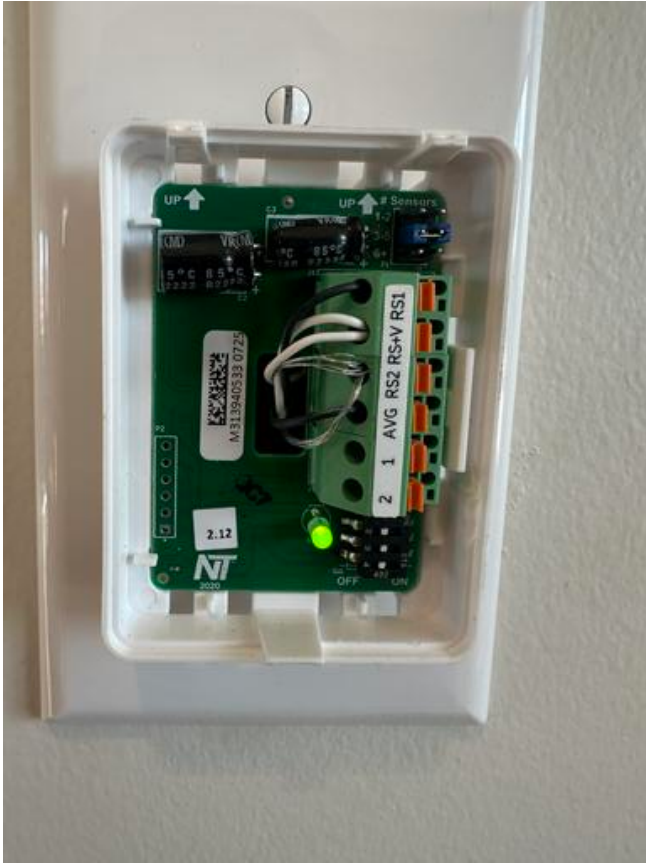
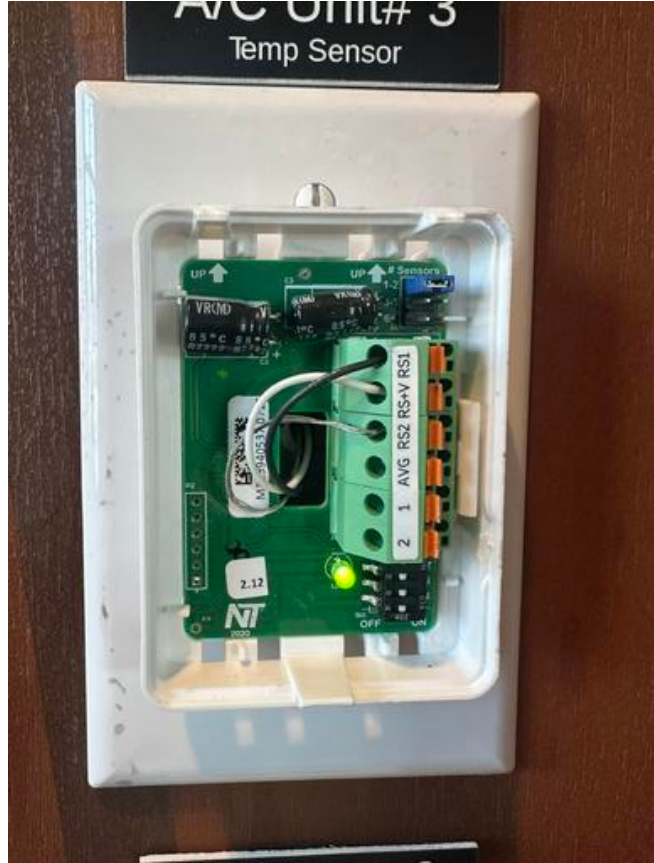
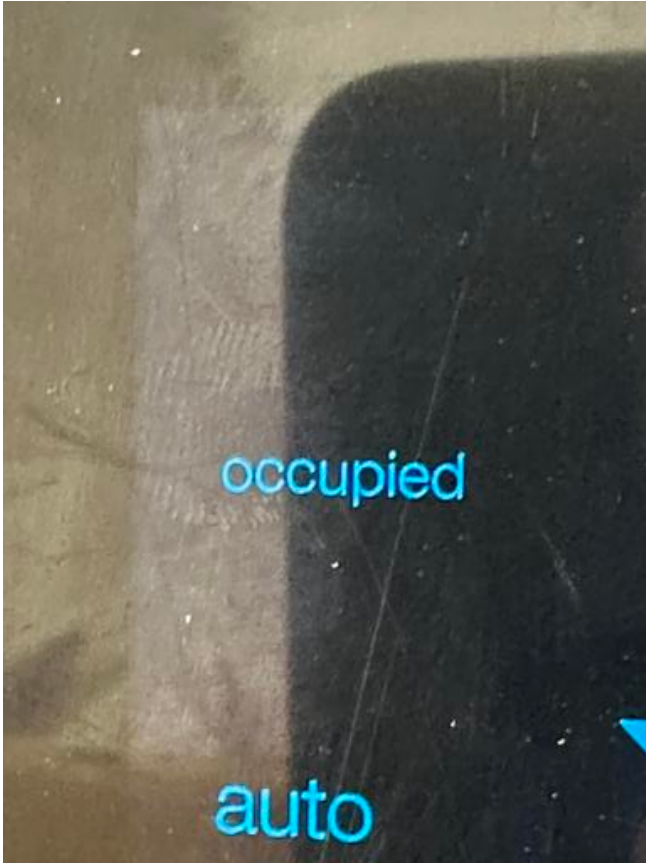
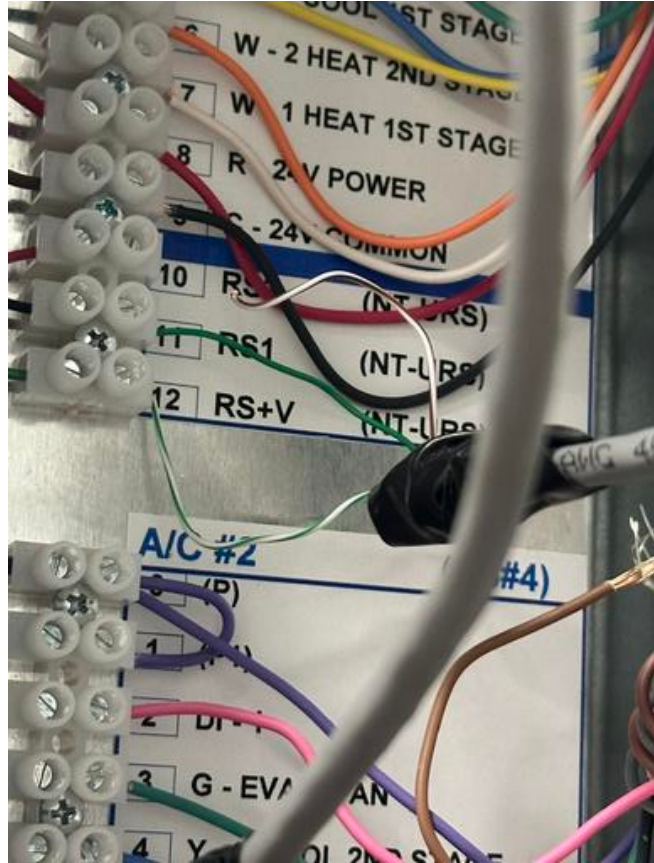
#92 [CNTL 016] [NEW] CRITICAL – Sensor communication.

AC3's averaging sensors not communicating properly, check for correct terminations, correct dip switch / jumper settings, and shorts to ground. AC1's temp sensor has a loose wire at the terminal.

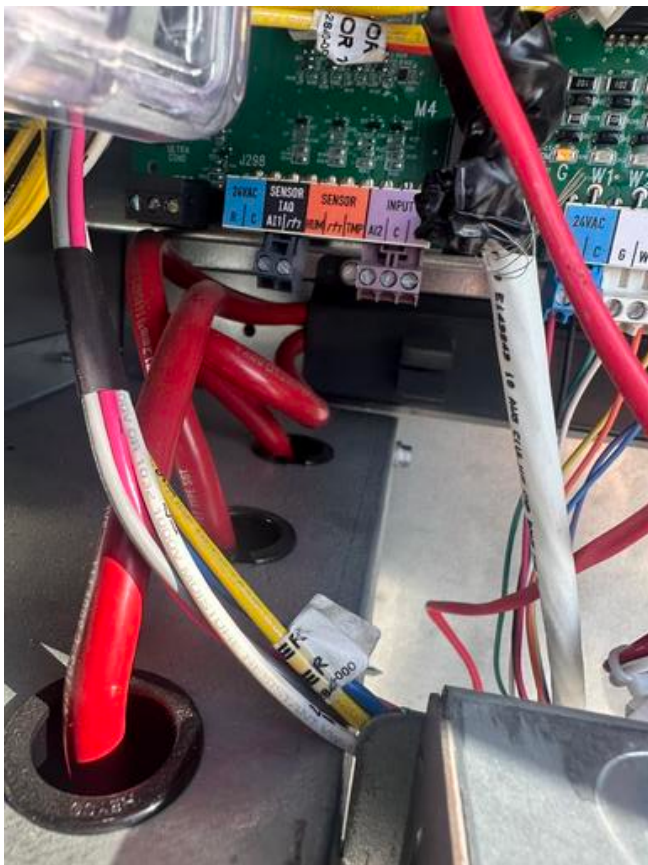
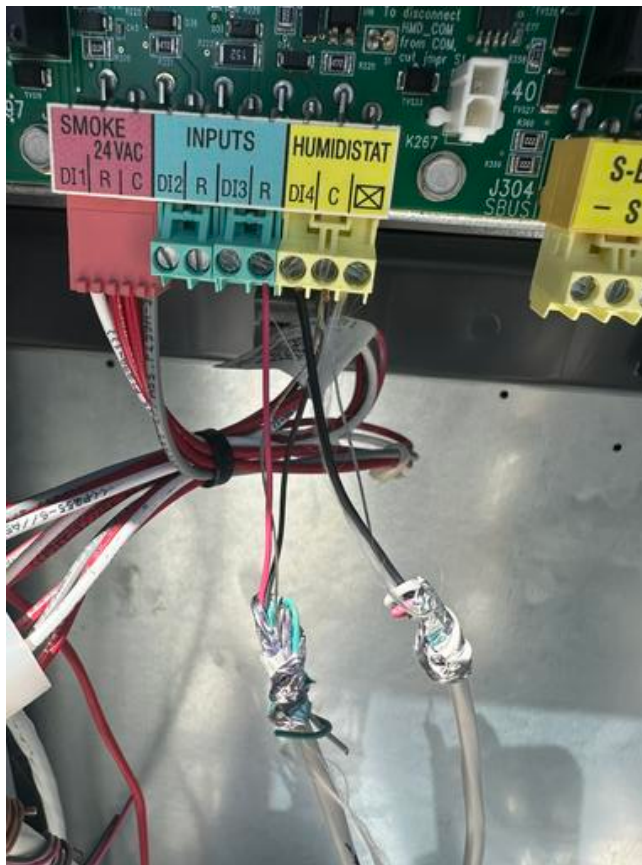
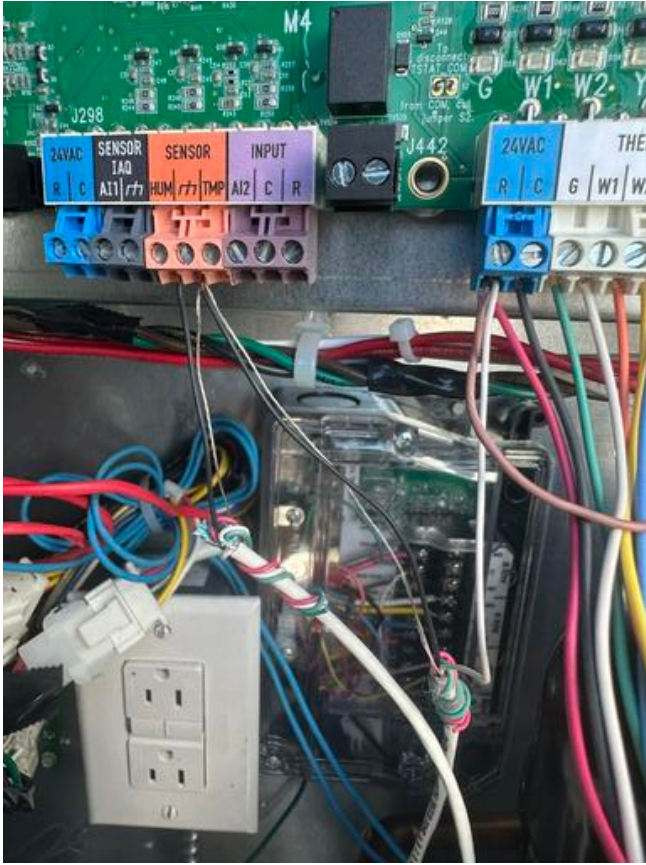
#91 [CNTL 499] [NEW] CRITICAL (MISC) – Humidity sensor wiring

AC1 and AC3 are missing the correct ports to connect the humidity sensor wiring. All units are experiencing alarms regarding the sensor's wiring.

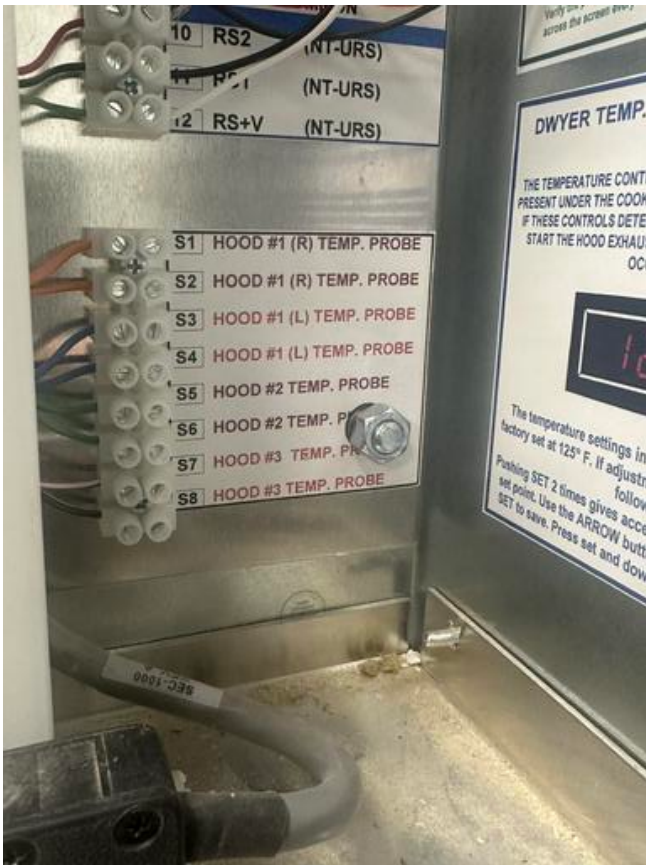
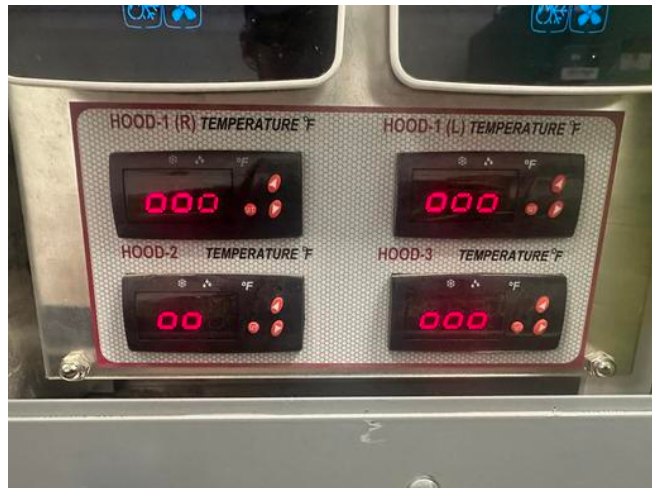
#90 [CNTL 506] [NEW] H.E.S. system

HESS sensors are not installed correctly in each hood duct riser and wires are not run to the panel.

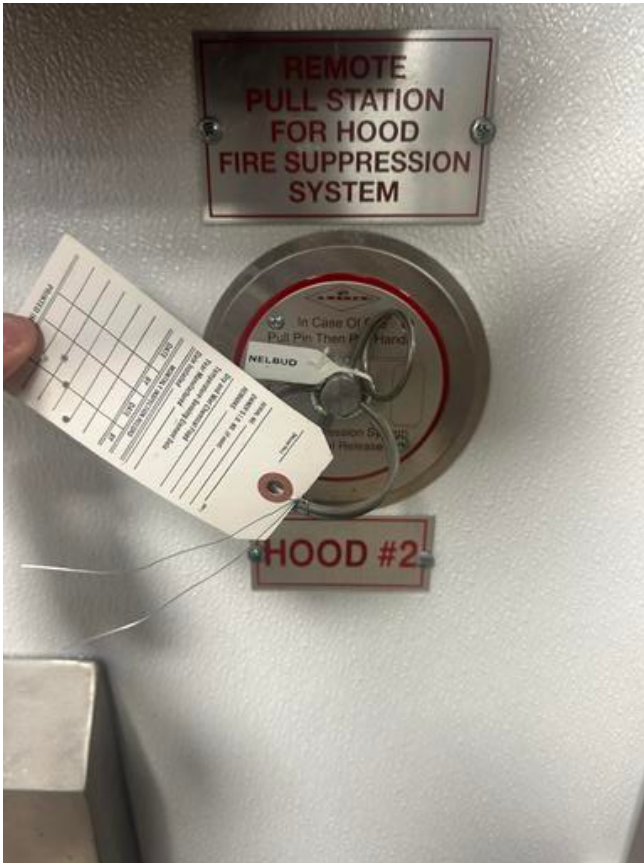
IMG_2798

#89 [CNTL 509] [NEW] Ansul pull labeling.

Status Open	Start Date Sep 12, 2025
Type Planned Work	Created Sep 12, 2025 11:40 AM bens@nationaltab.com
Description Hood 3's pull station is labeled for Hood 2.	Last Updated Sep 12, 2025 11:49 AM

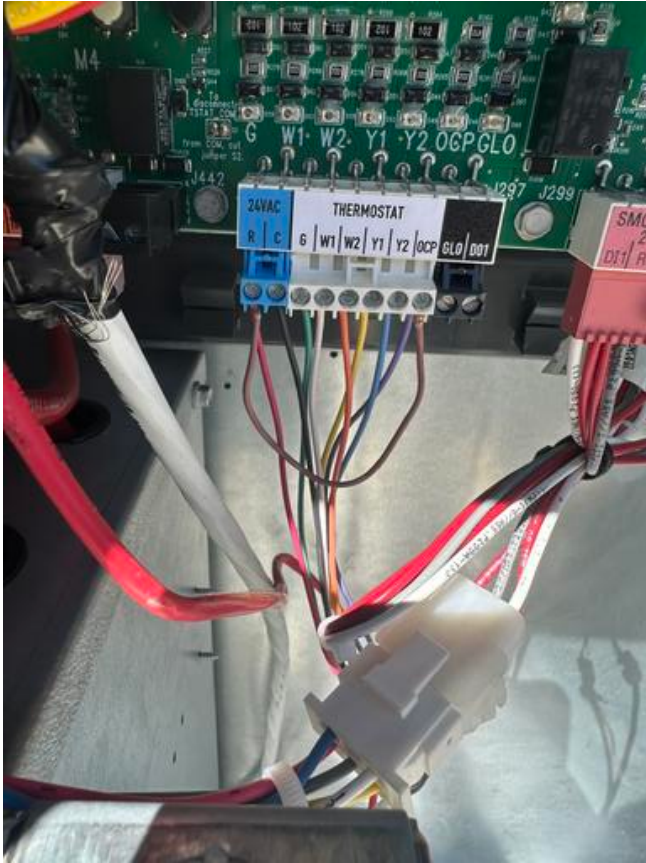
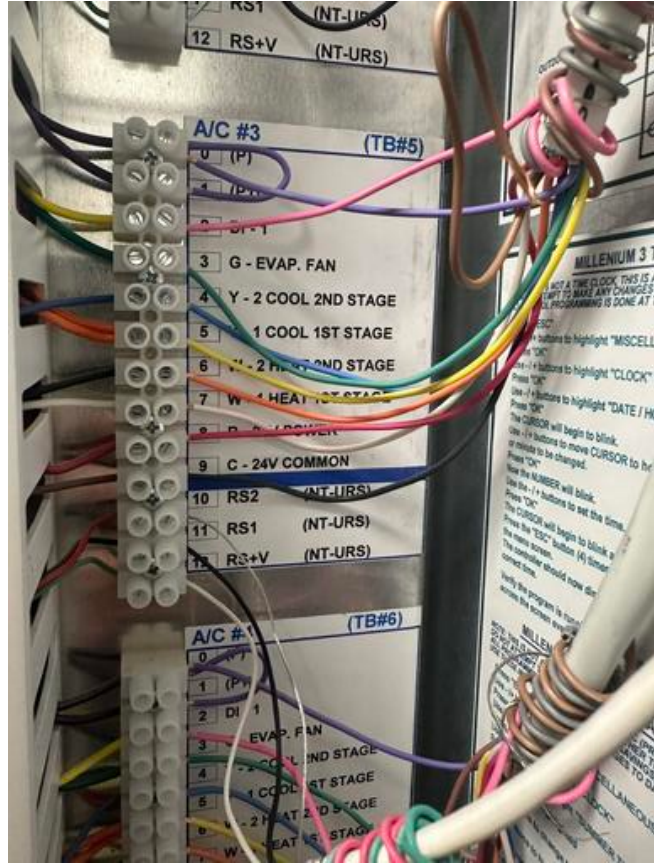
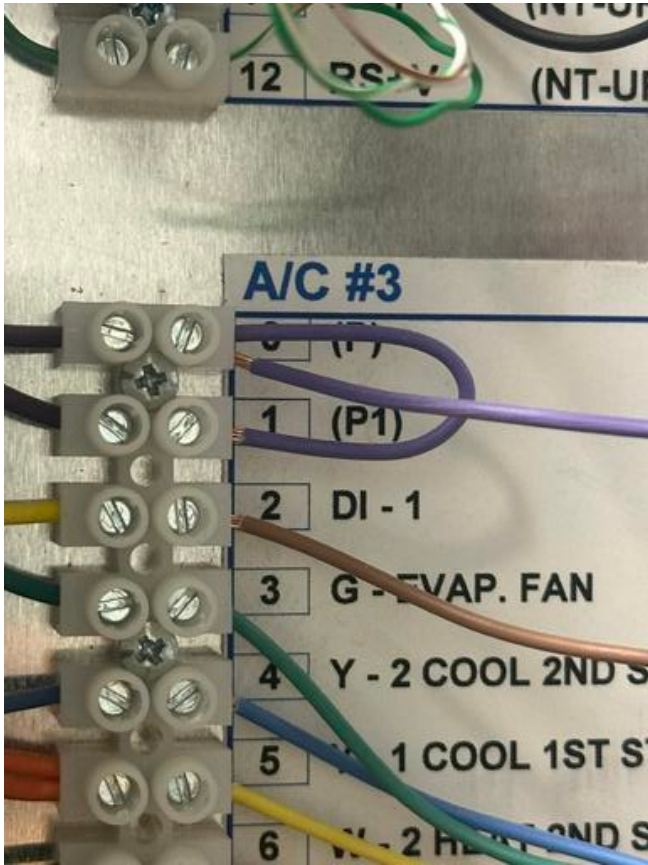
#88 [CNTL 999] [NEW] (MISC) OCC/UNOCC RTU sequence.

Store occupied / unoccupied switch does not properly alter RTU sequence. All units were jumpered from R to OCP. This wire needs to be removed and the wiring at the T-500 panel needs to be revised.

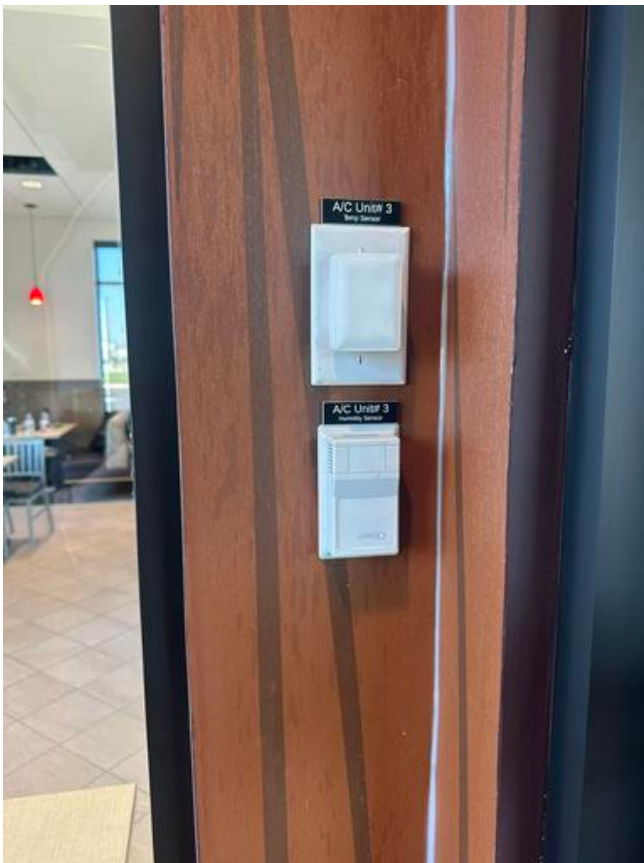
IMG_2864

#87 [CNTL 999] [NEW] (MISC) Sensor location.

The humidity sensor for AC3 is call to be located in the playroom. Recommend relocating the sensor to be outside of the playroom.

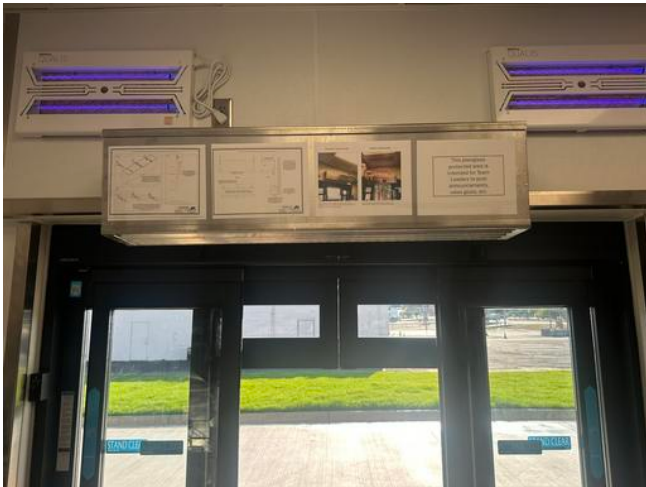
IMG_2800

#86 [CURT 502] [NEW] Air curtain diverter box.

Status	Start Date
Open	Sep 12, 2025
Type	Created
Planned Work	Sep 12, 2025 11:40 AM bens@nationaltab.com
Description	Last Updated
Air curtain diverter box is not installed correctly and should be bolted to wall, slid forward, and flush with door header.	Sep 12, 2025 11:49 AM

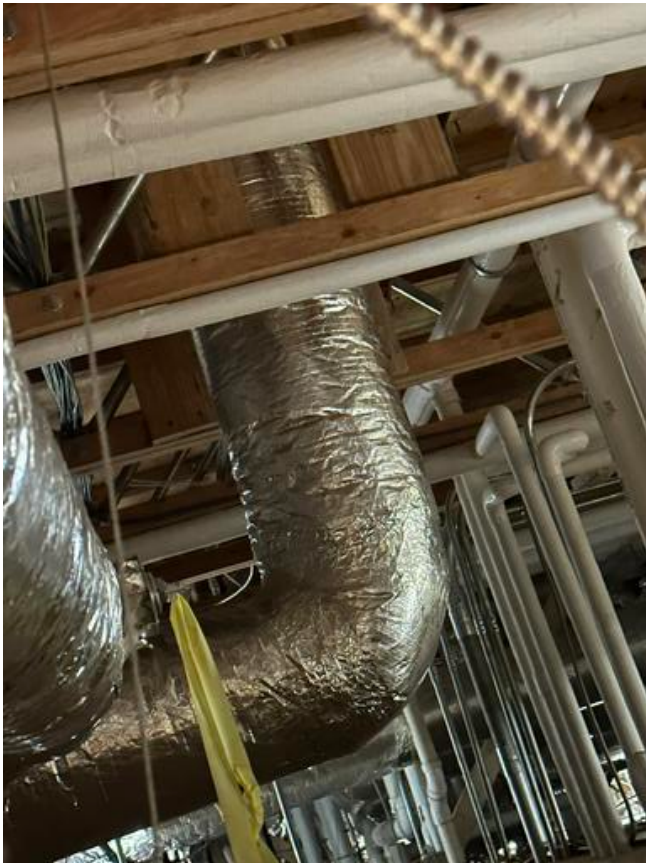
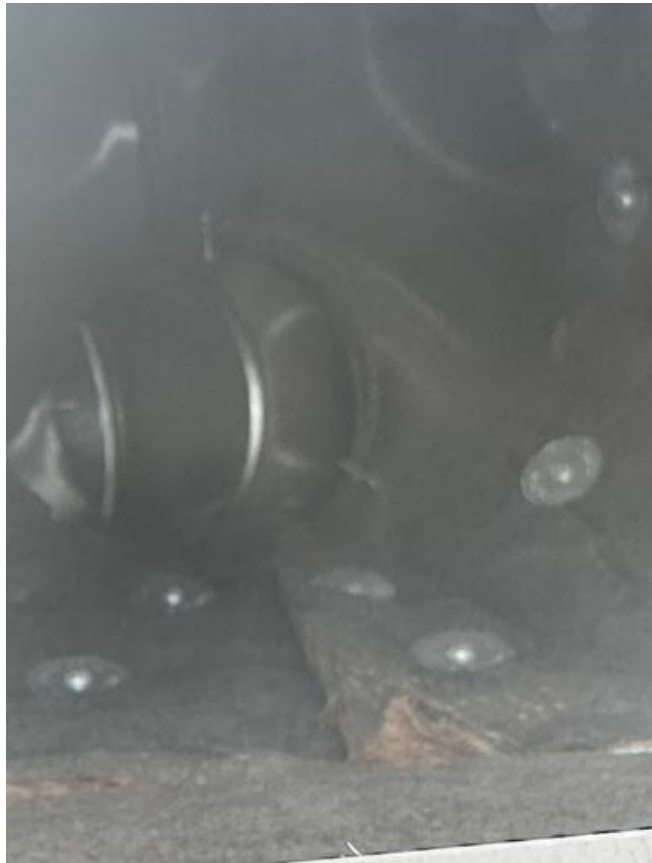
#85 [EXHA 500] [NEW] Restroom rectangular duct riser.

Restroom exhaust rectangular duct riser does not run all the way down per specification.

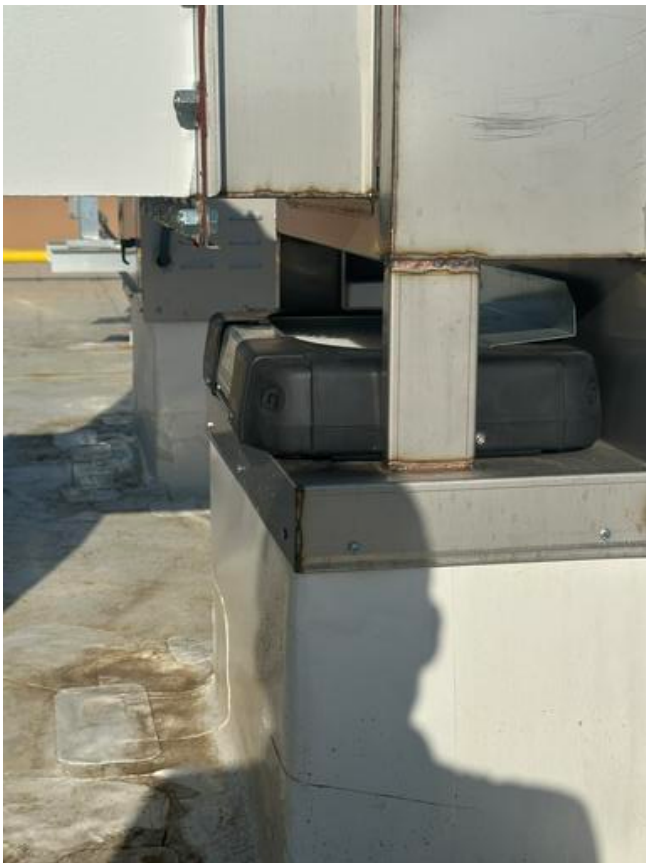
IMG_2804

#84 [EXHA 507] [NEW] Exhaust fan drain line.

Exhaust fan drain is not installed to center of drip guard per detail.

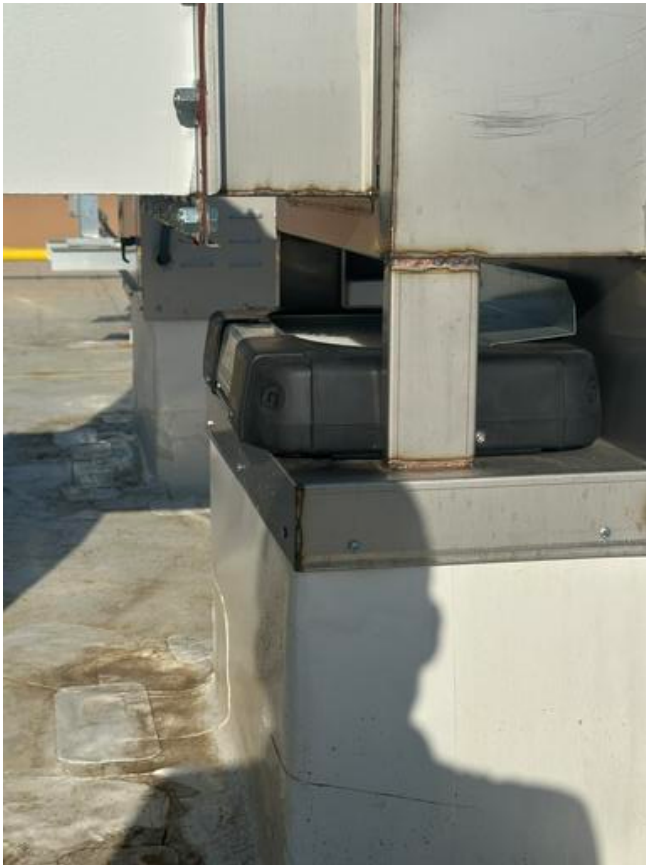
IMG_2804

#83 [EXHA 508] [NEW] Exhaust fan G2 Drip Guard.

Status Open	Start Date Sep 12, 2025
Type Planned Work	Created Sep 12, 2025 11:40 AM bens@nationaltab.com
Description Exhaust fan G2 Drip Guard is not installed correctly.	Last Updated Sep 12, 2025 11:50 AM

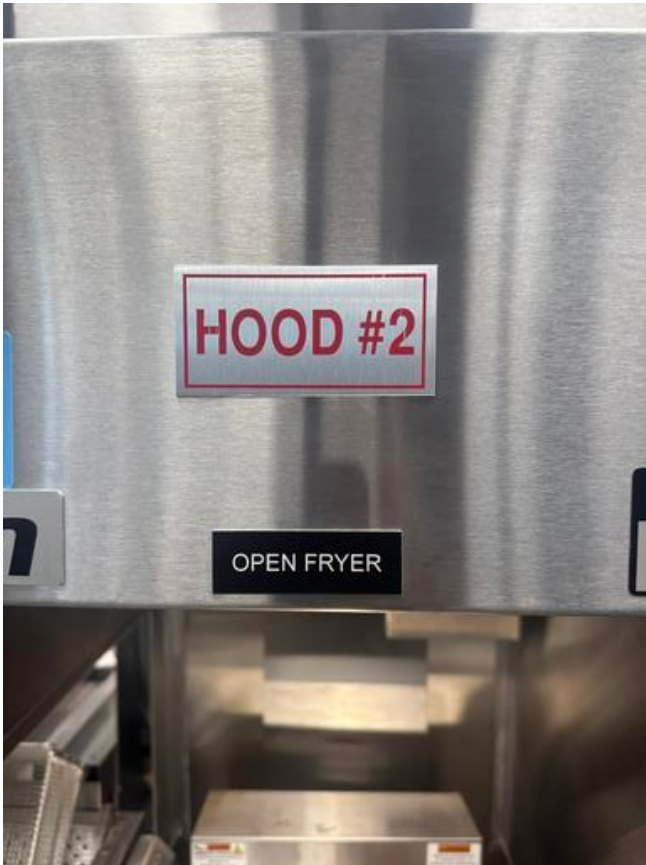
IMG_2797

#82 [HOOD 999] [NEW] (MISC) Hood labels.

Status Open	Start Date Sep 12, 2025
Type Planned Work	Created Sep 12, 2025 11:40 AM bens@nationaltab.com
Description Hood 3 is labeled as Hood 2	Last Updated Sep 12, 2025 11:51 AM

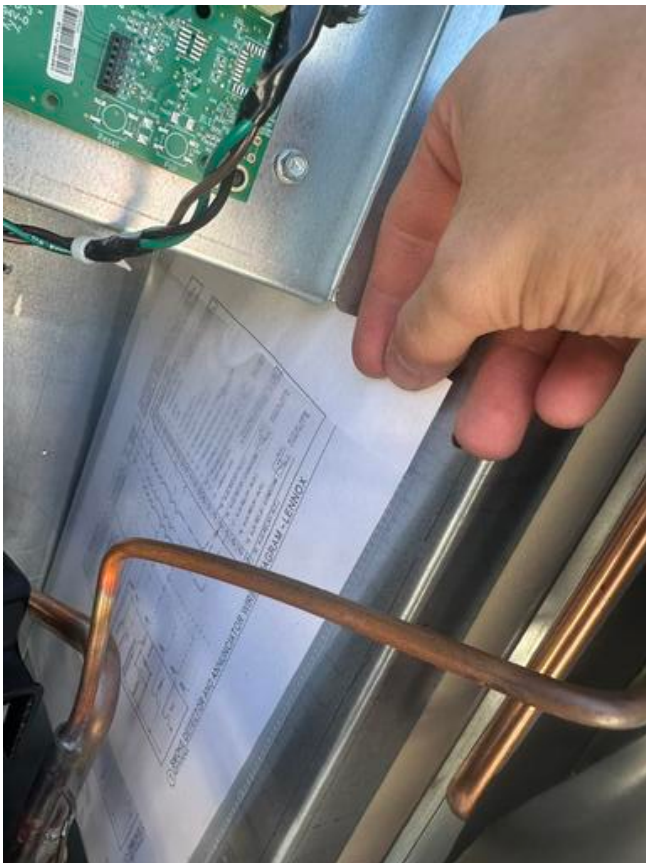
IMG_2848

#81 [UNIT 501] [NEW] Equipment low voltage diagrams

Equipment copy of controls detail low voltage wiring diagrams is not laminated.

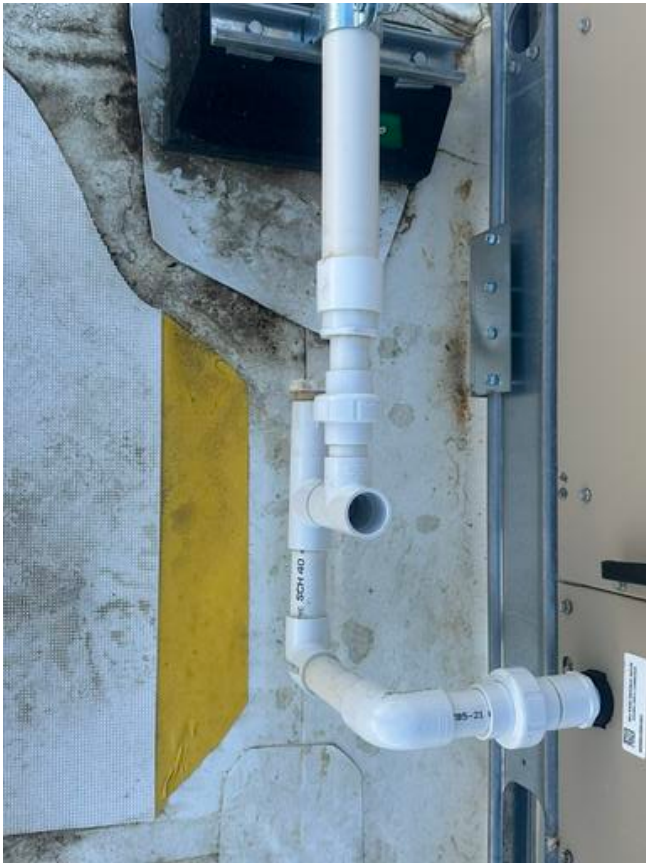
IMG_2802

#80 [UNIT 517] [NEW] Condensate piping construction.

Equipment condensate piping or p-trap is not constructed per normal CFA specifications. There should be no reduction in size.

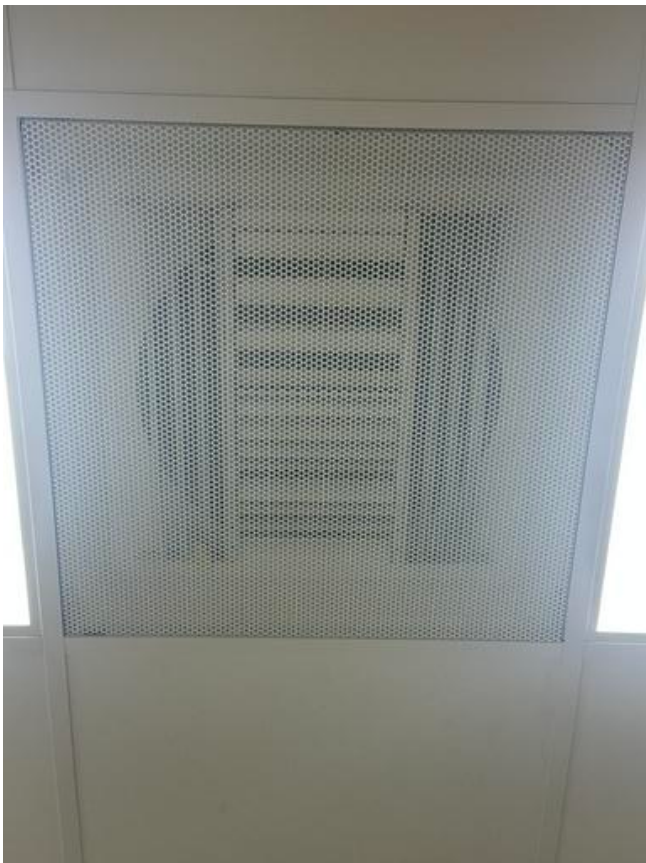
IMG_2869

#79 [DUCT 500] [NEW] Air pattern deflections.

Ensure air pattern deflectors are adjusted uniformly and close when specified.
Ensure all debris is cleaned out of the grille face.

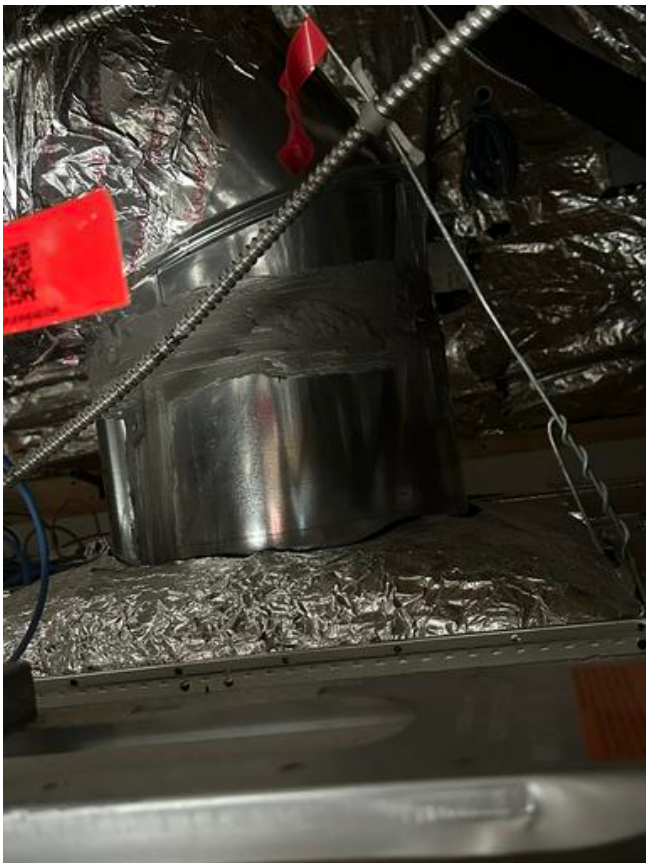
IMG_2836

#78 [DUCT 507] [NEW] Ductwork is not fully insulated.

Ductwork has exposed metal ductwork in some areas needs to be fully wrapped.

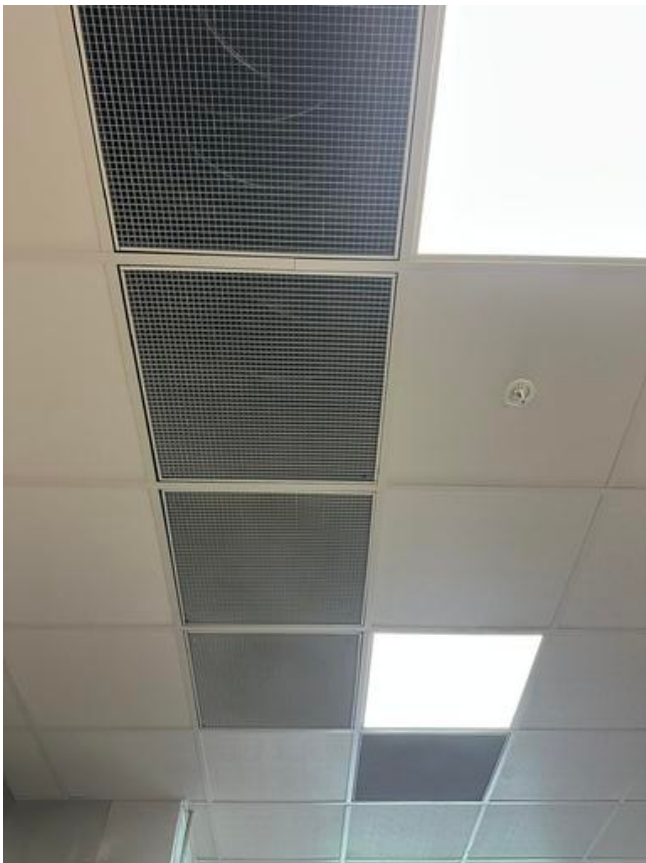
IMG_2839

#77 [DUCT 999] [NEW] (MISC) AC1 return noise.

There is an audible squeaking noise in the duct for AC1's return. Unable to tighten the opposite wing nut due to clearance restrictions.

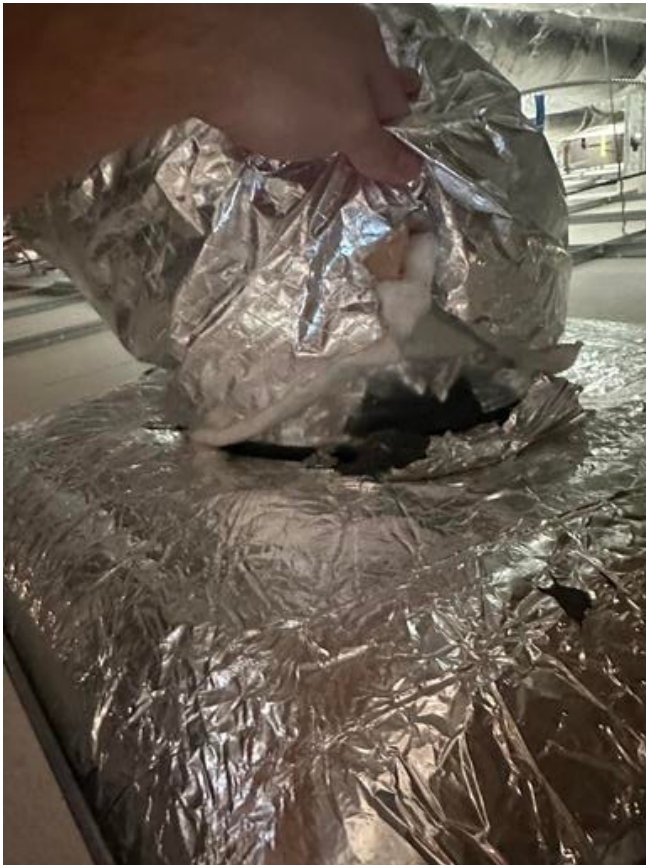
IMG_2865

#76 [DUCT 999] [NEW] (MISC) Insulation.

Status	Start Date
Open	Sep 12, 2025
Type	Created
Planned Work	Sep 12, 2025 11:40 AM bens@nationaltab.com
Description	Last Updated
Tape all seams of insulaion.	Sep 12, 2025 11:52 AM

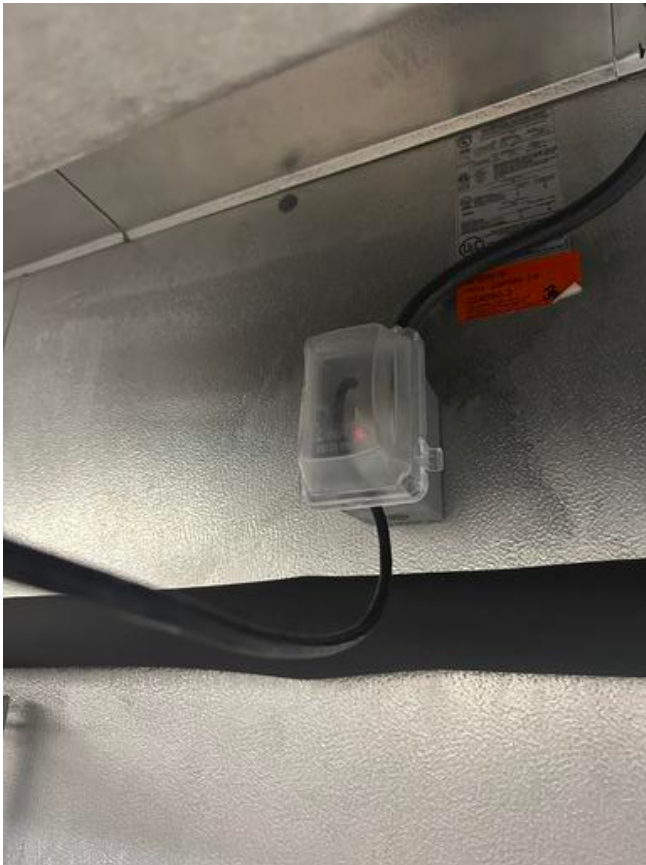
IMG_2871

#75 [REFG 507] [NEW] WIF heated drain.

Status Open	Start Date Sep 12, 2025
Type Planned Work	Created Sep 12, 2025 11:40 AM bens@nationaltab.com
Description WIF heat strip is not powered.	Last Updated Sep 12, 2025 11:52 AM

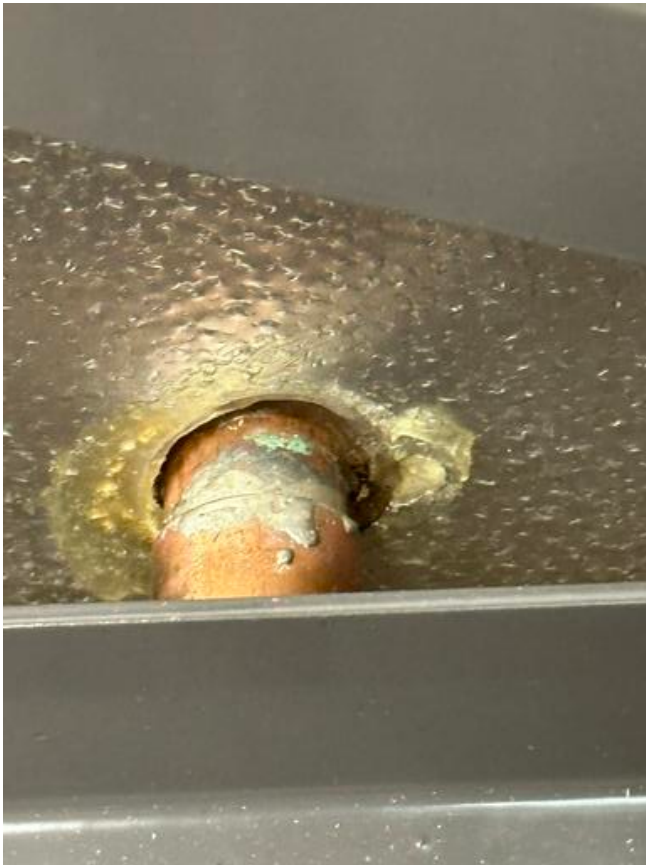
IMG_2870

#74 [REFG 509] [NEW] WIC/WIF Drain P-Traps and/or Drain pitch.

Escutcheon is not installed
on the p-trap penetration.

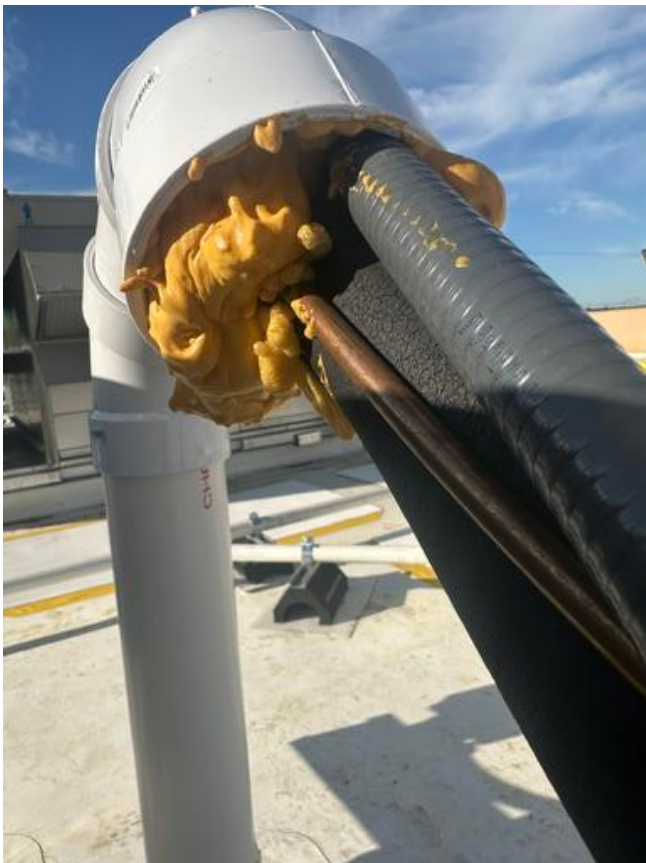
IMG_2806

#73 [REFG 511] [NEW] PVC pipe chase (gooseneck) installation.

PVC pipe chase risers are not constructed to drawing or is not sealed with spray foam and silicone to prevent weather/pest infiltration.

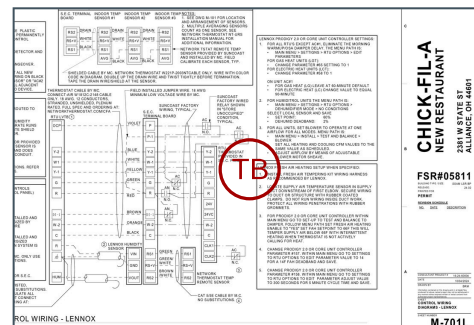
Sheet
M-701L

#27 [UNIT 504] [NEW] Equipment Fresh Air Tempering.

RTU Schedule indicates AC units are to have Fresh Air Tempering: Units with Fresh Air Tempering kits are to have the discharge sensor routed per specification into the discharge duct via wiring portal. The sensor should be installed after the first 90. For Lennox turn on FAH and set parameter #156 to 60 in Kitchen, 62 in Drive-Thru/Serving, & 63 in Dining/Play Area; then set parameters #157 to 14 & #158 to 300 on all.

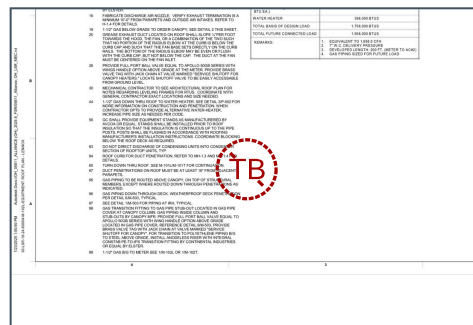
Sheet
M-102L

#22 [EXHA 999] [NEW] (MISC) Grease Duct Proximity to Parapet

Key Note 87 on M-102L indicates all duct penetrations on the roof must be at least 18" from the parapet. EF-1 duct penetration does not comply. Recommend Review.

This duct is installed as per the design shown on sheet M-102L. If it needs to be moved, the drawings should be revisited so that required work can be priced and performed

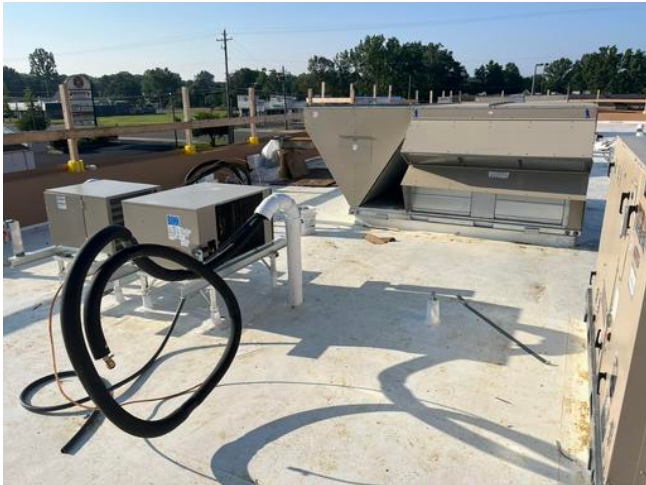
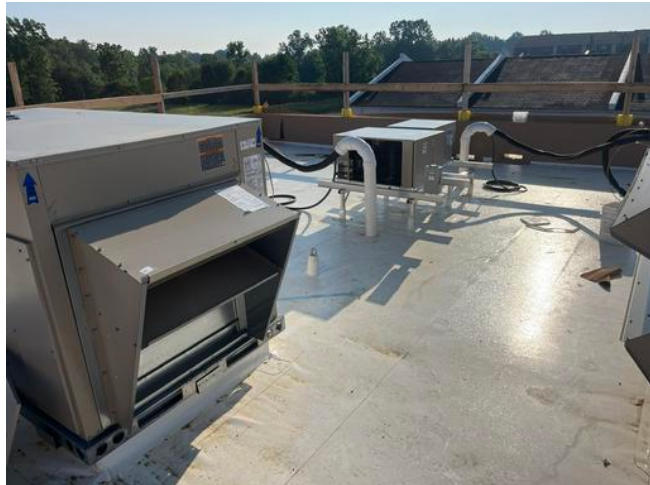
#20 [REFG 999] [NEW] (MISC) WIF/WIC Condenser Orientation

Recommend orientation of Condensers is reviewed. WIF condenser is discharging in general direction of AC-1 and AC-4 Outdoor air intakes.
