Report: TAB REPORT
Function: Test, Adjust, & Balance
Date: 11/12/2024
Completed By: National TAB

PROJECT
10-28-24 WAWA #5412 PLANTATION, FL

Project: 10-28-24 WAWA #5412 PLANTATION, FL

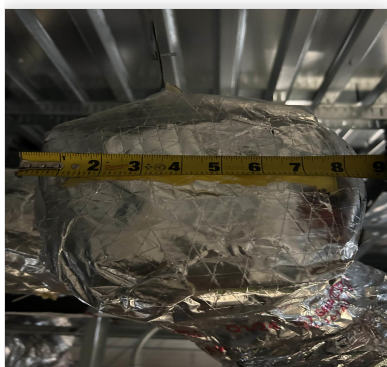
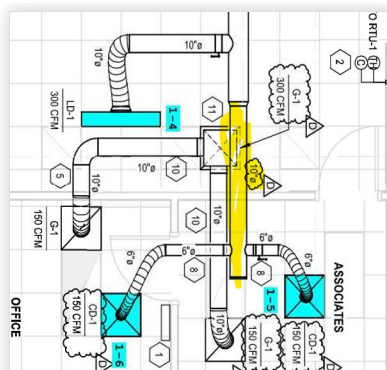
Issue Name : Diffusers 1-5 and 1-6 - Low Flow
Description : Diffusers 1-5 and 1-6 (Associates and Office) are currently outputting 119 CFM and 92 CFM, respectively (79% and 61% design). Dampers are fully opened. Airflow increases slightly when straightening flex duct. Recommend mechanical inspection.
Created By : National TAB **Assigned To :** National TAB - Will Turnbough
Status : Open
Priority : High **Asset Tag :** SGRD5
Originated Date : 10/29/2024 - Mark Johnson - National TAB

- **11/12/2024 National TAB - Stephen Tassinaro**
 - Duct size remains 8". No adjustments made to these diffusers.

- **10/30/2024 National TAB - Mark Johnson**
 - Branch duct serving these two diffusers is undersized (8" - required is 10"). This is likely the cause of their low flow. Recommend installing correct duct size.

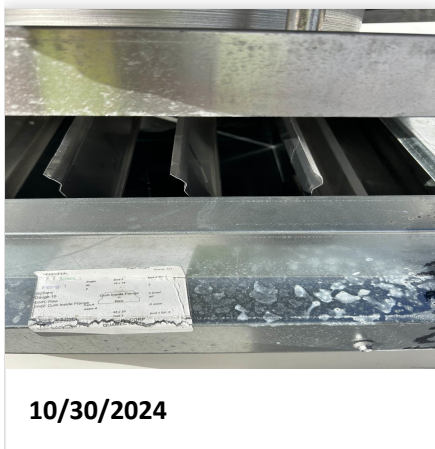
Issue Name : EF1 - Low Flow
Description : EF1 is currently outputting a total exhaust flow of 955 CFM (87% design). Fan is set to maximum speed. A likely cause is the gravity damper; it is installed too close to the fan and cannot stay fully open. Recommend moving gravity damper per page M3.0, Detail 7.
Created By : National TAB **Assigned To :** National TAB - Will Turnbough
Status : Open
Priority : Urgent **Asset Tag :** EF1
Originated Date : 10/30/2024 - Mark Johnson - National TAB

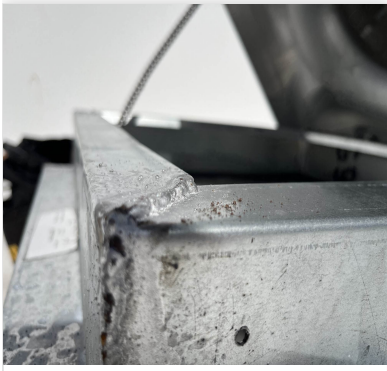
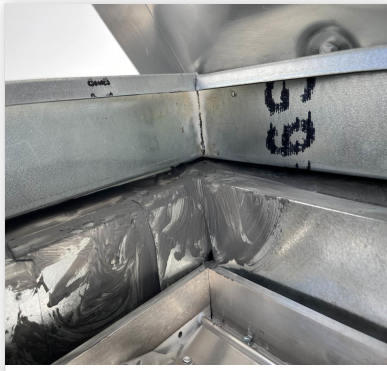
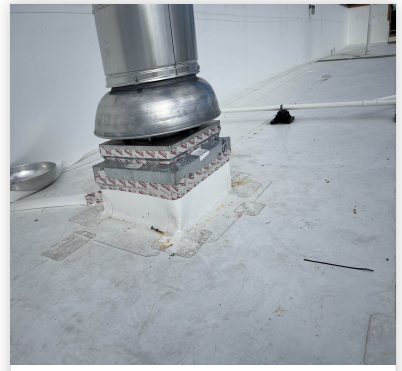
- **11/12/2024 National TAB - Stephen Tassinaro**
 - Backdraft damper was moved down slightly, enabling it to fully open. However there is significant leakage around the curb. NTi tech taped the fan to the curb to temporarily create a seal, this increased airflow to 1055CFM/1100CFM (96% of design).

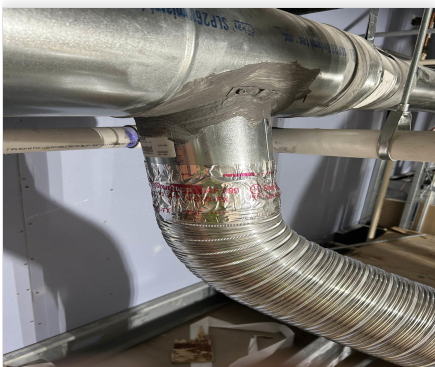
Issue Name : EF1 - No Dampers Installed
Description : There are no dampers installed for exhaust diffusers. See page M1.0 Key Note 9.
Created By : National TAB **Assigned To :** National TAB - Will Turnbough
Status : Open
Priority : **Urgent** **Asset Tag :** EF1
Originated Date : 10/30/2024 - Mark Johnson - National TAB

- **11/12/2024 National TAB - Stephen Tassinaro**
 - Dampers are still missing from EGRD1-2 and 1-3. Unable to complete diffuser balance.

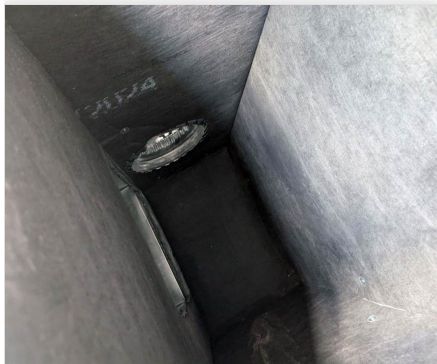
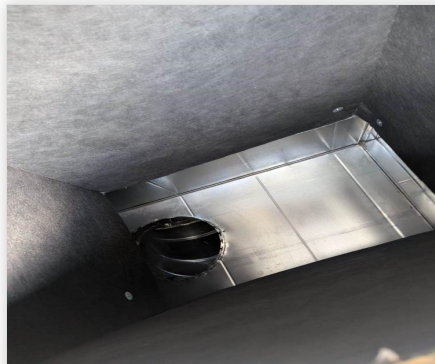
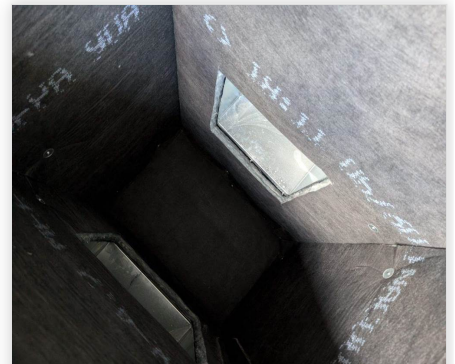
Issue Name : No Turning Vanes
Description : There are no turning vanes installed in the supply drops for any of the 3 RTUs.
Created By : National TAB **Assigned To :** National TAB - Will Turnbough
Status : Open
Priority : Urgent **Asset Tag :**
Originated Date : 11/11/2024 - Stephen Tassinaro - National TAB

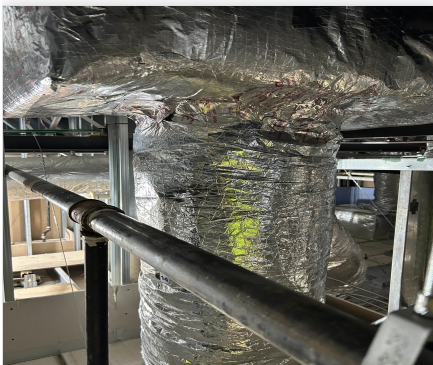
Issue Name : RTU-2 Returns - No Dampers Installed
Description : The return grilles for RTU 2 are missing dampers and cannot be balanced. Recommend installing per mechanical plans (refer to page M1.0, Key Note 9).
Created By : National TAB **Assigned To :** National TAB - Will Turnbough
Status : Open
Priority : High **Asset Tag :** RTU2
Originated Date : 10/30/2024 - Mark Johnson - National TAB

- **11/12/2024 National TAB - Stephen Tassinaro**
 - Return diffusers 3 thru 5, dampers still could not be located. MC tech stated they would need to return to install at a later date. Returns not balanced at this time.
