**Report: FINAL TAB REPORT  
Function: Test, Adjust, & Balance  
Date: 7/20/2022**

## **06-13 BLUE SUSHI - NASHVILLE, TN**

<b>Section</b>	<b>Page #</b>
Summary	3
Site Pictures	6
Balance Schedule	12
Checklist Data	13
AHU/RTU	14
FAN - Exhaust	18
Kitchen Hood Type I	21
Kitchen Hood Type II	22
GRD Layout	23

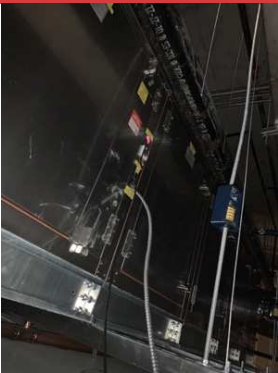
Notes:ONE BELT HAS COME OFF DUE TO LOOSE INNER MOTOR SHEAVE. PCU NOT TO DESIGN FLOW DUE TO RESTRICTION IN GREASE DUCT NEAR THE LOUVER
