**Report: FINAL TAB REPORT
Function: Test, Adjust, & Balance
Date: 7/20/2022**

06-13 BLUE SUSHI - NASHVILLE, TN

Project: 06-13 BLUE SUSHI - NASHVILLE, TN

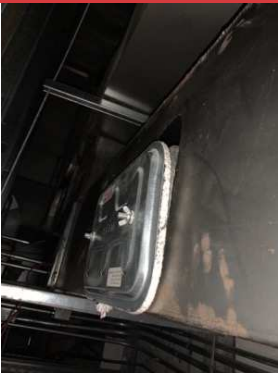
A 2nd visit was completed it was verified that the missing and loose cleanout doors were now properly installed. The Mechanical did not fix the first cleanout door that was loose and only halfway on, so NT fixed it as well as checked all cleanout doors for tightness and air leaks. Some cleanout doors were fully tight and still had trace amounts of air blowing through the gasket. At this point knowing we have fully sealed the duct, we checked the exhaust flow and found it was reduced by 40%. Completed various checks to make sure fan was operating correctly and it was determined that the additional 5 90-degree bends are causing the restriction in the duct.

FOUND LOOSE GREASE DOOR WAS NOT FIXED
NTAB corrected this

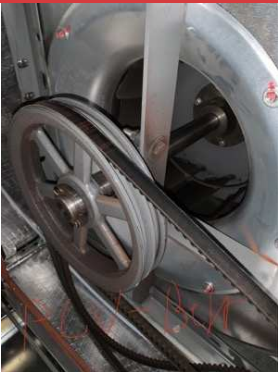
The PCU Fan has a drive belt that has been thrown off. Found that the inner motor sheave has come off its threads which caused the belt to become loose. Tried to fix by removing the key but unfortunately the key was seized in the pulley, so I was not able to fix. Recommend getting a new motor pulley and ensure that all setscrews are tightened down. Should the one remaining belt fail then the store or cooking will likely be shut down until it can be fixed since there is no redundant safety of the second belt.

FAN BELT HAS COME OFF

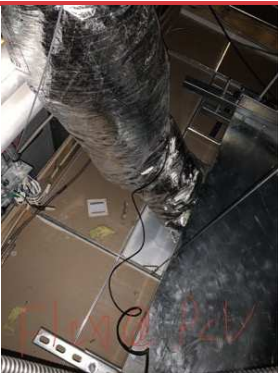
DIFFUSER FLEX STILL CRUSHED UNDER THE PCU

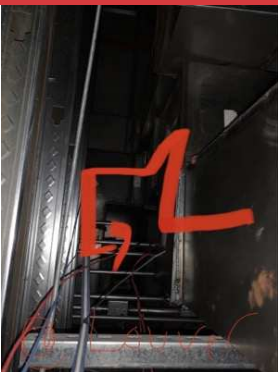
ADDED TURNS TO THE GREASE DUCT

1. Main cause of low airflow is the additional transitions that are added on the PCU discharge duct. These need to be reworked so that it is installed per design. This should increase airflow significantly as was observed when the grease cleanout door was not installed and airflow could bypass the transitions.

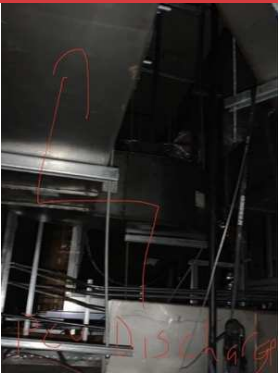
GREASE DUCT WAS DESIGNED TO HAVE 2 45 DEGREE ELBOWS

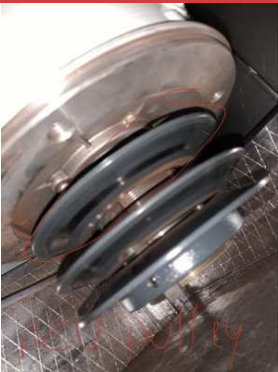
PCU- INNER FAN SHEAVE HAS COME LOOSE

NTAB tried to remove the key to put the sheave back on but the key was stuck in. Recommend replacing the Motor sheave

Notes:ONE BELT HAS COME OFF DUE TO LOOSE INNER MOTOR SHEAVE. PCU NOT TO DESIGN FLOW DUE TO RESTRICTION IN GREASE DUCT NEAR THE LOUVER

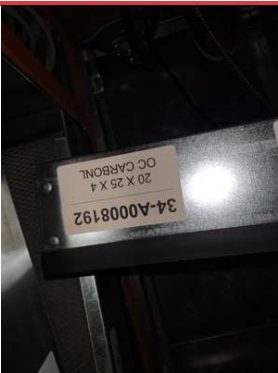
It was confirmed that there is noticeable odor and smoke from the louver. Verified that there are two banks of carbon filters with model numbers matching the submittals, 2 banks of HEPA filters, and then one bank of the SS captrate Solo filters. PCU's while effective at reducing odor and smoke will not ever fully remove all odor. However, it should be re-evaluated once the exhaust flow is within design.

PCU HAS TWO SETS OF CARBON FILTERS

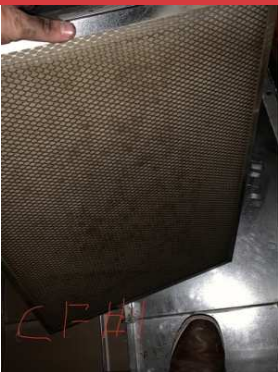
FIRST BANK OF CARBON FILTER CLEANLINESS

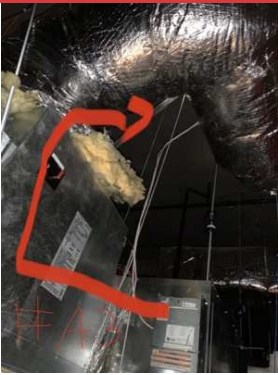
AHU-3 supply duct was traversed and around 500 cfm was measured but measuring air velocity of the return grille showed the unit was returning 1800cfm. The only access to the unit was removing a diffuser above the sushi bar but this is only visual access where we were able to feel supply leakage coming from the unit heater, the intended access doors were installed above the sushi counters so ladder placement is not possible. The unit heater was installed as an elbow meaning the fan discharges horizontally into the heater then the mechanical contractor installed their duct to the top of the heater, so it discharges vertically. Duct heaters should typically be installed with the same inlet and outlet configuration, meaning horizontal inlet and horizontal exit or vertical/vertical. Since the heater is currently used as an elbow it may be creating turbulence since there are no turning vanes in a duct heater, this would cause ununiform heating of the airstream and potentially be the cause of the leakage we are seeing. Again, better access to the unit is needed to be able to get to the filters and water balance valve.

Unit has a lot of supply leakage coming from the heater section. Access the the OA damper and water valve is not possible do to counter being underneath the access doors

7. Locate and seal the duct leaks on AH-3 and AH-4
8. Redo the elbow/duct heater at AH-3
9. Replace all filters in the AHUs
10. OA/Return air damper motors for all AHU's are missing a mechanical stop and are secured in place with sheet metal screws. Recommend repairing mechanical stop so that the sheet metal screws do not fail.

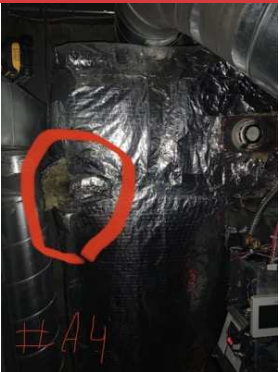
AHU-4 LEAKAGE AT THE DISCHARGE DUCT

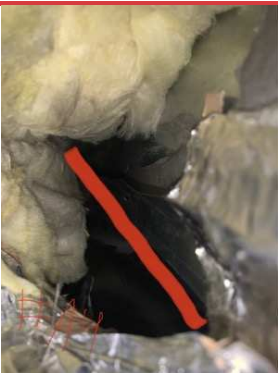
AHU4 LEAKAGE IS AT THE CANVAS CONNECTOR SEAM

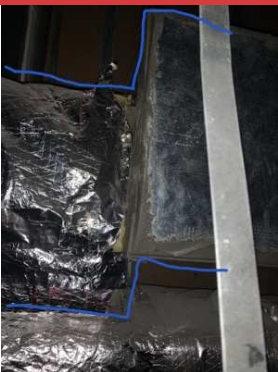
AHU-4 RETURN DUCT DOES NOT CONNECT SQUARELY TO THE RETURN PLENUM

This installation is reducing free flow area of the duct and could cause lower flow when unit is pulling full return

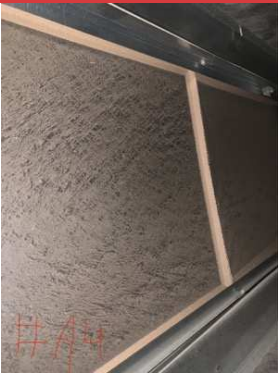
AHU-4 FILTERS ARE DIRTY

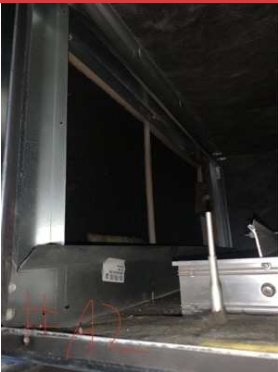
AHU-2 FILTERS ARE EXTREMELY DIRTY

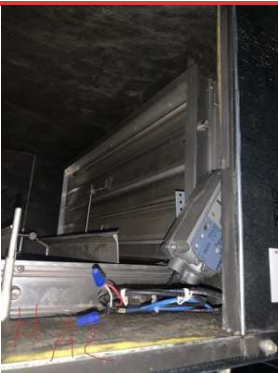
TYPICAL AHU OA AND RETURN DAMPER

If there is a mechanical stopper on the damper it is not accessible due to being butted up against the outside of the unit

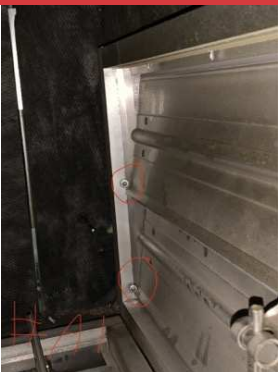
On all AHU's, the OA damper and return damper motor is a power open motor that is supposed to have a mechanical stop on the motor, however self-tapping screws were used to physically stop the damper blades from opening. My concern is if the self-tapping screws eventually fail then the units will only be able to pull in outside air which will cause heating and cooling issues along with building pressure issues. Ideally 0-10v damper motor and controller should be installed or a proper motor mechanical stop should be used.

AHU-1 OA DAMPER STOPPED BY SELF TAPPING SCREWS

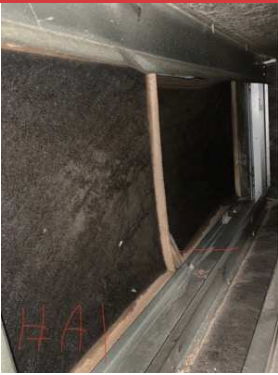
AHU-1 FILTERS
