# BLUE SUSHI 6/16

Thursday, June 16, 2022

23 Remarks Identified

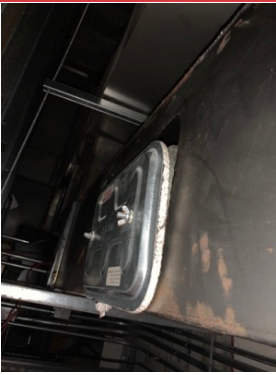
**FOUND LOOSE GREASE DOOR WAS NOT FIXED**  
NTAB corrected this

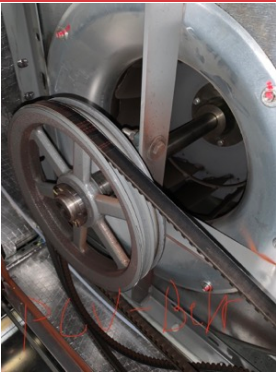
**FAN BELT HAS COME OFF**

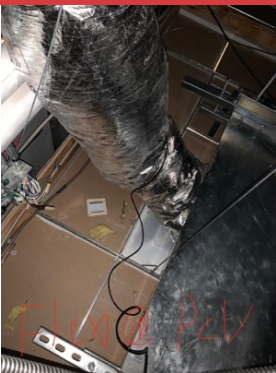
**DIFFUSER FLEX STILL CRUSHED UNDER THE PCU**

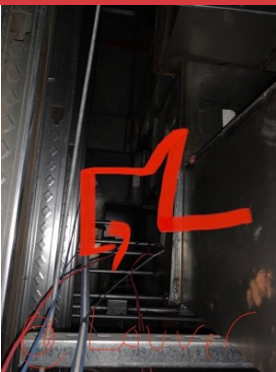
**ADDED TURNS TO THE GREASE DUCT**

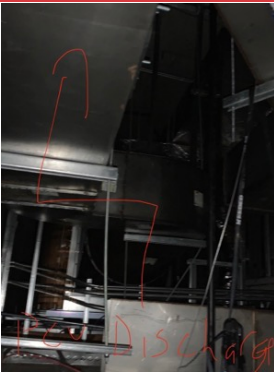
**GREASE DUCT WAS DESIGNED TO HAVE 2 45 DEGREE ELBOWS**

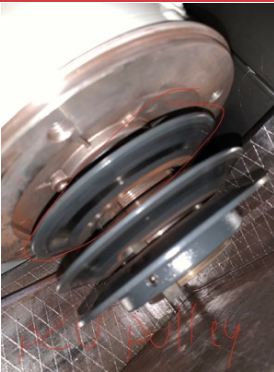
**PCU- INNER FAN SHEAVE HAS COME LOOSE**

NTAB tried to remove the key to put the sheave back on but the key was stuck in. Recommend replacing the Motor sheave

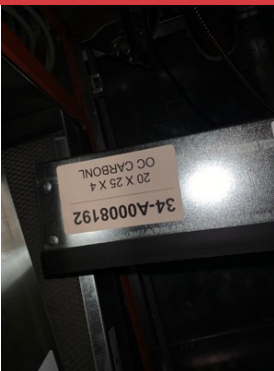
**PCU HAS TWO SETS OF CARBON FILTERS**

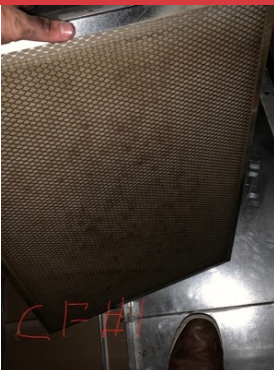
**FIRST BANK OF CARBON FILTER CLEANLINESS**

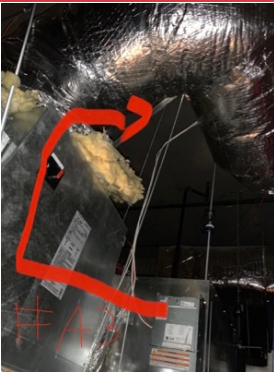
### **AHU-3**

Unit has a lot of supply leakage coming from the heater section. Access the the OA damper and water valve is not possible do to counter being underneath the access doors

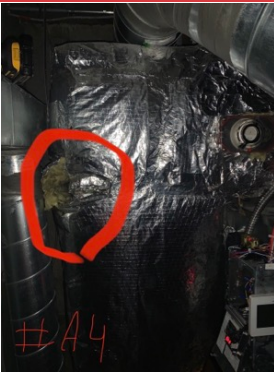
### **AHU-4 LEAKAGE AT THE DISCHARGE DUCT**

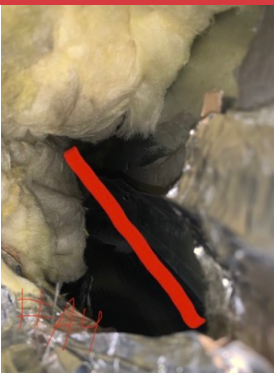
### **AHU4 LEAKAGE IS AT THE CANVAS CONNECTOR SEAM**

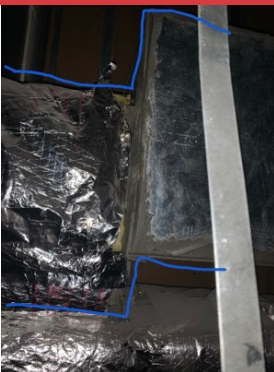
### **AHU-4 RETURN DUCT DOES NOT CONNECT SQUARELY TO THE RETURN PLENUM**

This installation is reducing free flow area of the duct and could cause lower flow when unit is pulling full return

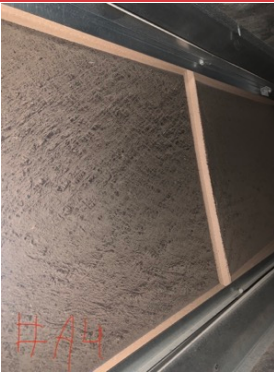
**AHU-4 FILTERS ARE DIRTY**

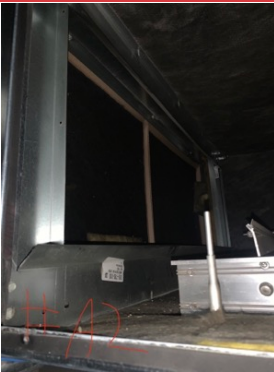
**AHU-2 FILTERS ARE EXTREMELY DIRTY**

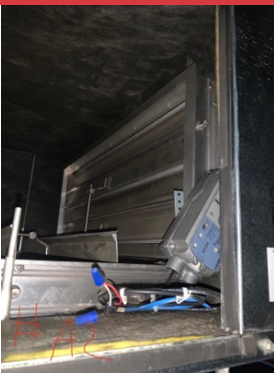
**TYPICAL AHU OA AND RETURN DAMPER**

If there is a mechanical stopper on the damper it is not accessible due to being butted up against the outside of the unit

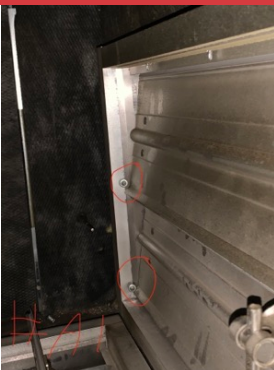
**AHU-1 OA DAMPER STOPPED BY SELF TAPPING SCREWS**
