**Report: FINAL TAB REPORT
Function: Test, Adjust, & Balance
Date: 7/20/2022**

06-13 BLUE SUSHI - NASHVILLE, TN

Project: 06-13 BLUE SUSHI - NASHVILLE, TN

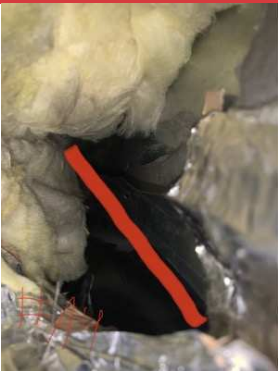
Airflows were measured on all AHU's. 1,2,4 were all found slightly low. Increased these units by 2-3% until motor amperage was maxed out. AHU 4 has some supply leakage at the discharge of the unit where canvas connector attaches two pieces of duct. Sealing the leakage will likely put the unit closer to 100% flow. AHUs 1,2,4 all have dirty air filters some are even starting to collapse. AHU-2 filters were particularly bad due to sucking in greasy smoke from the capture issues. One diffuser that has pinched flex duct should be switched to a 12x24" diffuser with three-way throw pattern so it can be installed against the wall, but it should be placed closer to the center of the prep area and not towards the pass-through window where it currently is. Drawing shows it more centered in that area.

AHU4 LEAKAGE IS AT THE CANVAS CONNECTOR SEAM

7. Locate and seal the duct leaks on AH-3 and AH-4
8. Redo the elbow/duct heater at AH-3
9. Replace all filters in the AHUs
10. OA/Return air damper motors for all AHU's are missing a mechanical stop and are secured in place with sheet metal screws. Recommend repairing mechanical stop so that the sheet metal screws do not fail.
