BLUE SUSHI, NASHVILLE TN

Sunday, June 5, 2022

31 Remarks Identified

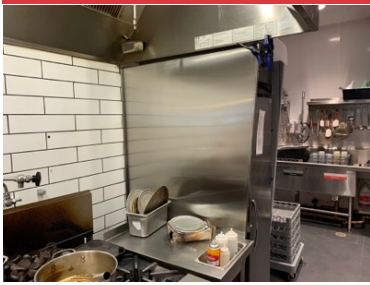
RIGHT END PANEL IS CLAMPED ON

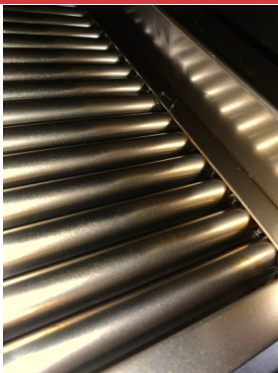
CAPRATE FILTERS IN PCU NOT TOO HEAVILY LOADED

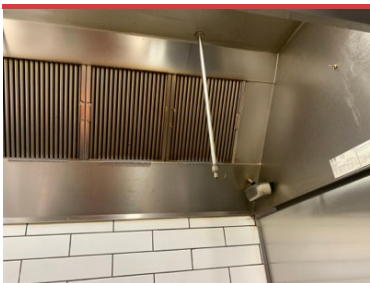
FILTERS ON RIGHT SIDE OF THE HOOD

Are loaded heavier and have lower FPM

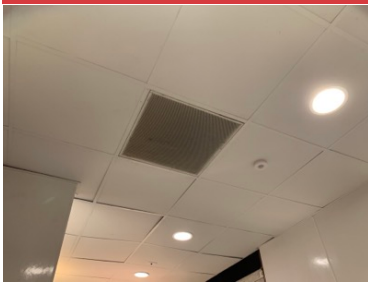
AHU-2 RETURN GRILLE HAS GRIME BUILDUP

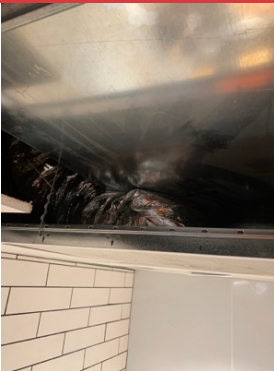
FLEX IS SMASHED DO TO PCU DRIP PAN

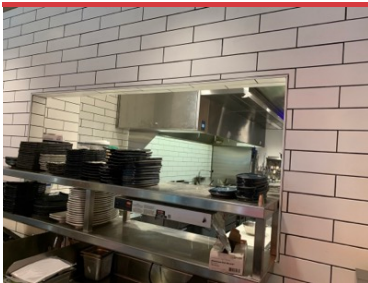
**DINING TO COOKLINE PASS THROUGH WINDOW
70-80 FPM VELOCITY AVG**

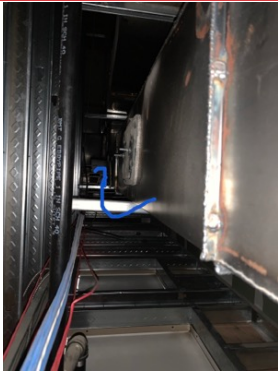
SECOND DOOR PICTURED LOOKS LOOSE

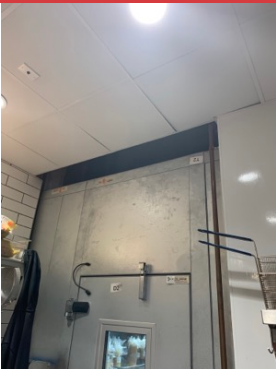
CEILING NOT SEALED TO WALK-IN COOLER.

Did not observe any airflow going through

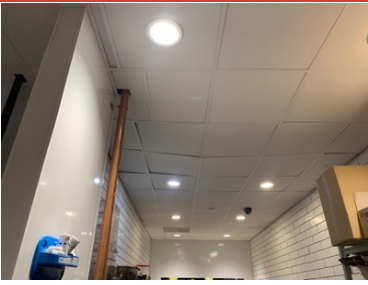
CEILING OVER PREP LINE IS SAGGING

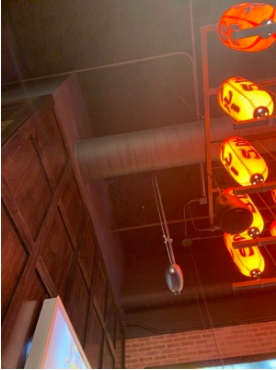
DUCTWORK IN DINING IS 20' ISH OF THE GROUND
