National TAB  
1329 E. KEMPER ROAD  
SUITE 4210  
CINCINNATI, OH 45246

**Report: TAB REPORT**  
**Function: Test, Adjust, & Balance**  
**Date: 11/07/2024**  
**Completed By: National TAB**

**11-04-24 CHIPOTLE #5453 MINNEAPOLIS,  
MN (DINKYTOWN)**

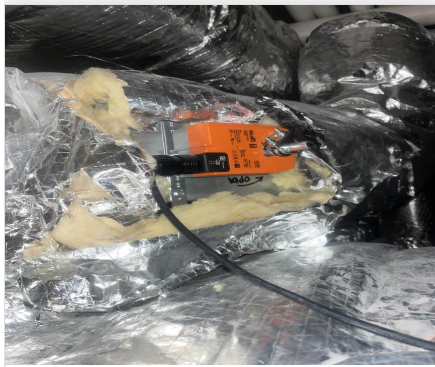
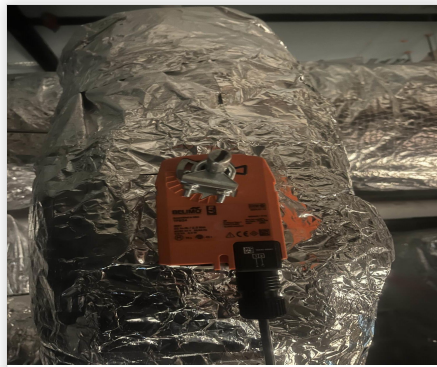
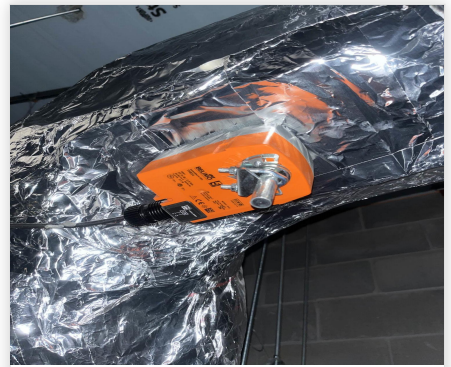
**Issue Name :** FCUs 1-2-3: OA Damper / Actuator Orientation  
**Description :** OA Dampers on FCUs 1,2, and 3 appear oriented incorrectly. The actuator opens the opposite way the damper needs to be moved. Was able to adjust damper position so actuators appear to open damper to correct position when energized. They do not all appear to be fully closing when unit is not running. OA dampers need to be set to roughly 2/3-3/4 open  
**Created By :** National TAB                      **Assigned To :** National TAB - Michael McDonnell  
**Status :** Open  
**Priority :** Low                                      **Asset Tag :**  
**Originated Date :** 11/07/2024 - Michael McDonnell - National TAB

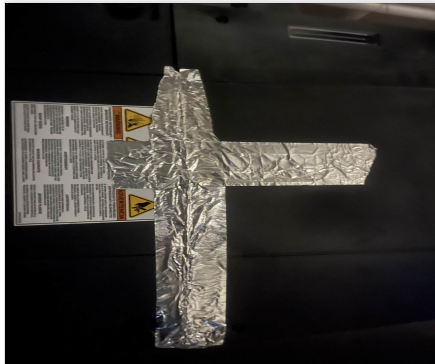
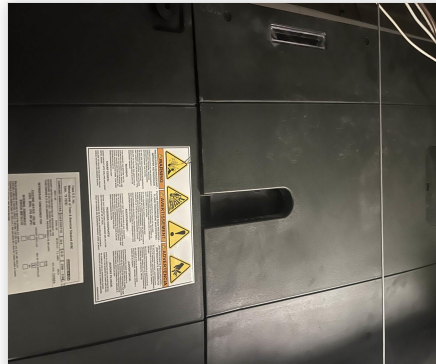
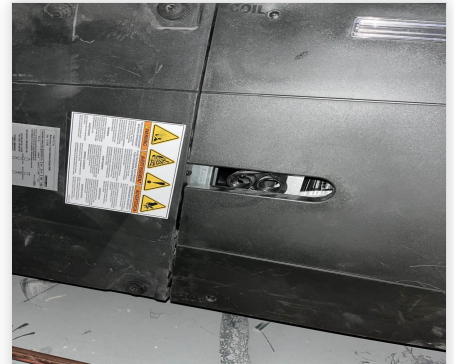
**Issue Name :** FCUs: Leakage at Unit / Missing Pieces  
**Description :** The FCUs have an open area on the coil panel door, as well as near the condensate drain, that are leaking air. Unsure if pieces are missing. Leaks were sealed as best as possible for TAB. Recommend FCUs are sealed.  
**Created By :** National TAB                      **Assigned To :** National TAB - Michael McDonnell  
**Status :** Open  
**Priority :** High                                      **Asset Tag :**  
**Originated Date :** 11/07/2024 - Michael McDonnell - National TAB

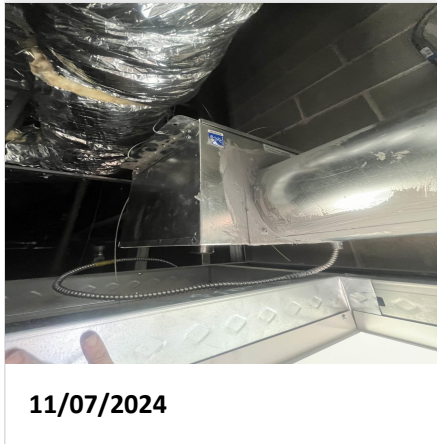
**Issue Name :** INFO ONLY: EF-2: High on Exhaust Airflow  
**Description :** EF-2, serving the restroom, is above design airflow, exhausting 210 / 150 cfm. Fan is single speed and does not have speed controller installed. Not anticipated to cause any issue.  
**Created By :** National TAB                      **Assigned To :** National TAB - Brianna Biggs  
**Status :** Open  
**Priority :** InfoOnly                                      **Asset Tag :**  
**Originated Date :** 11/07/2024 - Michael McDonnell - National TAB

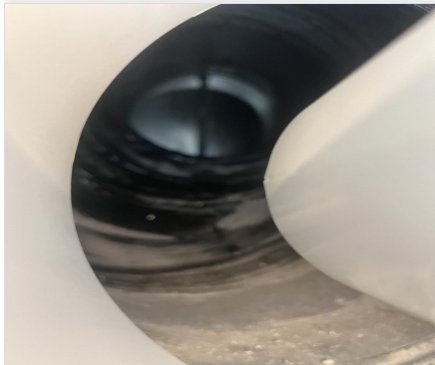
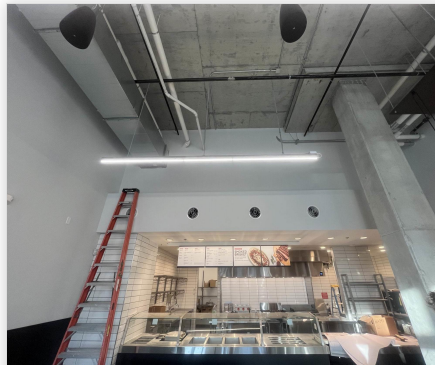
**Issue Name :** INFO ONLY: FCU-3: Dampers Not Accessible  
**Description :** FCU-3 has dampers installed at the takeoffs as indicated on the drawing. These are not accessible due to hard ceiling / location of duct. Plans also list that SR1 turbo diffusers should have face accessible OBD dampers installed. These are not installed. Unit total within design airflow, unable to balance individual diffusers.

- **11/07/2024 National TAB - Michael McDonnell**
  - Not anticipated to cause any issue, as diffusers serve same space from same wall.

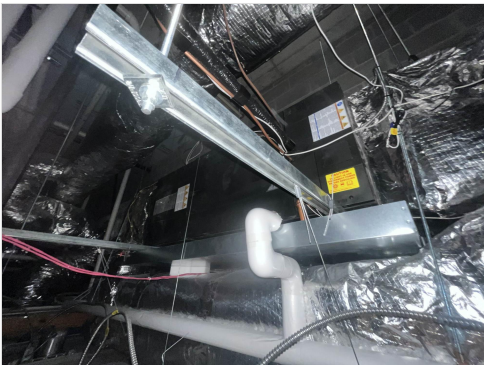
IMG\_1995\_23592066.jpe..

[1] UNIT TOTAL WITHIN DESIGN. INDIVIDUAL DIFFUSERS NOT BALANCED DUE TO DAMPER ACCESIBILITY. NOT

ANTICIPATED TO CAUSE ANY ISSUE AS DIFFUSERS SERVE SAME SPACE FROM SAME WALL.

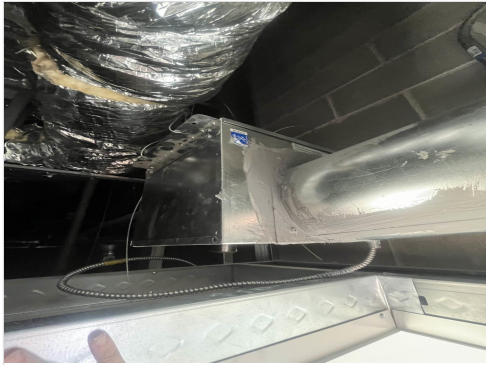
IMG\_2047\_825630222.jp..

[1] EXHAUST ABOVE DESIGN AIRFLOW. NO SPEED CONTROL SPECIFIED OR INSTALLED. NOT ANTICIPATED TO CAUSE ANY ISSUE.

[2] COULD NOT ACCESS SAFELY
