**Report: TAB REPORT**  
**Function: Test, Adjust, & Balance**  
**Date: 11/07/2024**  
**Completed By: National TAB**

**11-04-24 CHIPOTLE #5453 MINNEAPOLIS,  
MN (DINKYTOWN)**

Project: 11-04-24 CHIPOTLE #5453 MINNEAPOLIS, MN (DINKYTOWN)

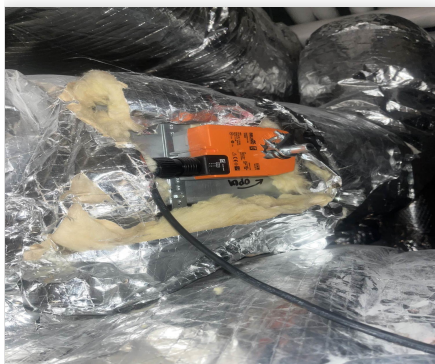
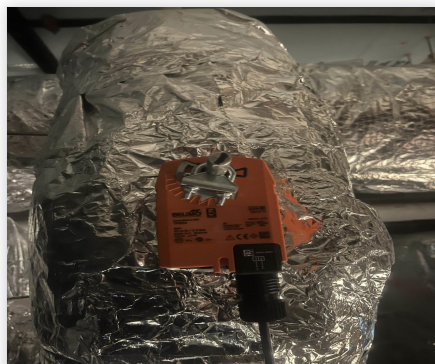
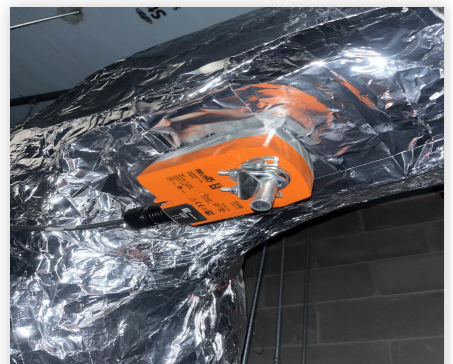
**Issue Name :** FCUs 1-2-3: OA Damper / Actuator Orientation  
**Description :** OA Dampers on FCUs 1,2, and 3 appear oriented incorrectly. The actuator opens the opposite way the damper needs to be moved. Was able to adjust damper position so actuators appear to open damper to correct position when energized. They do not all appear to be fully closing when unit is not running.  
**Created By :** National TAB                      **Assigned To :** National TAB - Michael McDonnell  
**Status :** Open  
**Priority :** Low    **Asset Tag :**  
**Originated Date :** 11/07/2024 - Michael McDonnell - National TAB

- **11/07/2024 National TAB - Michael McDonnell**
  - Recommend this is corrected and dampers are set to 75% open on FCU-1 and 2, and 66% open on FCU-3.

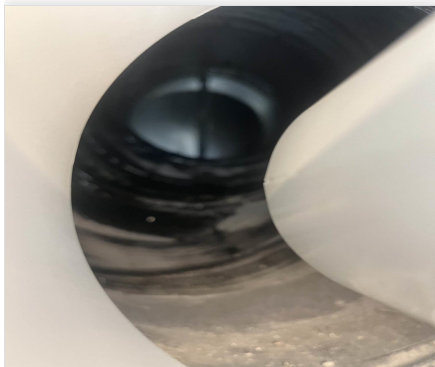
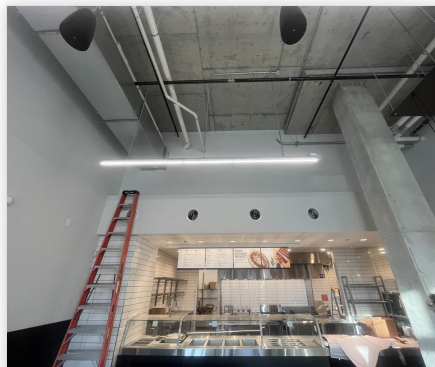
**Issue Name :** INFO ONLY: FCU-3: Dampers Not Accessible  
**Description :** FCU-3 has dampers installed at the takeoffs as indicated on the drawing. These are not accessible due to hard ceiling / location of duct. Plans also list that SR1 turbo diffusers should have face accessible OBD dampers installed. These are not installed. Unit total within design airflow, unable to balance individual diffusers.

- **11/07/2024 National TAB - Michael McDonnell**
  - Not anticipated to cause any issue, as diffusers serve same space from same wall.
