# PlanGrid Task Report - Jul 8, 2025

Prepared by Stephen Tassinaro

Jul 8, 2025

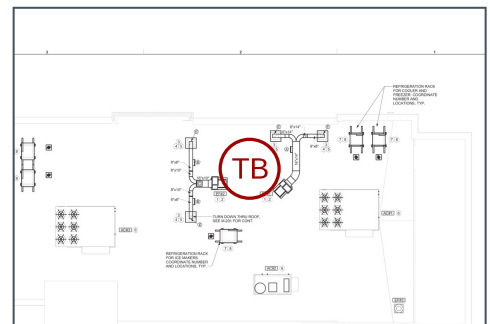
Access doors are not constructed properly in grease ductwork. EF-1 has a "C" sized door where it should have an "A". EF-2 has a "A" sized door where it should have a "C". Recommend discussing with

EOR and CFA to make sure  
this is acceptable.

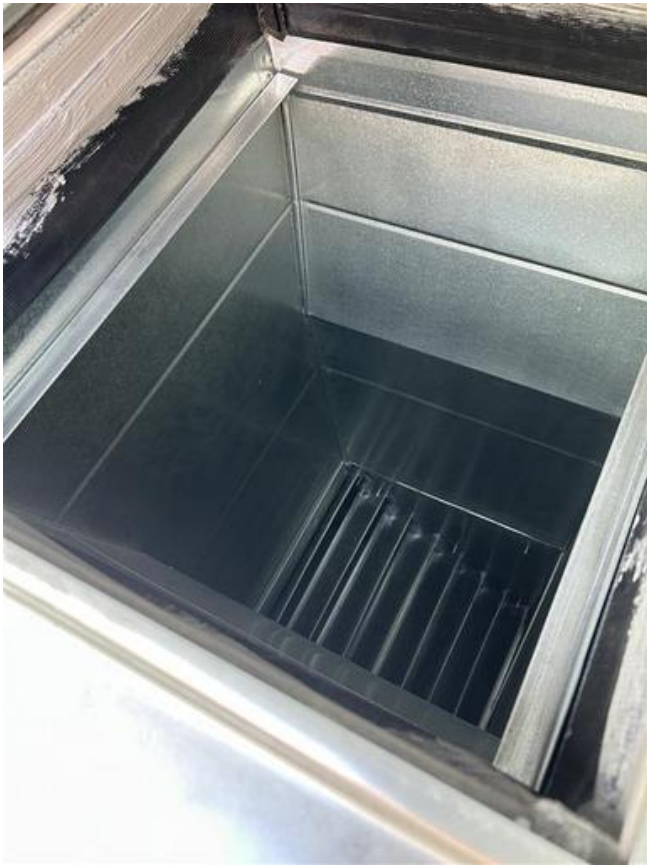
Double thickness turning vanes are present in the system. Per specification only single thickness are to be installed in 90 degree turns where any dimension is greater than 12”.

No longer considered critical as RTU ESPs were found to be at, or below, design.

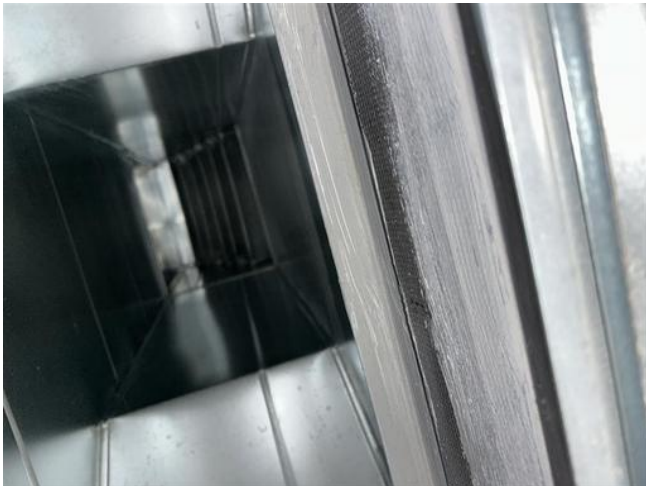
Turning vanes are present in the return duct and need to be removed per specification.

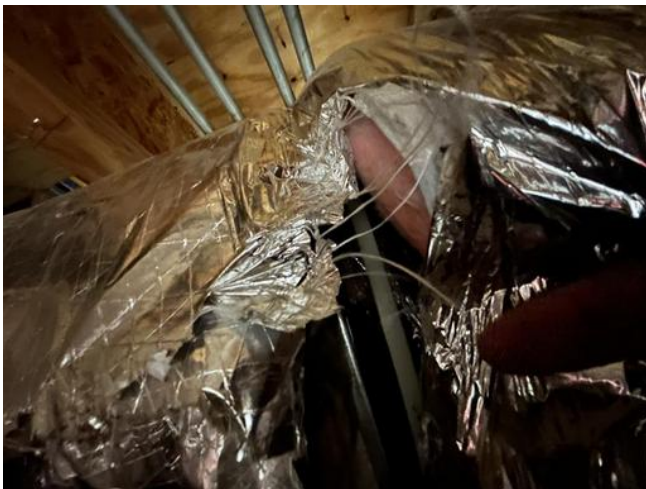
Ensure flex inner core is taped and banded, along with tape or banding on outer insulation jacket. Flex is to be ran in lengths no greater than 4'0" in horizontal positions only.

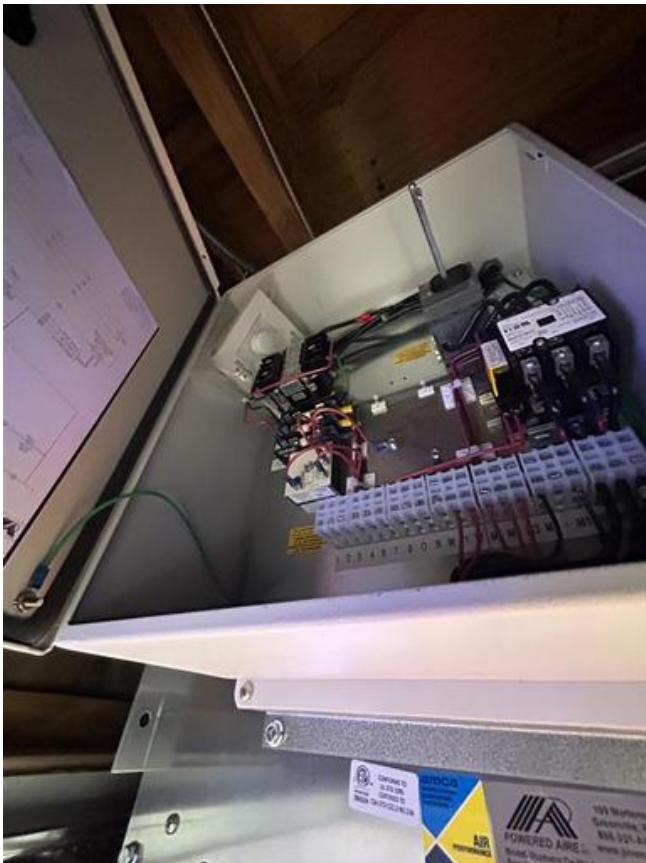
Air curtain remote switches are not installed or do not control curtain functions properly between modes (fan on / auto, heat on / off) at time of TAB inspection.

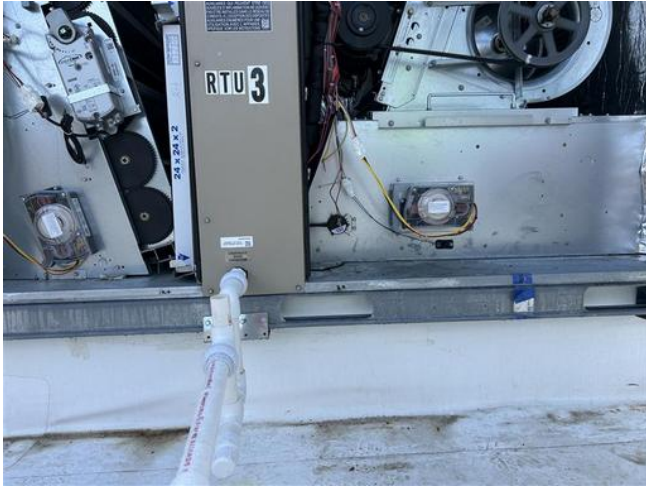
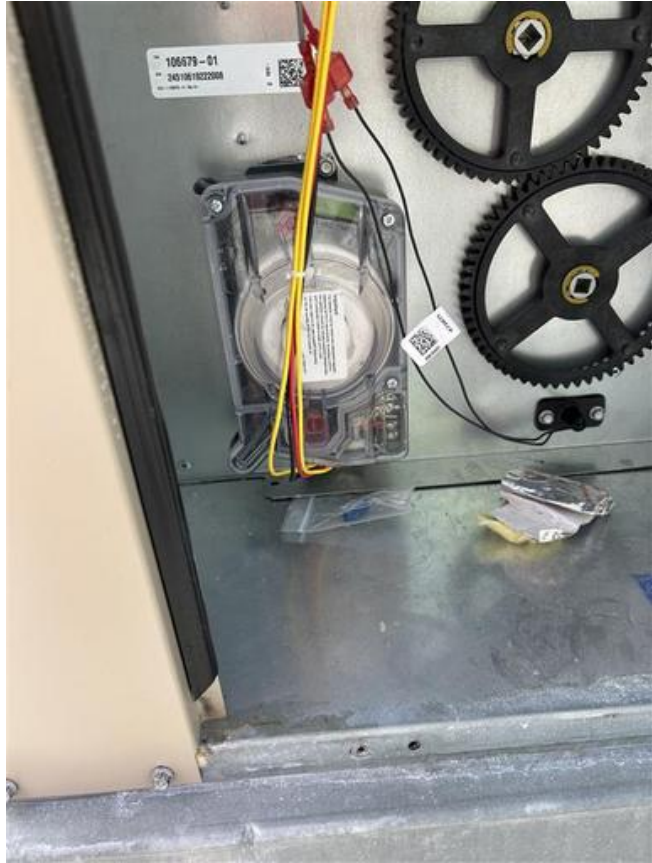
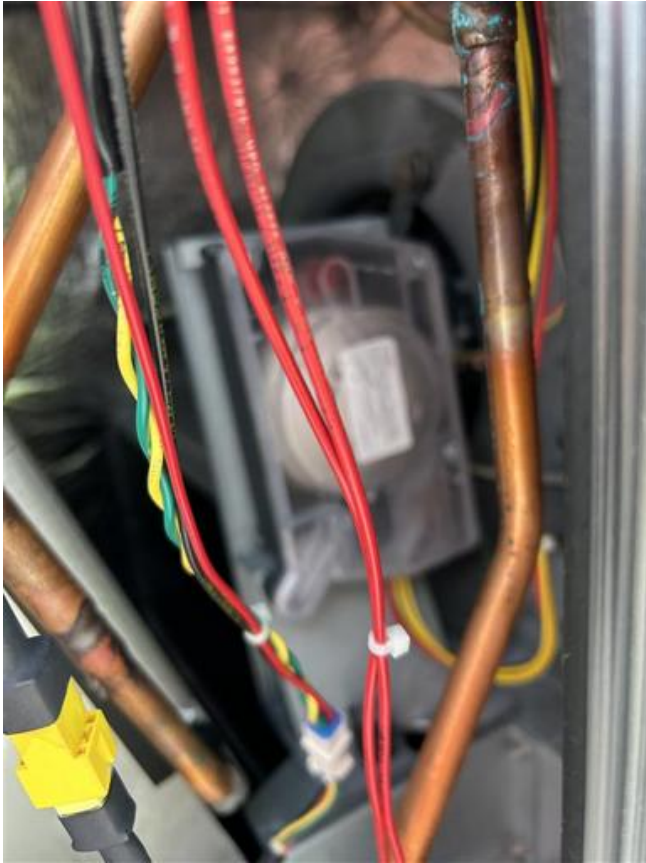
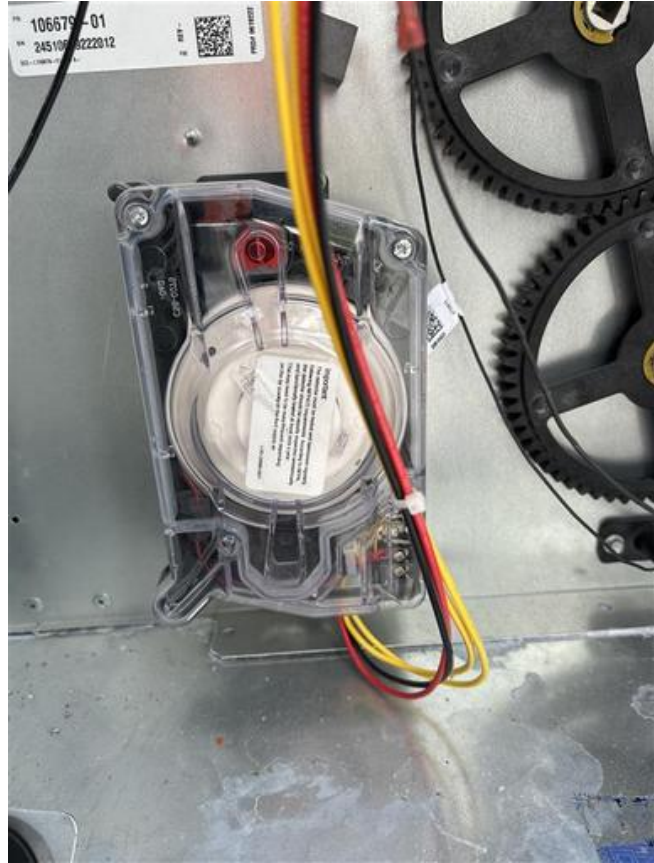
Dust plugs to be removed from smoke detectors or device dip switches set incorrectly, cleaning smoke detector head and sampling tube is needed or smoke detector or sampling tube cap is missing entirely.

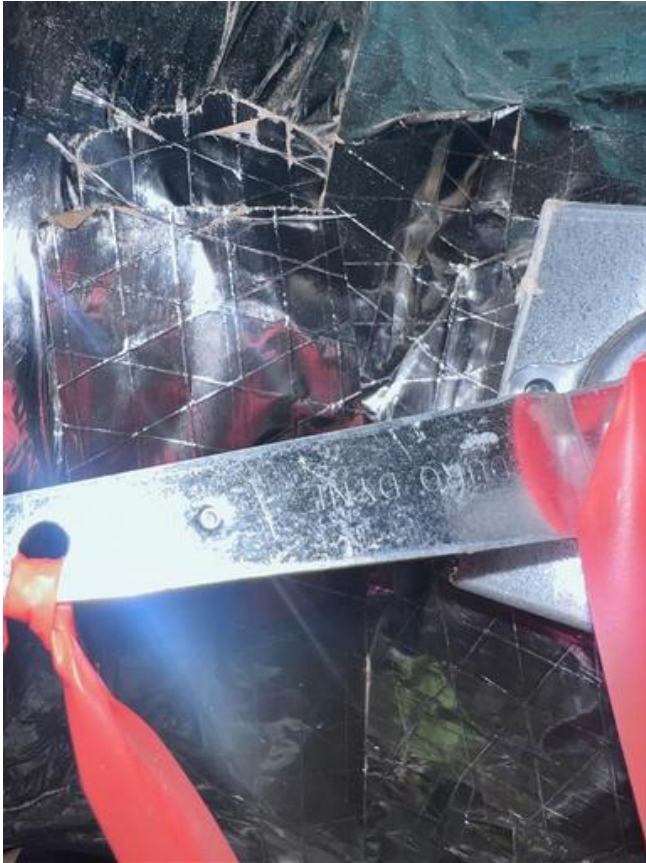
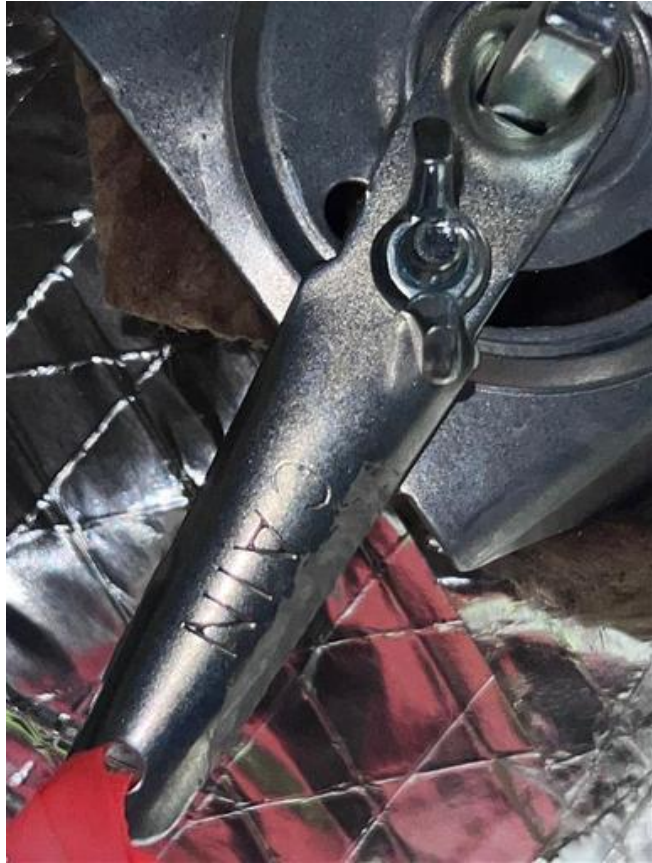
Dampers observed of wrong type with incorrect standoff. Contact national account provider for replacements. Multiple damper manufacturers found across all units. Unit's were able to be balanced recommend contact for EOR for approval.

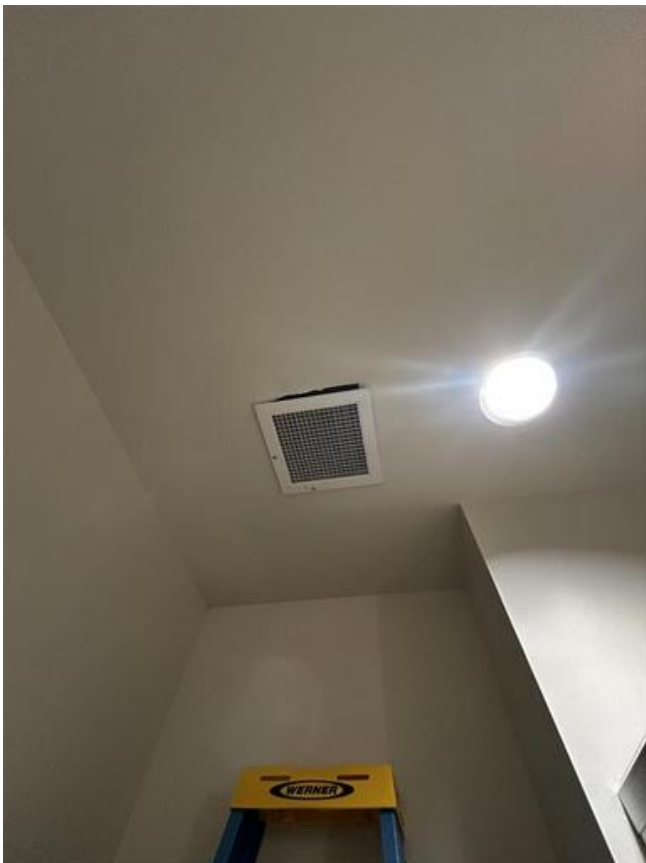
Female restroom exhaust register is incorrect.

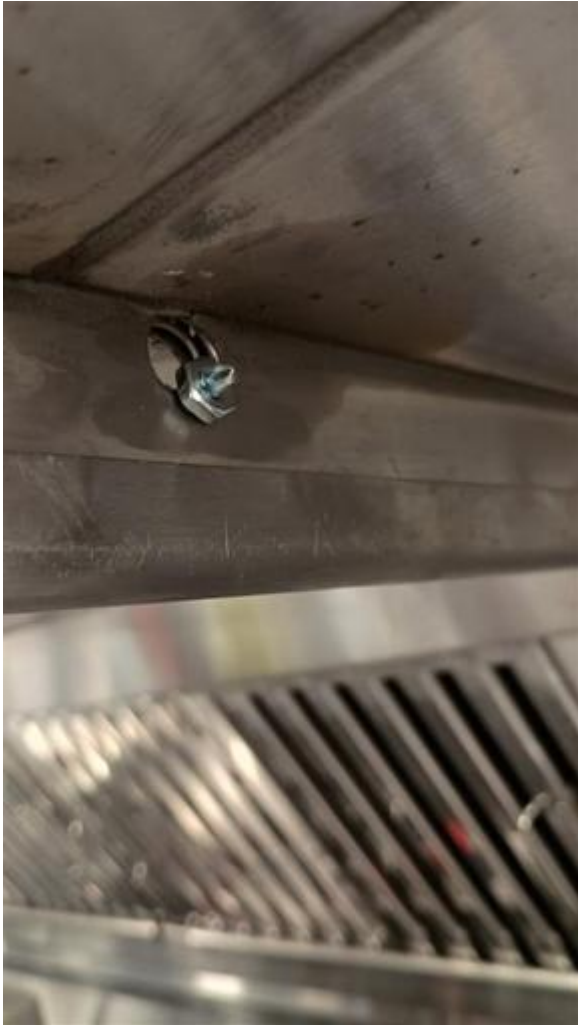
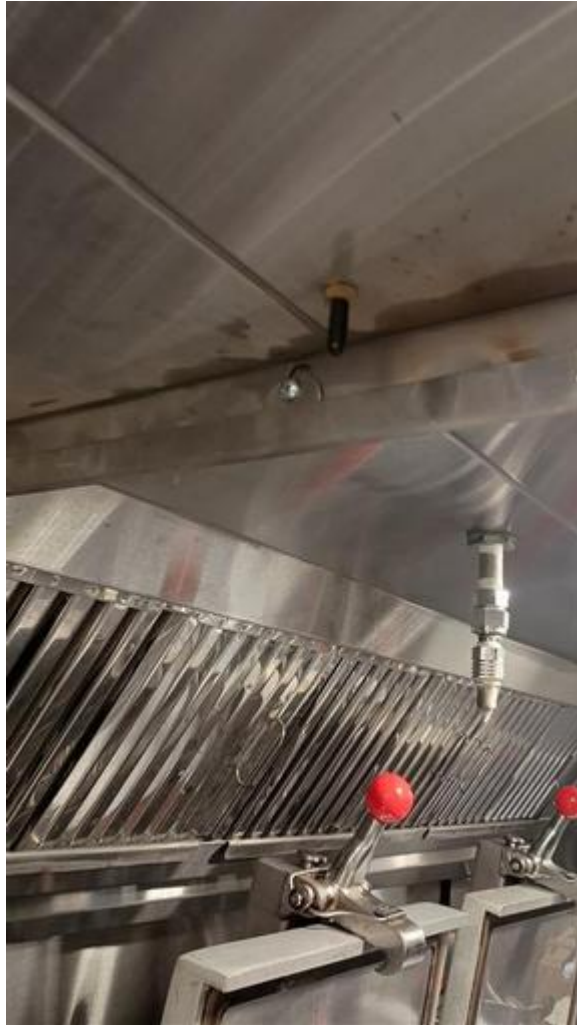
Hoods 1L/1R are missing bolting hardware and / or the splice brackets that are to be installed at their midpoint connection seams.

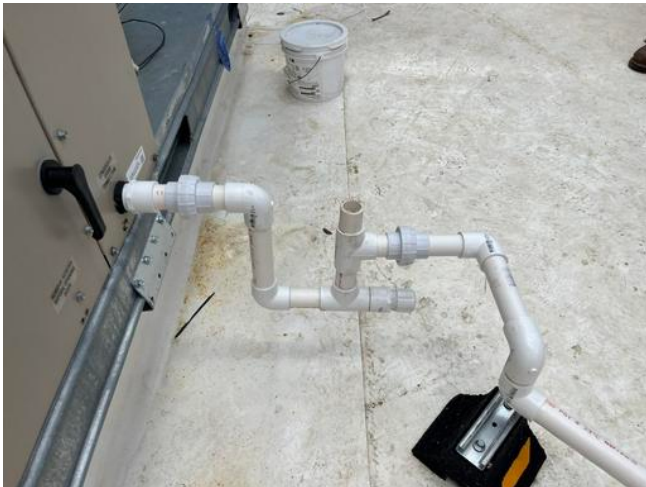
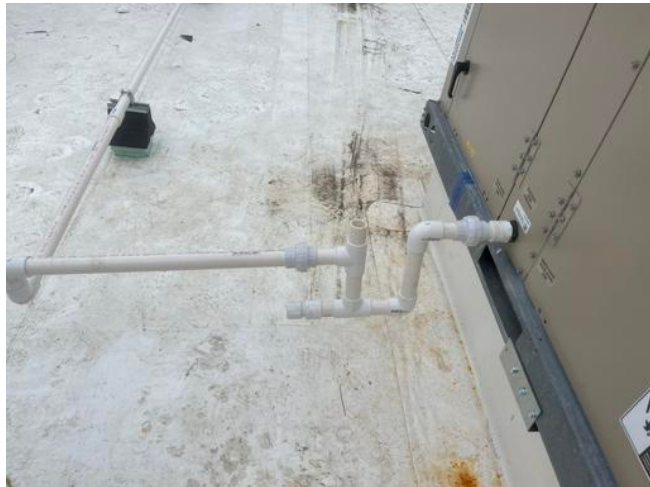
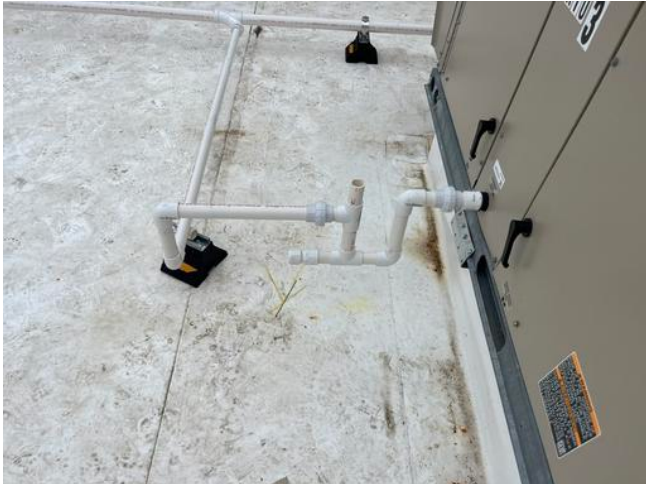
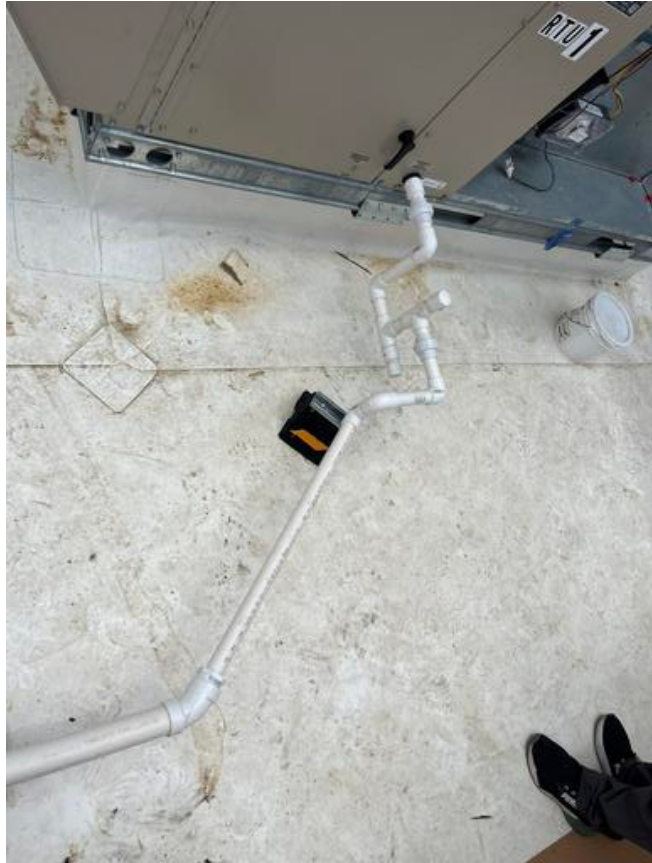
Equipment condensate piping or p-trap is not constructed per normal CFA specifications. RTU is constructed with 1" pipe not 1 1/2" as per plan.

Vent extensions to be removed as they are not necessary.

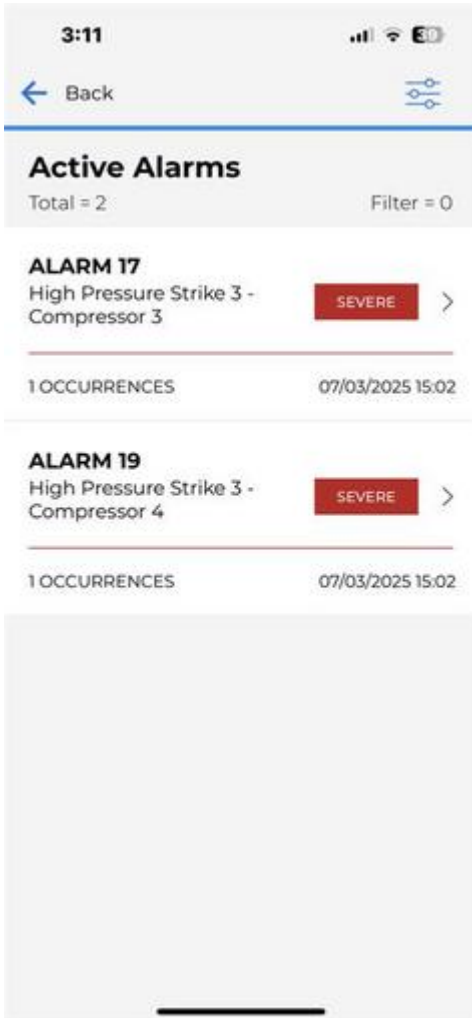
Unit not cooling properly, Unit alarms (High Pressure Strike 3-Compressor 3, High Pressure Strike 3-Compressor 4). Units supply temperature is 71 degrees.

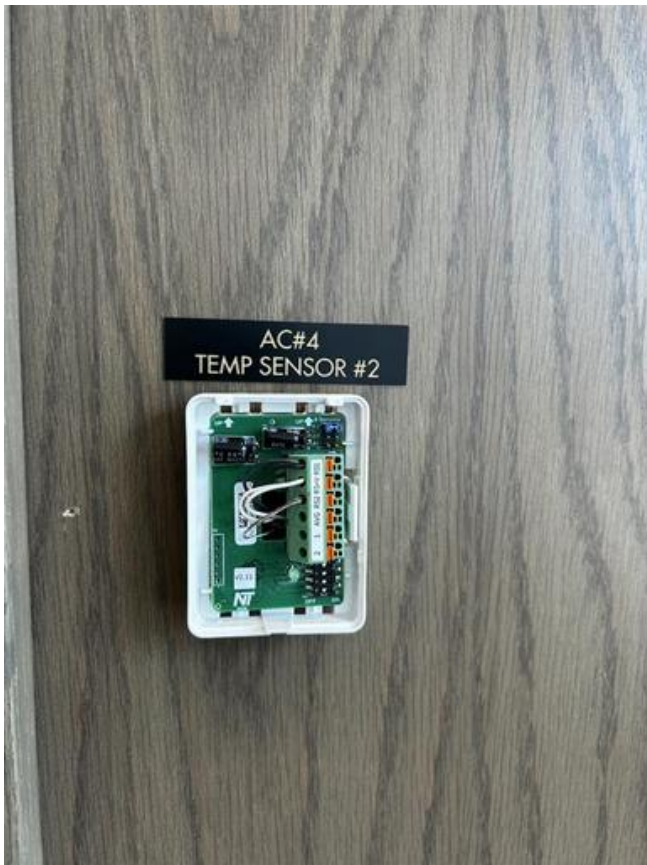
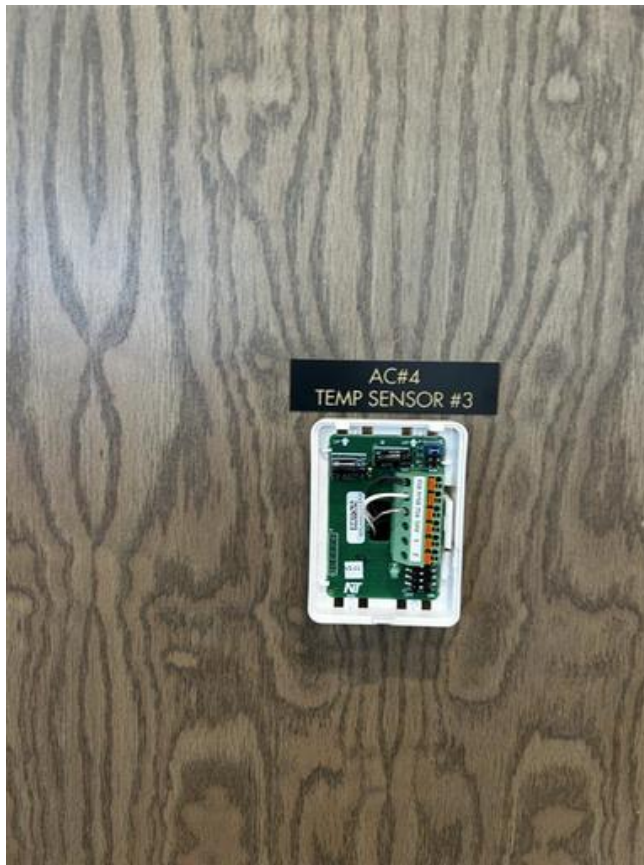
Label all sensors, humidistats, thermostats, smoke annunciators and remote space mounted OADs, MODs, VFD's for which piece of equipment they serve. AC-3 temperature sensor labels 4 and 5 are not labeled correctly.

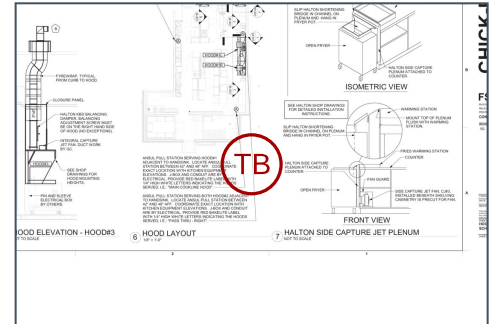
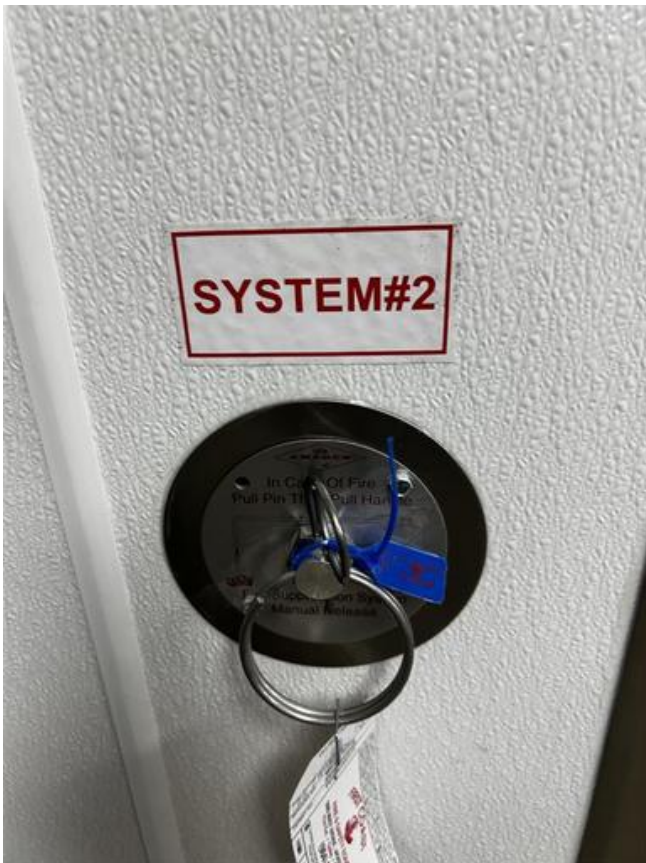
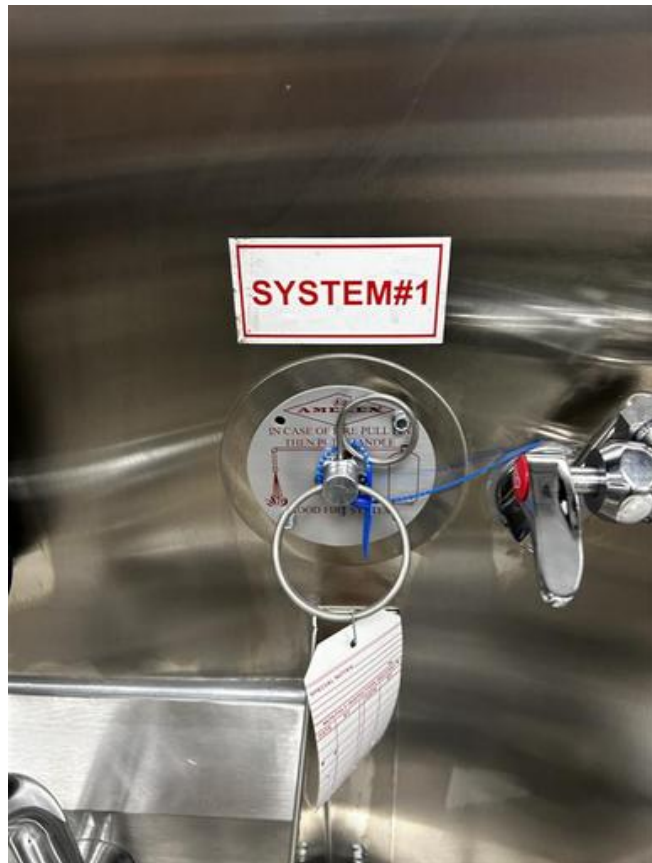
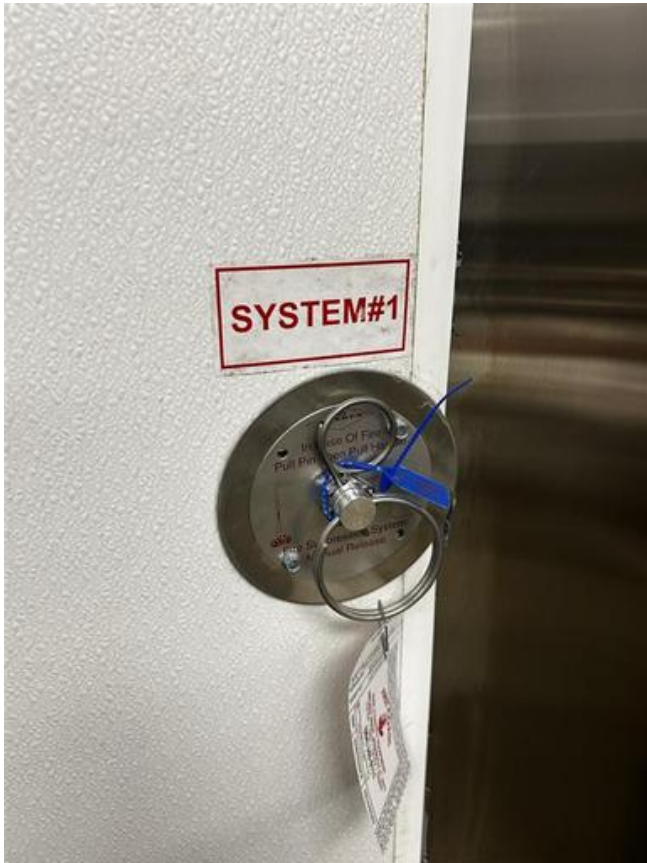
**Description**  
Label all ansul pull stations with bakelite labels per mechanical plans.

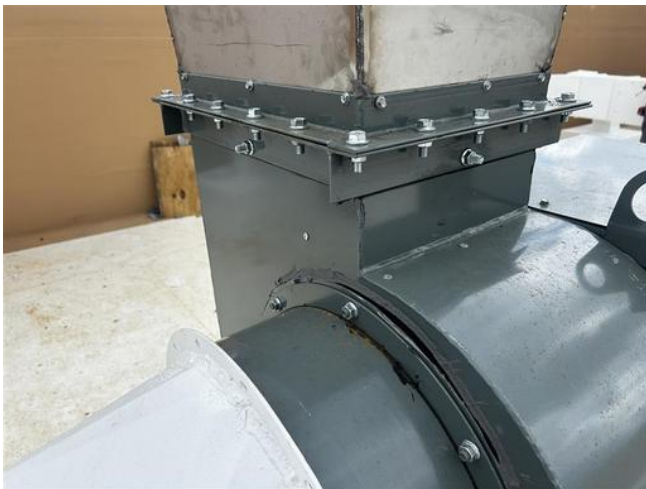
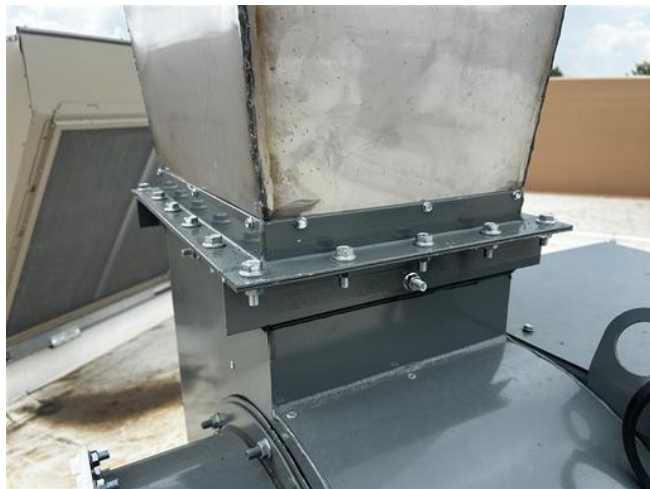
Exhaust fan discharge nozzle is not constructed to kitchen hood exhaust fan detail or is not welded to discharge flange.

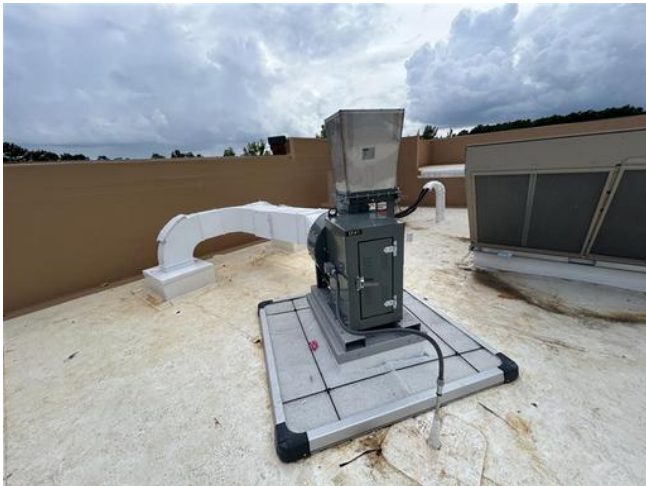
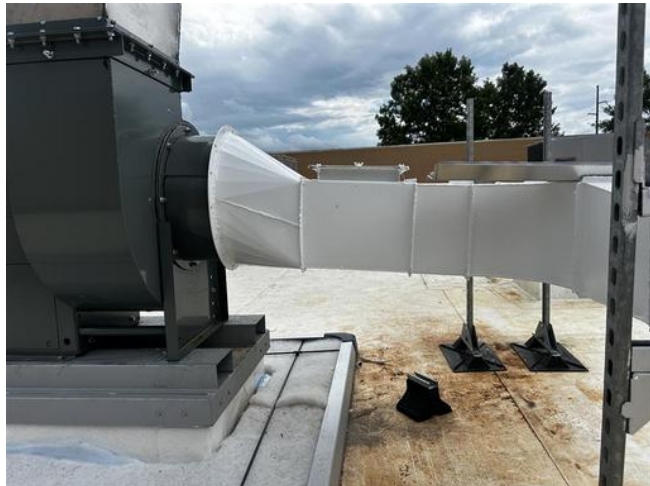
Exhaust fan G2 Drip Guard is not installed. Generic guard has been installed around the fan base.

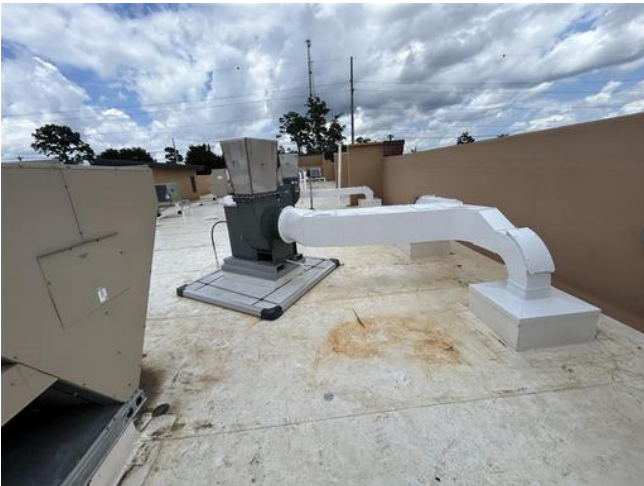
Exhaust duct is to be supported per kitchen hood exhaust fan detail on 6'0" centers.

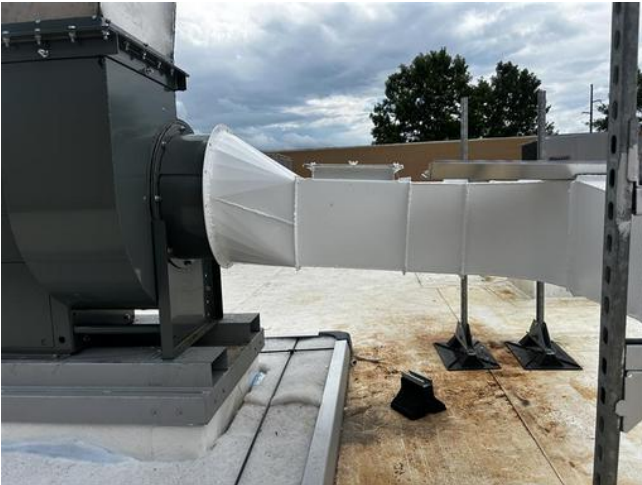
EF-2 grease duct is not centered on fan inlet and is welded onto fan. Fan will be balanced tomorrow to provide update for static pressure.

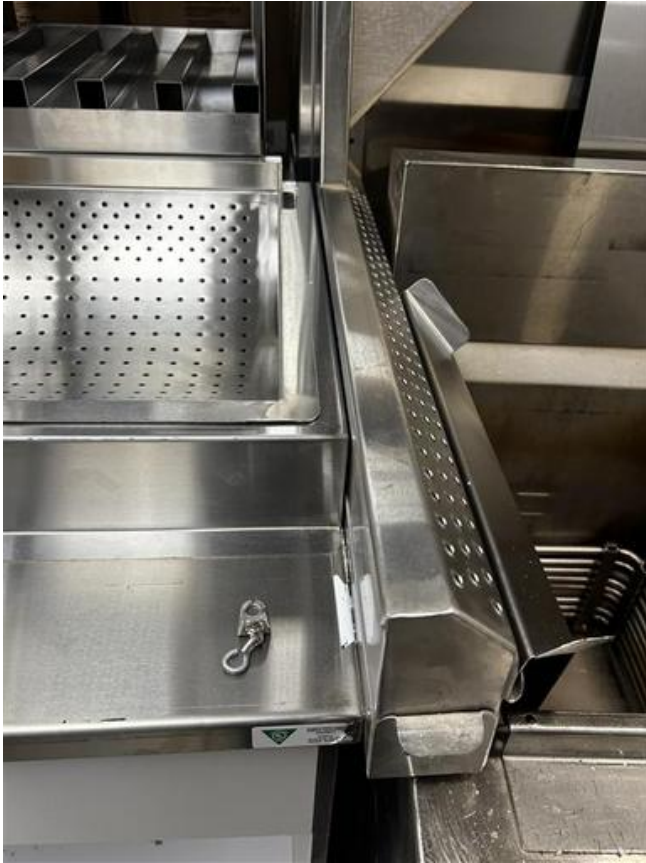
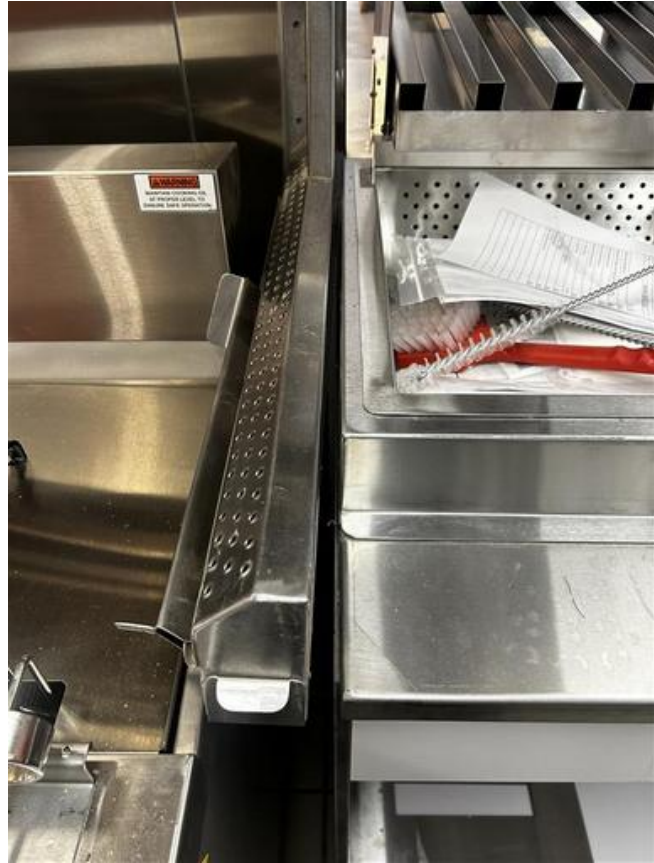
The Halton supplied angle bracket that connects the integral sidejet arm to the counter is missing or not installed correctly. Secure bracket to arm and bracket to counter underneath removeable fry dump via stainless steel rivets.

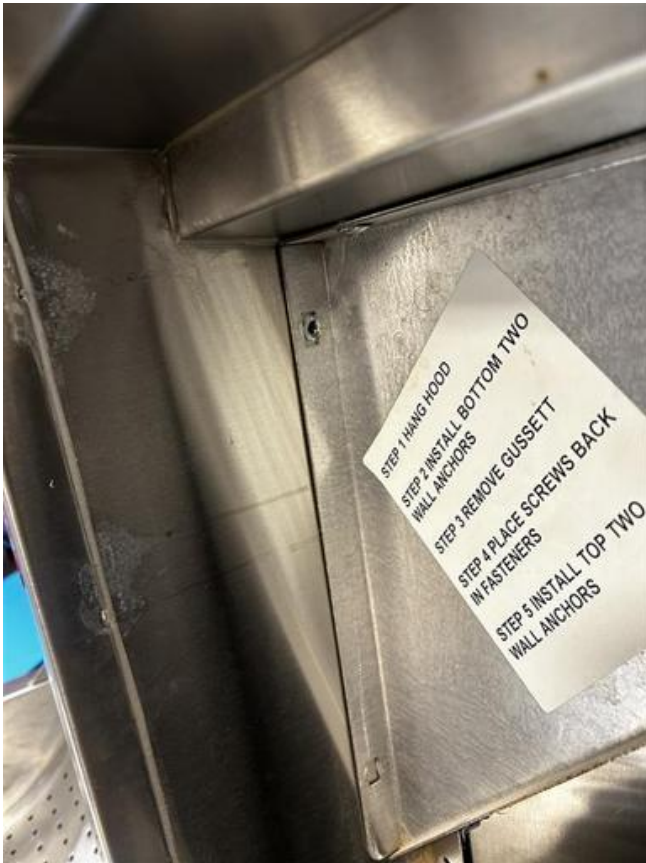
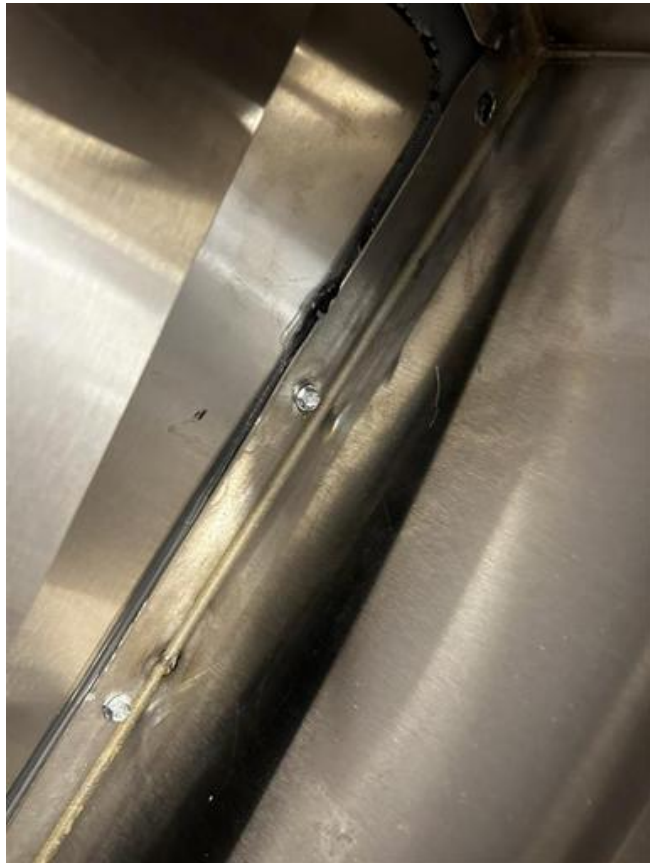
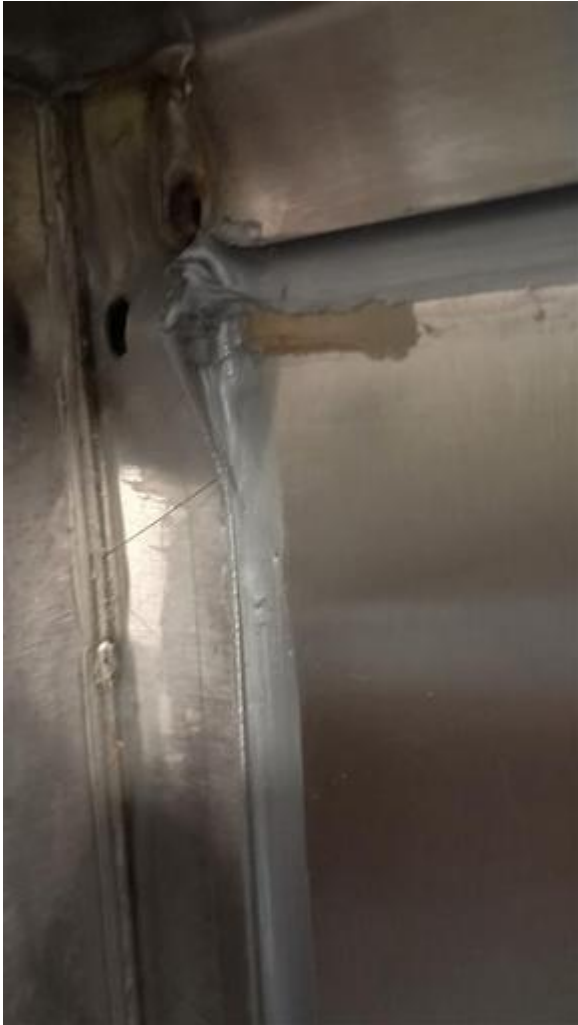
Hoods are to be secured to back panes via pre-punch holes with stainless steel screws.
