Report: TAB Report
Function: Test, Adjust, & Balance
Date: 06/10/2025
Completed By: National TAB

**06-09-25 WHATABURGER #1555 CANTON,
GA**

6021 Hickory Flat Hwy

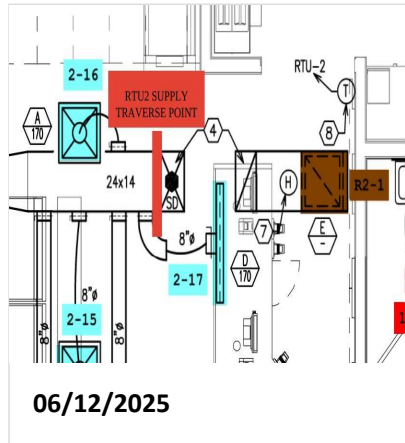
Screenshot of the GRD marked up with supply and return traverse locations for RTU-2 (Add picture here)

RETURN WAS UNABLE TO BE TRAVERSED DUE TO THE HARD CEILING

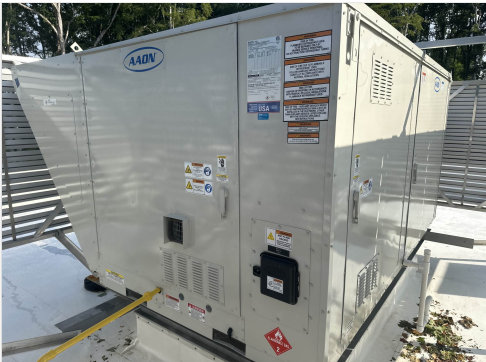
Asset: RTU1

Issue Name : DIFFUSER 1-9 IS OUT OF DESIGN
Description : The diffuser serving the back entrance is low on total airflow (55%). This appears to be due to a metal pipe going right under the center of the flex duct, cutting off half of the duct before it reaches the grille.
Created By : National TAB **Assigned To :** National TAB - Ben Searles
Status : Open
Priority : Urgent **Asset Tag :**
Originated Date : 06/12/2025 - Ben Searles - National TAB

Asset	Notes	Date	Written By
SGRD9	FLEX DUCT IS RESTRICTED DUE TO A METAL PIPE IN THE WAY. AIRFLOW IS DRASTICALY LOW (55%) DUE TO THE FLEX'S ANGLE AGAINST THIS PIPE. RECOMMEND RUNNING THE FLEX IN A WAY THAT DOES NOT RESTRICT AIRFLOW.	06/09/2025	Ben Searles

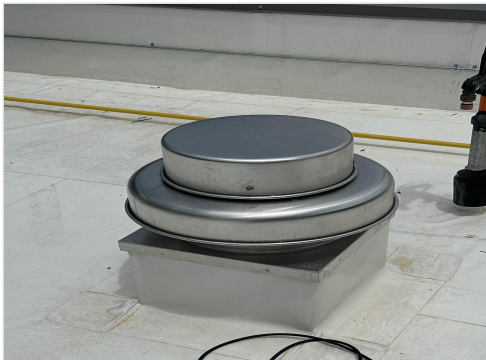
Asset: EF1

Issue Name : EF1 IS OVERAMPING
Description : EF1, serving the restrooms, is overramping at the lowest speed setting and shutting off repeatedly. The motor may be faulty and need to be replaced. If the motor is replaced, the red wire will have to be connected to L2 to reach the design airflow. This fan was turned off during building pressure, so the pressure will drop once the fan is running.

FAN IS OVERAMPING AND SHUTTING OFF REPEATEDLY. RECOMMEND REPLACING THE MOTOR. THE FAN IS SET TO OPERATE AT THE LOWEST SPEED (1050 RPM - RED WIRE)
