Report: TAB Report
Function: Test, Adjust, & Balance
Date: 02/19/2025
Completed By: National TAB

PROJECT
02-17-25 FREDDY'S DOUGLAS, GA

Project: 02-17-25 FREDDY'S DOUGLAS, GA

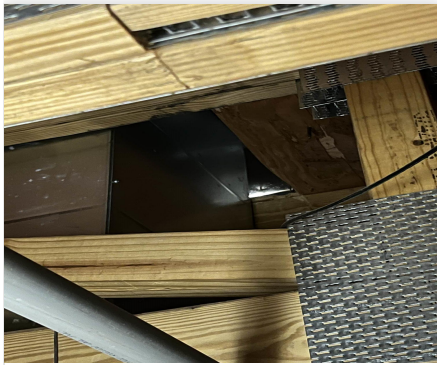
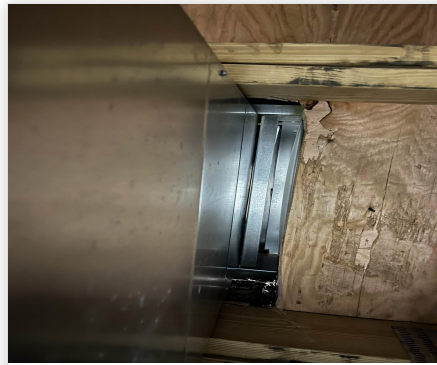
Issue Name : DOAS (Unit 2) Duct Leakage
Description : The kitchen DOAS unit is leaking significantly at the supply drop. The leakage can be felt by hand on the side of the drop. Airflow is currently ~1900CFM out of 2800CFM design (68%) as-is. The fan speed is set to the maximum allowed frequency on the controller. (50Hz).
Created By : National TAB **Assigned To :** National TAB - Dan Hertenstein
Status : Open
Priority : Urgent **Asset Tag :**
Originated Date : 02/18/2025 - Stephen Tassinaro - National TAB

DOAS airflow is higher than measured due to leakage at the supply drop.

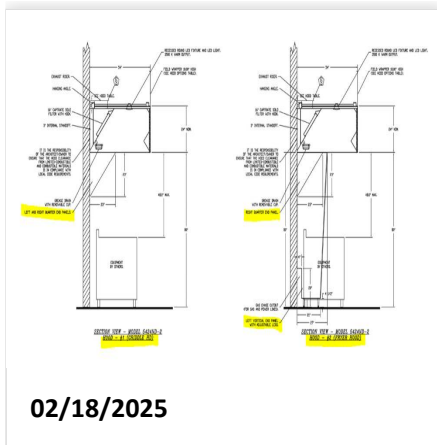
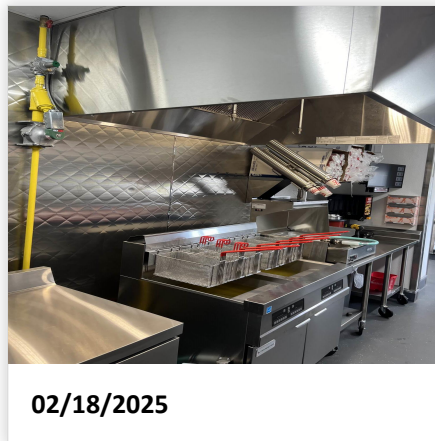
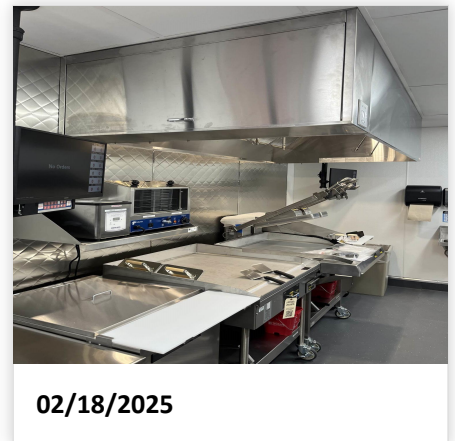
Issue Name : Hood End Panels Not Installed
Description : None of the Captive Air hood end panels are installed. Hood 1 is to have left & right quarter end panels. Hood 2 is to have a right quarter end panel and left vertical end panel. See M300.
Created By : National TAB **Assigned To :** National TAB - Dan Hertenstein
Status : Open
Priority : High **Asset Tag :**
Originated Date : 02/18/2025 - Stephen Tassinaro - National TAB

- **02/19/2025 National TAB - Stephen Tassinaro**
 - Some containment is ~95% on both hoods without the end panels installed. Small amounts of smoke escape out of the back corners where end panels would normally be present.

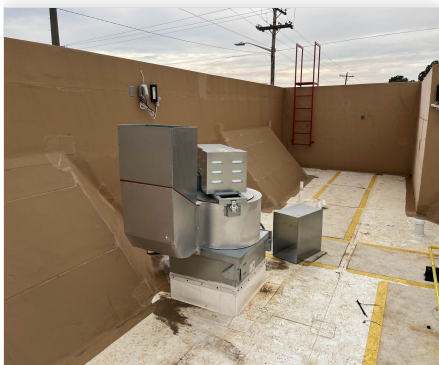
Issue Name : KEF-1 (HD-1 Exhaust Fan) Leakage
Description : Leakage can be felt and heard around the base of the rooftop kitchen exhaust fan for Hood-1. Recommend adding an appropriate fire rated gasket to the fan or otherwise sealing the leakage.
Created By : National TAB **Assigned To :** National TAB - Dan Hertenstein
Status : Open
Priority : Urgent **Asset Tag :**
Originated Date : 02/19/2025 - Stephen Tassinaro - National TAB

Fan leaking at curb connection. This is making noise and can be felt by hand when feeling around the base of the fan.

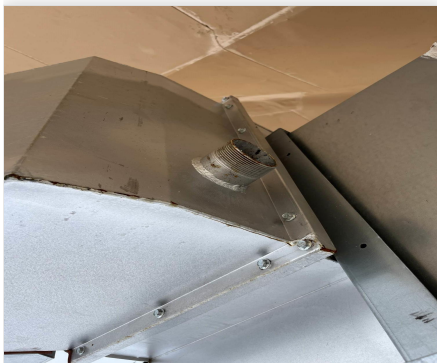
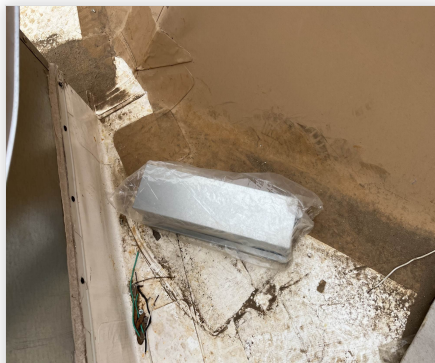
Issue Name : KEF-1 Grease Trap Not Installed
Description : The grease trap is not installed on KEF-1. The trap is sitting on the rooftop in its original packaging.
Created By : National TAB **Assigned To :** National TAB - Dan Hertenstein
Status : Open
Priority : Low **Asset Tag :**
Originated Date : 02/19/2025 - Stephen Tassinaro - National TAB

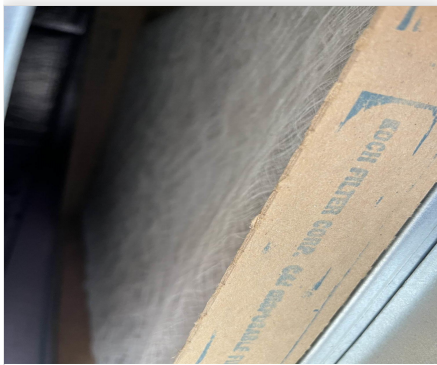
Issue Name : RTU 1 Construction Filters
Description : The manufacturer provided construction filters are still installed on RTU-1 (Dining). Recommend replacing with MERV 8 or greater filters.
Created By : National TAB **Assigned To :** National TAB - Dan Hertenstein
Status : Open
Priority : Medium **Asset Tag :**
Originated Date : 02/19/2025 - Stephen Tassinaro - National TAB

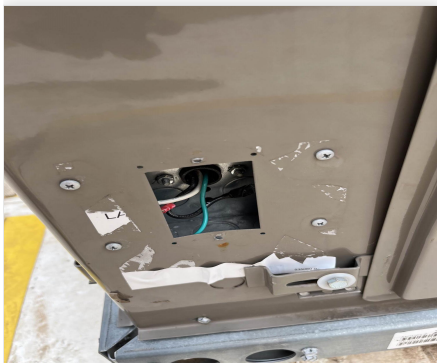
Issue Name : RTU-1 Missing GFI Outlet
Description : GFI outlet is not installed on RTU-1. The wires are electrical taped and there is an open hole into the unit. Recommend installing GFI or patching hole and removing wires.
Created By : National TAB **Assigned To :** National TAB - Dan Hertenstein
Status : Open
Priority : Medium **Asset Tag :**
Originated Date : 02/19/2025 - Stephen Tassinaro - National TAB

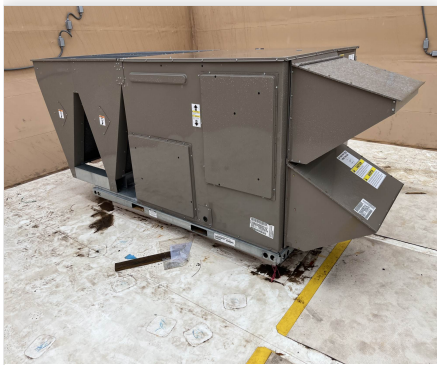
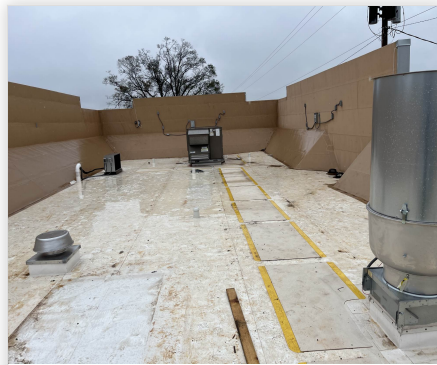
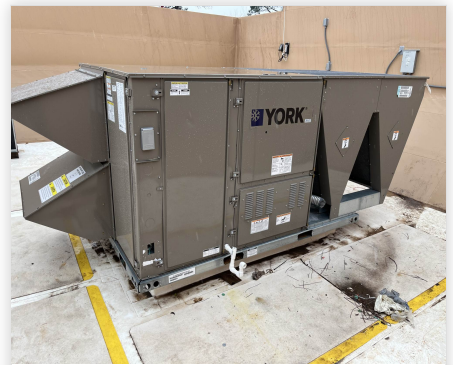
Issue Name : RTU-1 No Gas Line
Description : There is no gas line ran to RTU-1. This is causing discomfort in the dining area as there is no heat.
Created By : National TAB **Assigned To :** National TAB - Dan Hertenstein
Status : Open
Priority : High **Asset Tag :**
Originated Date : 02/19/2025 - Stephen Tassinaro - National TAB

Dining room too cold due to lack of heat.

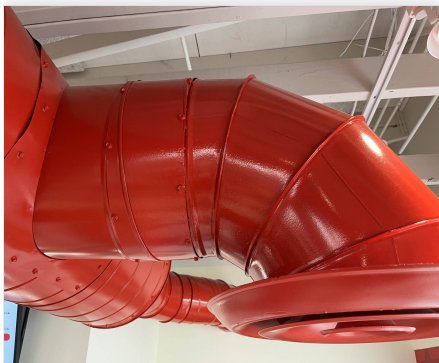
Issue Name : SGRD1-11 Missing Damper
Description : RTU 1 (Dining) Diffuser 11 does not have a manual balancing damper installed. Space adjusted for comfort only. A damper will need to be installed to push air to the remaining low diffusers.
Created By : National TAB **Assigned To :** National TAB - Dan Hertenstein
Status : Open
Priority : Urgent **Asset Tag :**
Originated Date : 02/19/2025 - Stephen Tassinaro - National TAB

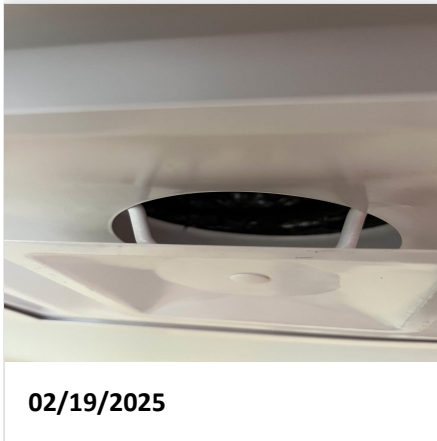
Issue Name : SGRD1-12, 13, 14 - No OBDs Installed
Description : The face accessible opposed blade dampers were not installed on diffusers 12 thru 14 in the dining area. These face accessible dampers are required when the ductwork is above a hard ceiling. This is called for on the Diffusers Schedule.
Created By : National TAB **Assigned To :** National TAB - Dan Hertenstein
Status : Open
Priority : Urgent **Asset Tag :**
Originated Date : 02/19/2025 - Stephen Tassinaro - National TAB

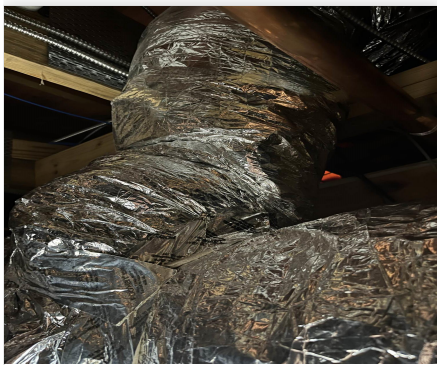
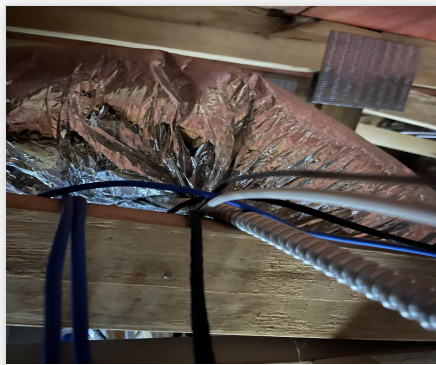
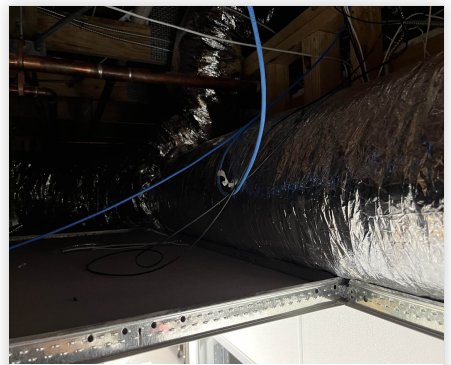
Issue Name : SGRD2-6 Low Flow
Description : The office supply diffuser is low on airflow. Currently 60CFM out of 200CFM design. The flex duct is kinked in a few places, restricting airflow. The air device is also too small. Mechanical plans call for a 24"x24" air device, a 12"x12" is currently installed.
Created By : National TAB **Assigned To :** National TAB - Dan Hertenstein
Status : Open
Priority : Urgent **Asset Tag :**
Originated Date : 02/18/2025 - Stephen Tassinaro - National TAB

- **02/18/2025 National TAB - Stephen Tassinaro**
 - Even with the DOAS being low on total supply airflow, the office should still have 120-140CFM as-is.

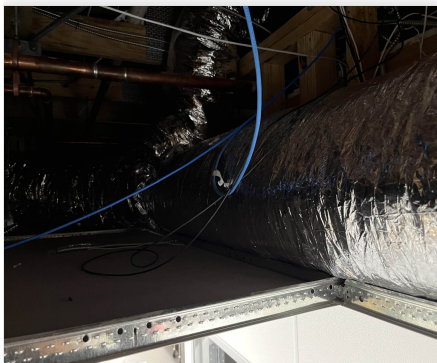
Issue Name : SGRD2-7 Missing Damper
Description : SGRD2-7 (Drive-thru payment window) is missing a manual balancing damper. This is denoted by the "B" symbol on the mechanical plans. As a result this diffuser is high on supply airflow (118% proportionally).
Created By : National TAB **Assigned To :** National TAB - Dan Hertenstein
Status : Open
Priority : Urgent **Asset Tag :**
Originated Date : 02/18/2025 - Stephen Tassinaro - National TAB

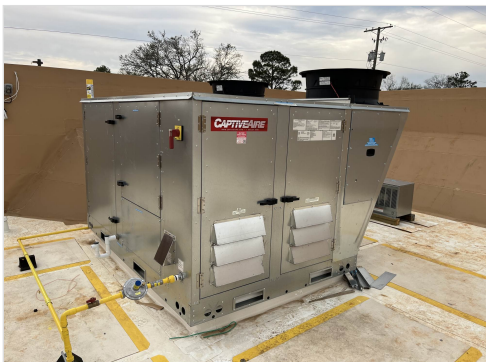
Asset: DOAS1

[1] Leakage at supply drop. [2] Model number discrepancy.

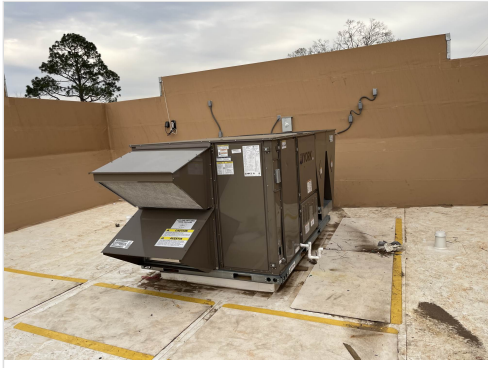
Asset: RTU1

General	
	Actual
Fan Rotation Correct	YES
Unit Filters Clean	CONSTRUCTION FILTERS
Condensate Drain Installed	YES

Notes:
*Readings taken before VFD as VFD cannot be accessed without blower door being open.
