# PlanGrid Task Report - Nov 15, 2024

Prepared by Dale Wheeler

23 tasks in this report.

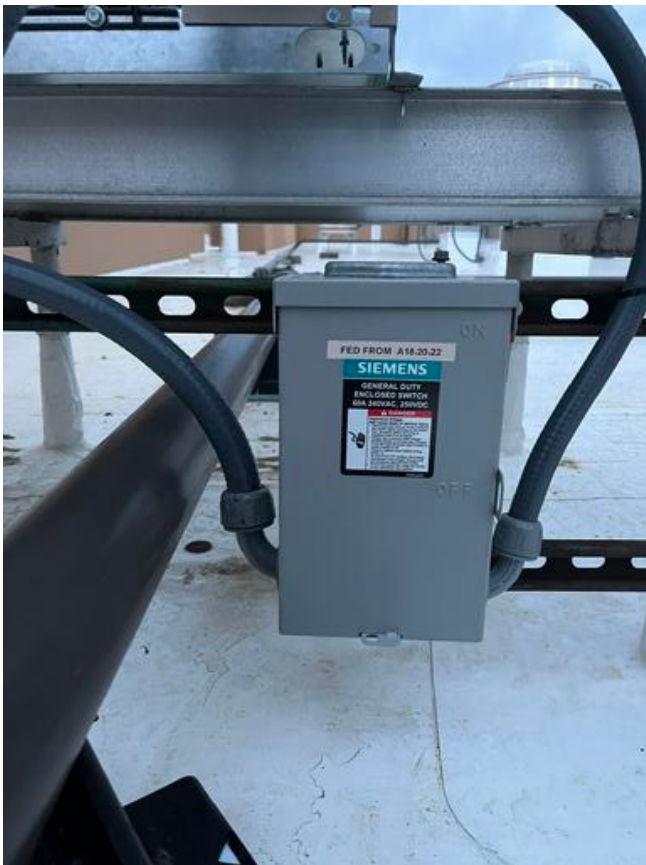
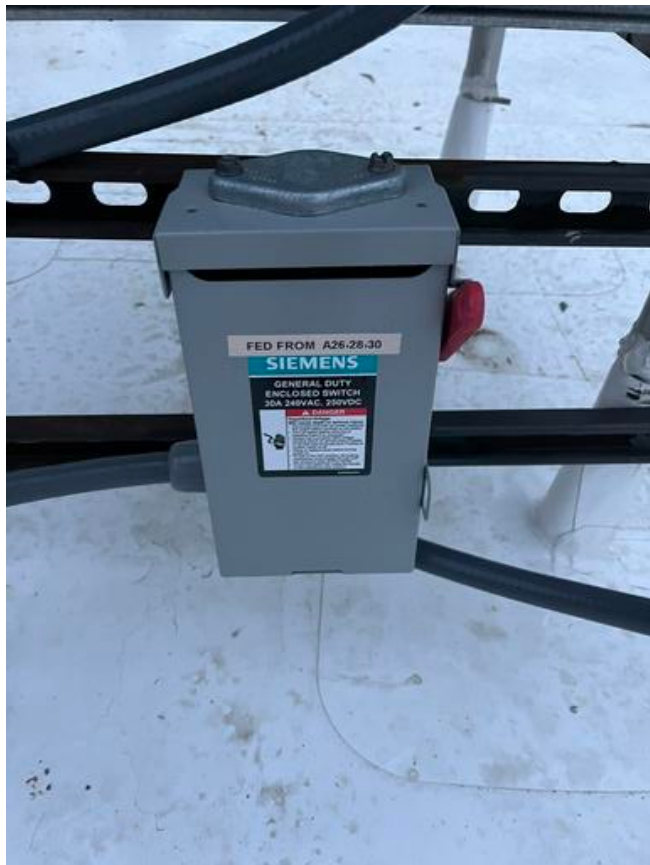
## #57 [REFG 516] [NEW] Condenser electrical disconnects.

WIF & WIC disconnects  
need to be labeled.

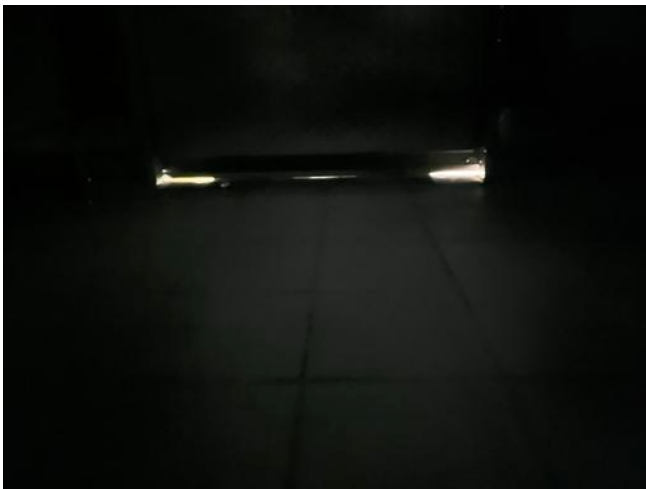
IMG\_6218

**#56 [REFG 506] [NEW] WIF door sweep vs threshold.**

WIF door sweep needs to be adjusted, there should be no visible light under door.

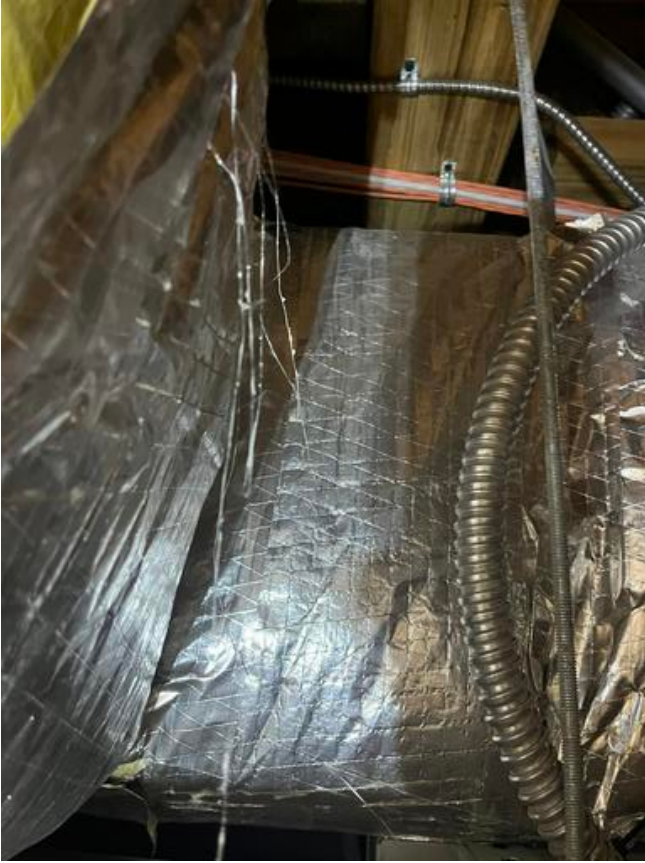
IMG\_6185

## #55 [UNIT 504] [NEW] Equipment Fresh Air Tempering.

Fresh air tempering kits are not installed on AC1, AC2, AC3, AC4, AC5, AC6. Fresh Air Tempering kits are to have the discharge sensor routed per specification into the discharge duct via wiring portal. Using the Lennox Core Board turn on FAH and set parameter #156 to 60 in Kitchen, 62 in Drive-Thru/Serving, & 63 in Dining/Play Area; then set parameters #157 to 14 & #158 to 300 on all.

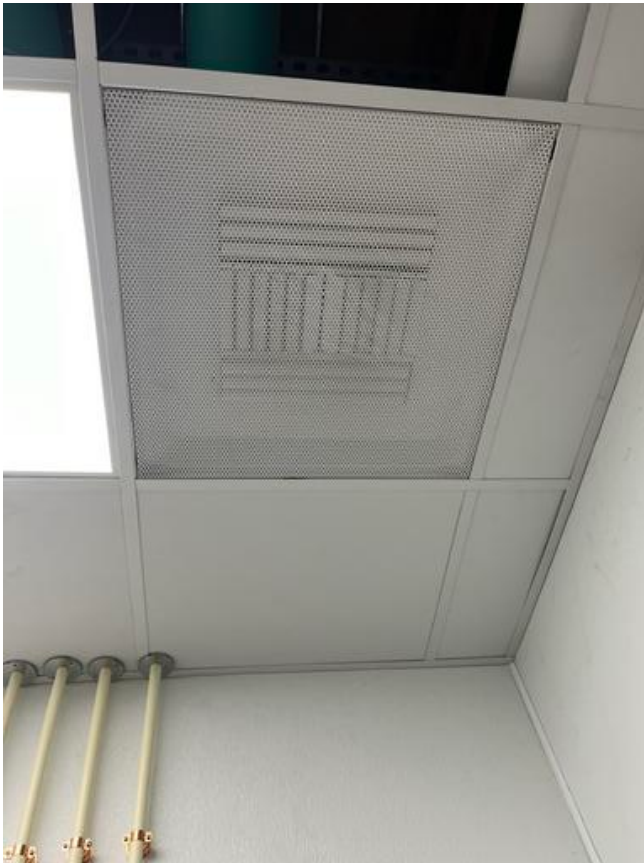
IMG\_6165

**#54 [DUCT 015] [NEW] CRITICAL – Air device wrong type.**

AC2 return grill over the water heater has a supply type grill installed, should be a return style grill.

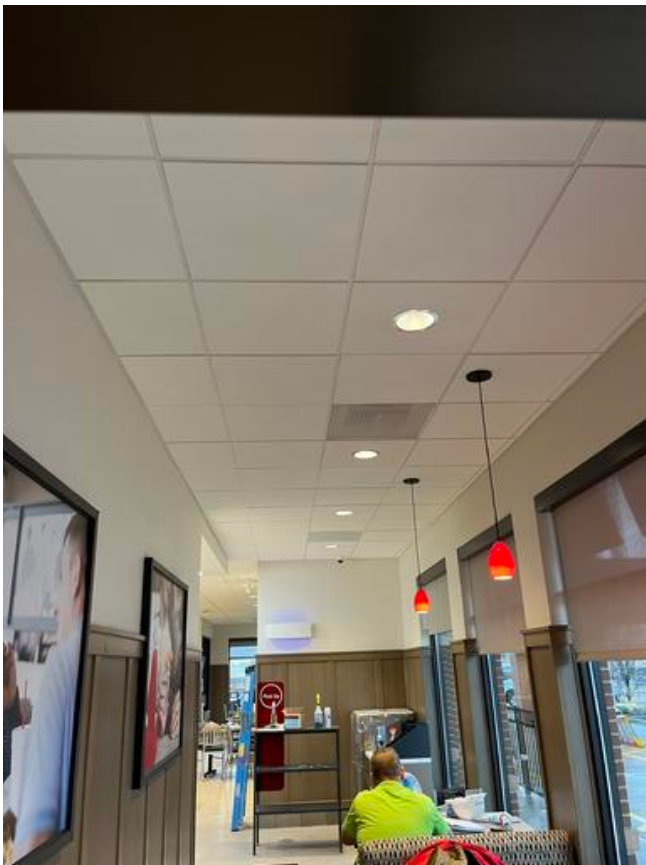
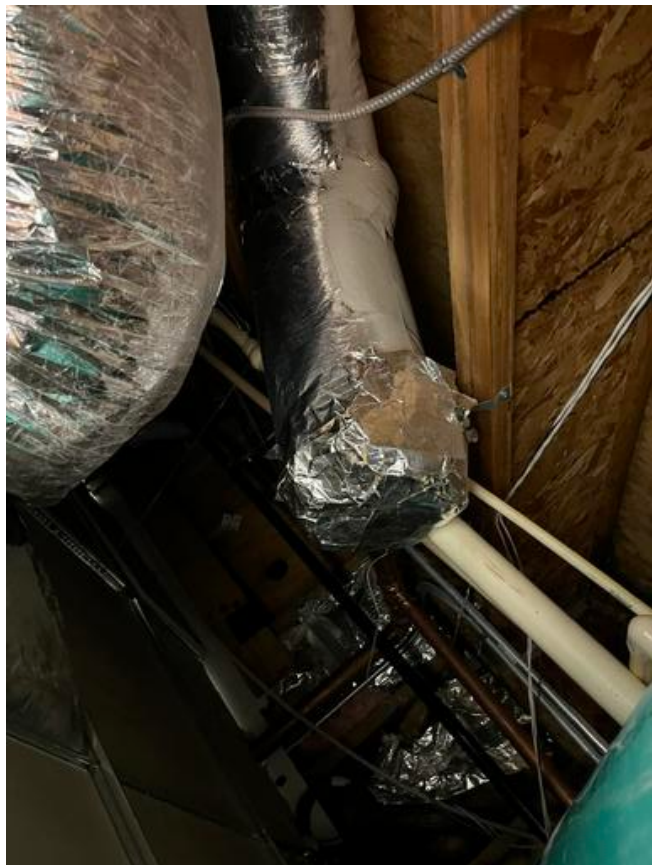
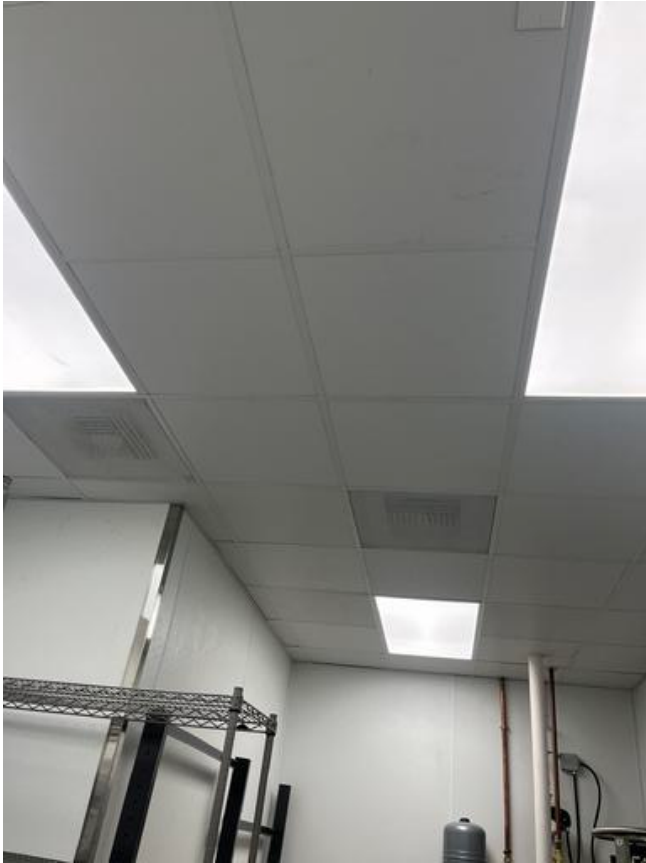
### #53 [DUCT 021] [EXIST] CRITICAL – Diffuser total deficiency.

AC2 is existing ductwork and is missing two supply grills per prints. Supply grill design airflows were adjusted due to this issue.

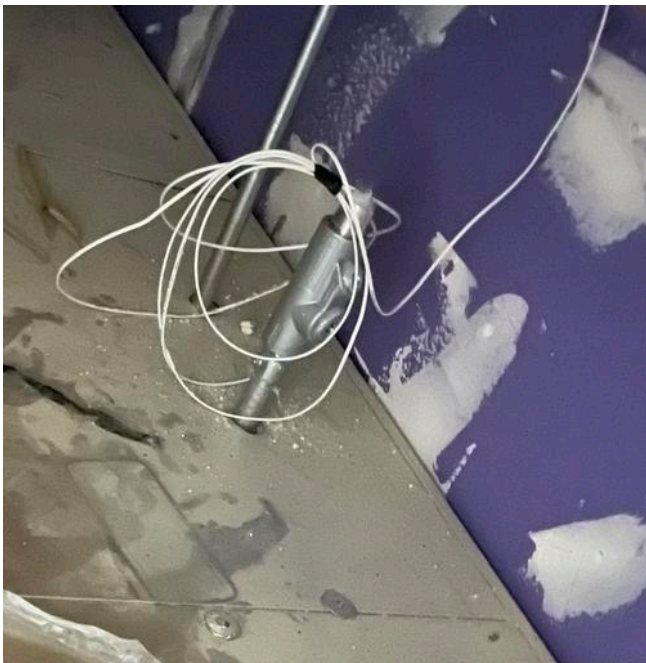
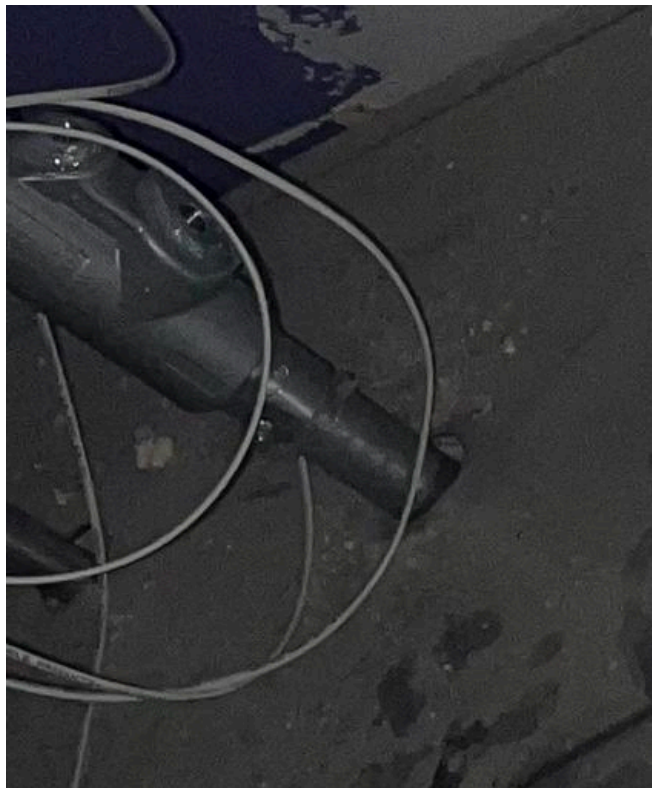
#52 [REFG 508] [NEW] WIC/WIF panel penetrations.

Electrical line entries on top of WIF & WIC need to be sealed.

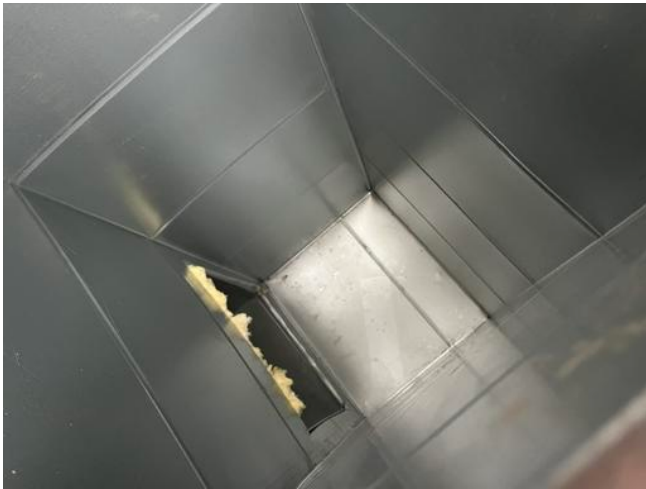
IMG\_6199

## #51 [DUCT 003] [NEW] CRITICAL – Canvas connections.

AC6 canvas connector is not installed.

AC1 unable to remove motor tray due to Evap coil piping obstruction, provide verification canvas connector was installed on AC1.

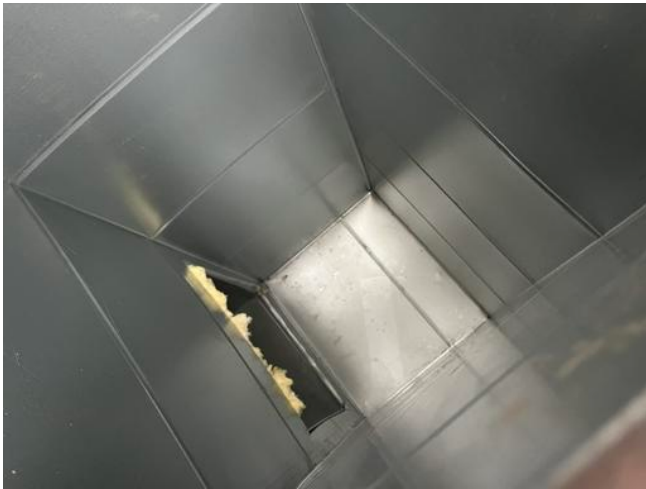
IMG\_6199

## #50 [DUCT 002] [NEW] CRITICAL – Turning vanes in return duct.

AC6 turning vanes are not installed.  
AC1 unable to remove motor tray due to Evap coil piping obstruction, provide verification that turning vanes were installed.

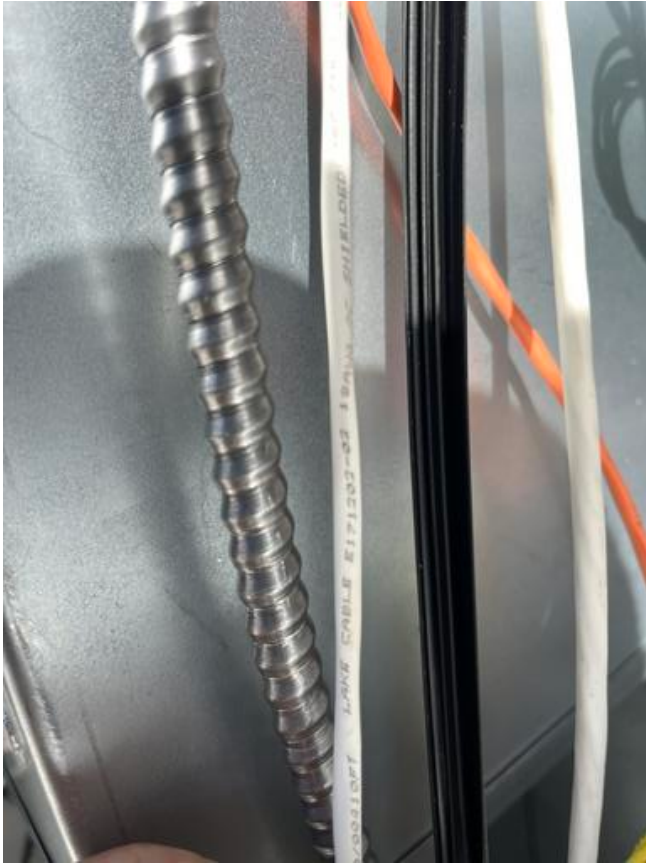
IMG\_6156

**#49 [CNTL 003] [NEW] CRITICAL – Wiring specifications.**

AC1, AC2, AC3, AC4, AC5, AC6 humidity sensor cables installed should both be ConnectAir W221P-2003NT cable. Each humidity sensor currently has one ConnectAir brand cable installed & one Lake Brand cable installed

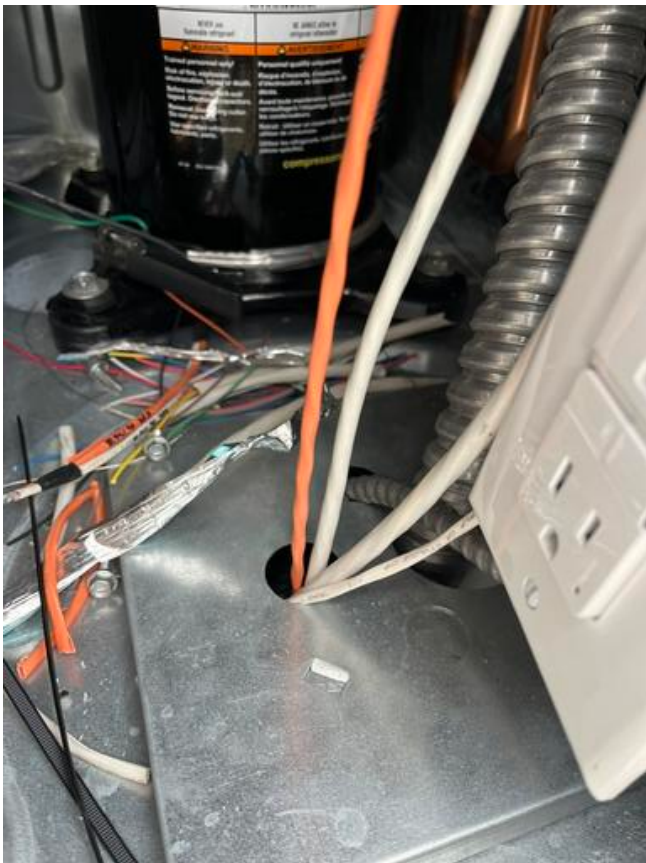
IMG\_6197

## #48 [UNIT 505] [NEW] Equipment wiring portals.

AC1, AC2, AC3, AC4, AC5,  
AC6 low voltage wiring portal  
needs grommet installed.

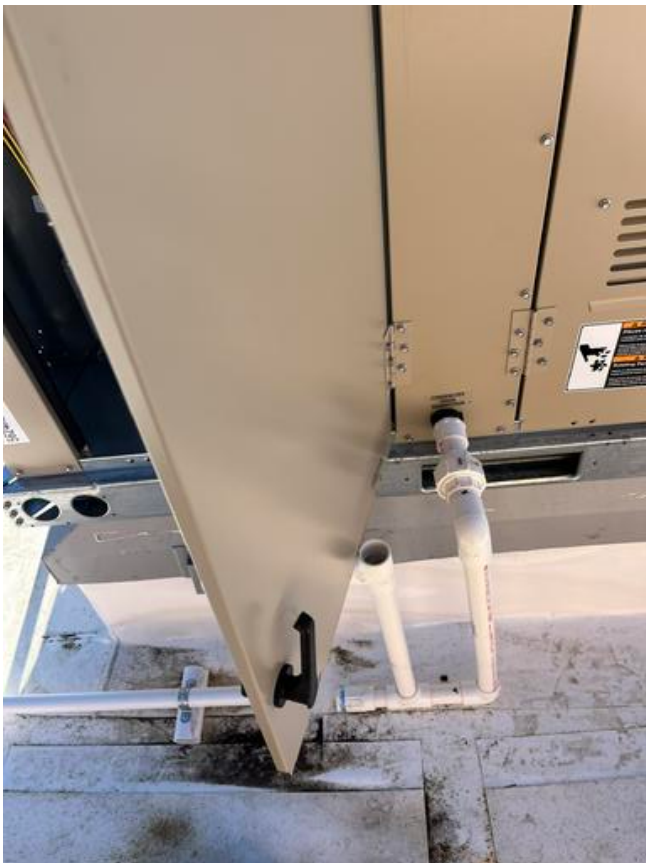
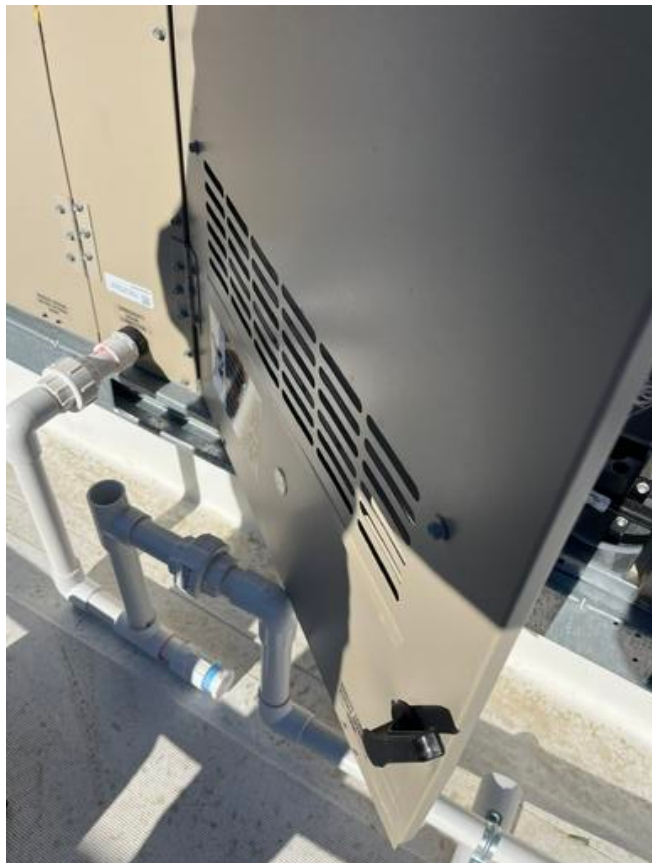
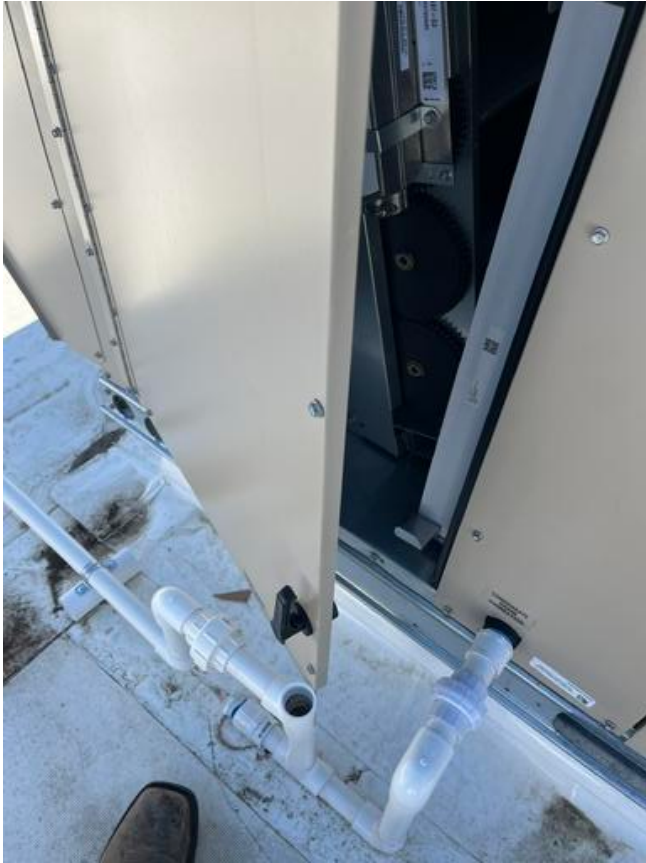
## #47 [UNIT 517] [NEW] Condensate piping construction.

AC1, AC5, AC6 p-traps obstruct the opening of unit's door.

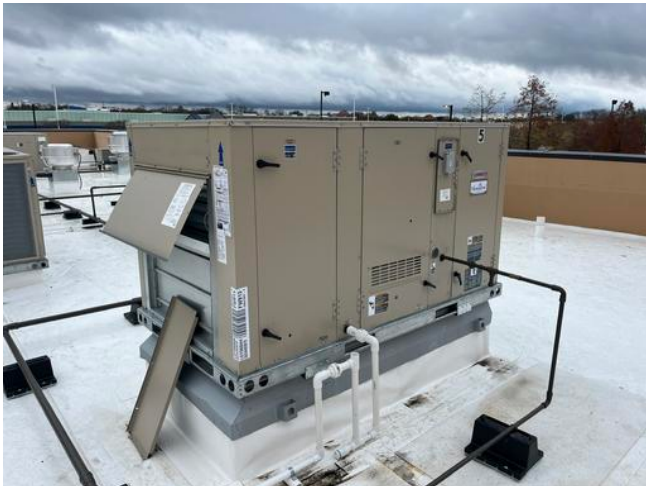
IMG\_6208

## #46 [UNIT 521] [NEW] Equipment is missing specified options.

AC5 is missing the outside air intake and filters. Per mechanical these parts have been ordered.

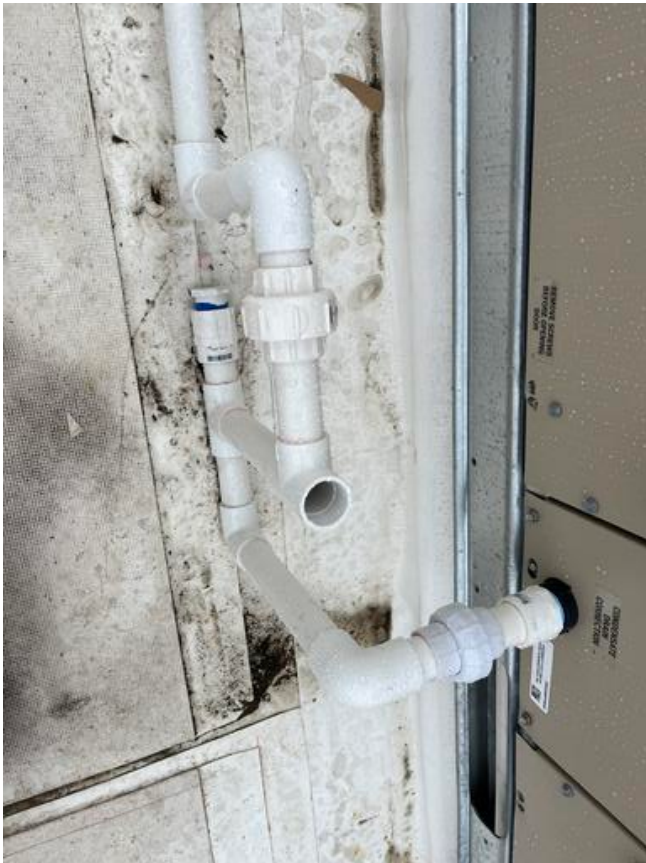
IMG\_6193

## #45 [UNIT 517] [NEW] Condensate piping construction.

AC1 condensate line installed does not match the correct line size called for in prints. Condensate line should be 1.5" not 1.0"

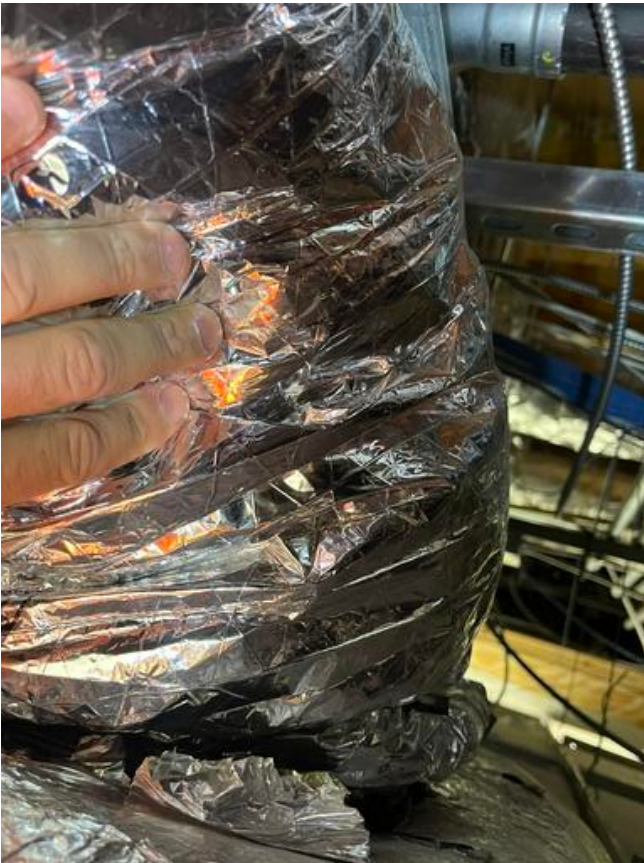
IMG\_6190

#44 [DUCT 007] [NEW] CRITICAL – Diffuser rigid 90's.

AC6 SGRD1 ductwork does not have a rigid 90 degree fitting installed.

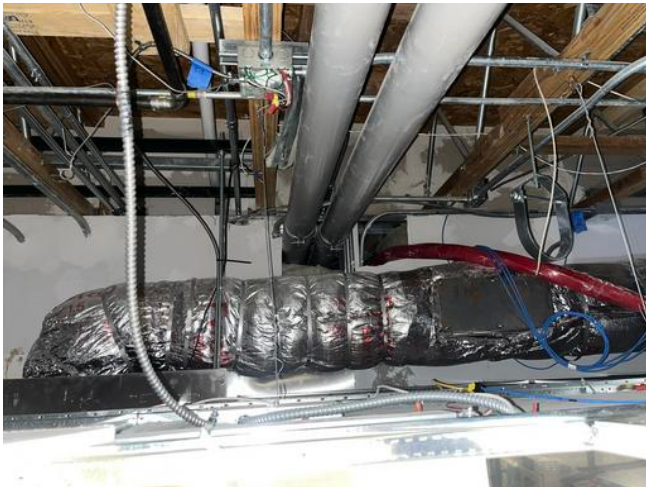
IMG\_6187

### #43 [EXHA 001] [NEW] CRITICAL – Grease duct access doors.

EF2 is missing one grease cleanout door per prints.

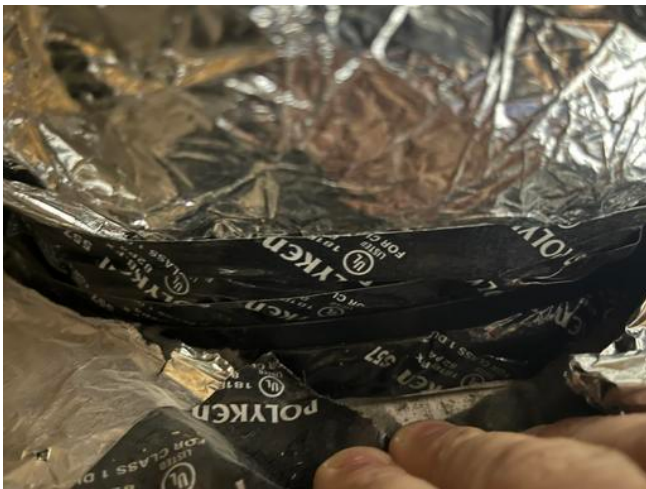
IMG\_6181

## #42 [DUCT 999] [NEW] (MISC) [MASTIC]

AC1& AC6 duct connections to air device collar need be sealed with mastic.

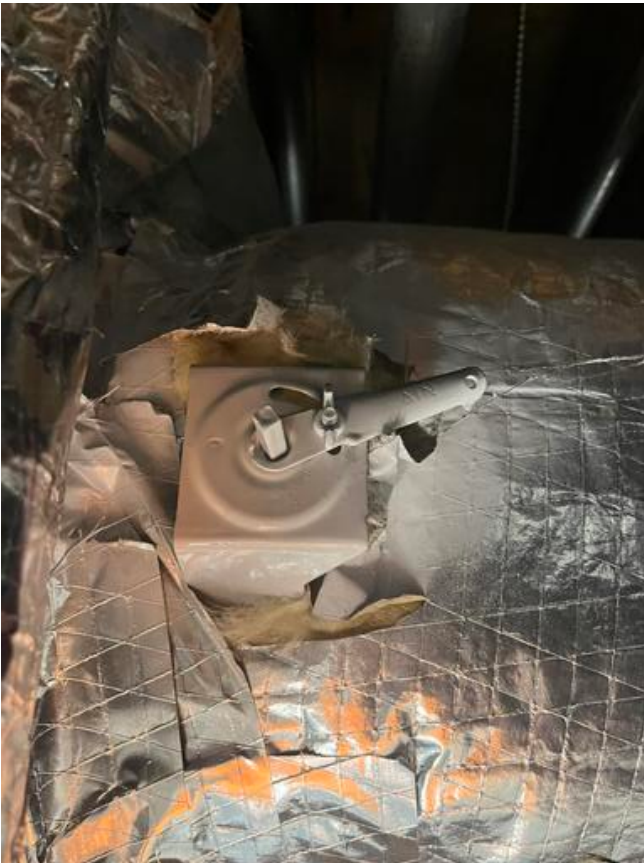
IMG\_6167

## #41 [DUCT 503] [NEW] Damper flags.

AC1 & AC6 supply and return dampers need fluorescent flags installed.

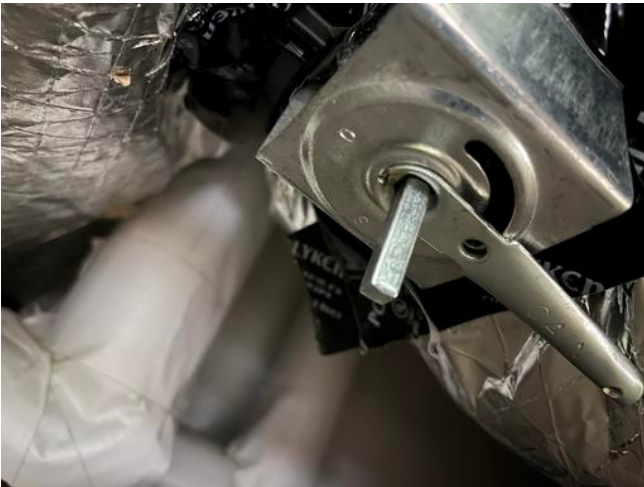
IMG\_6158

**#40 [DUCT 010] [NEW] CRITICAL – Damper(s) missing hardware.**

AC1 return damper is missing set screw and wing nut.

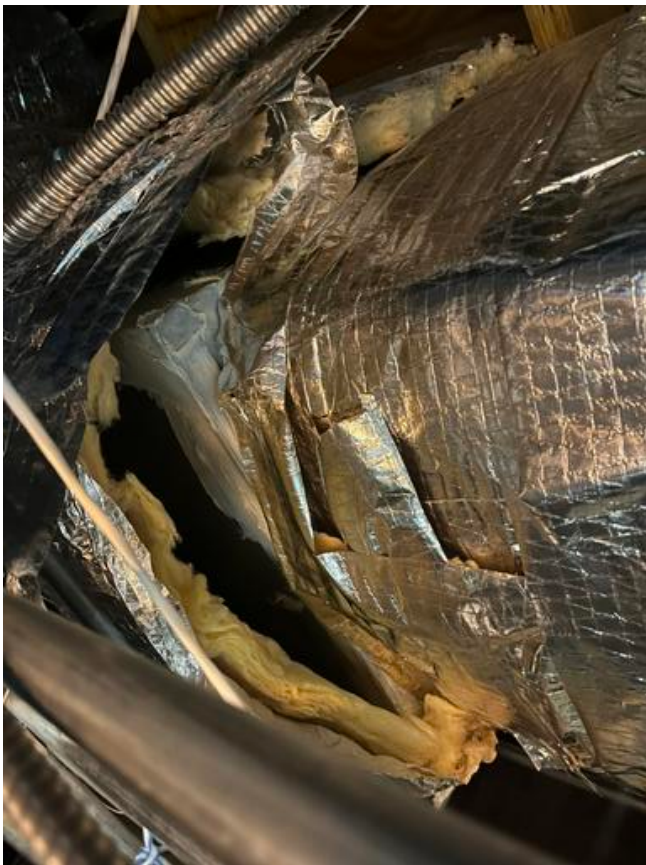
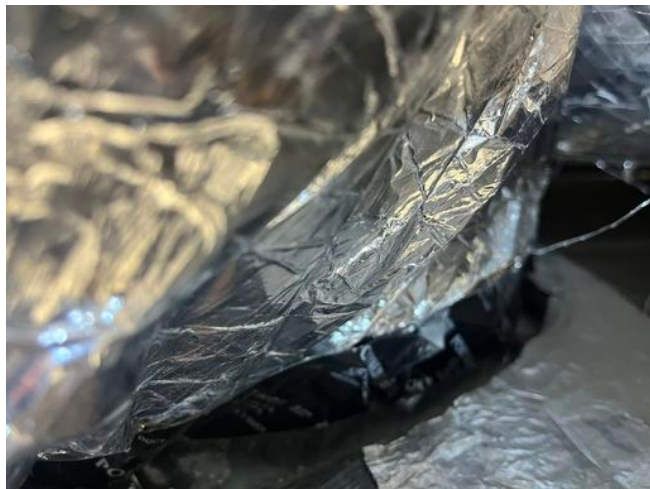
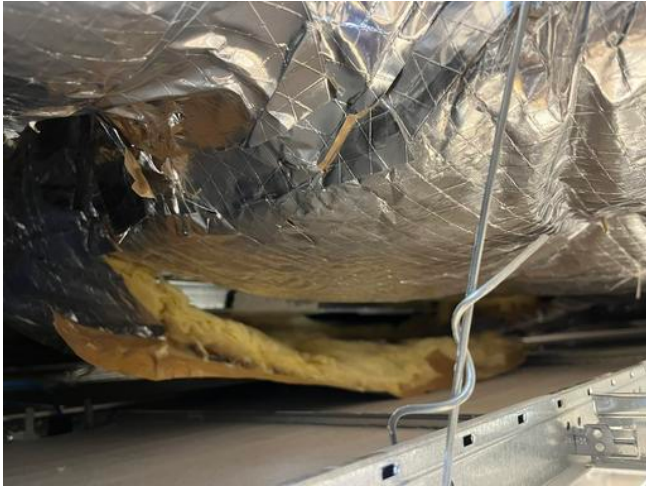
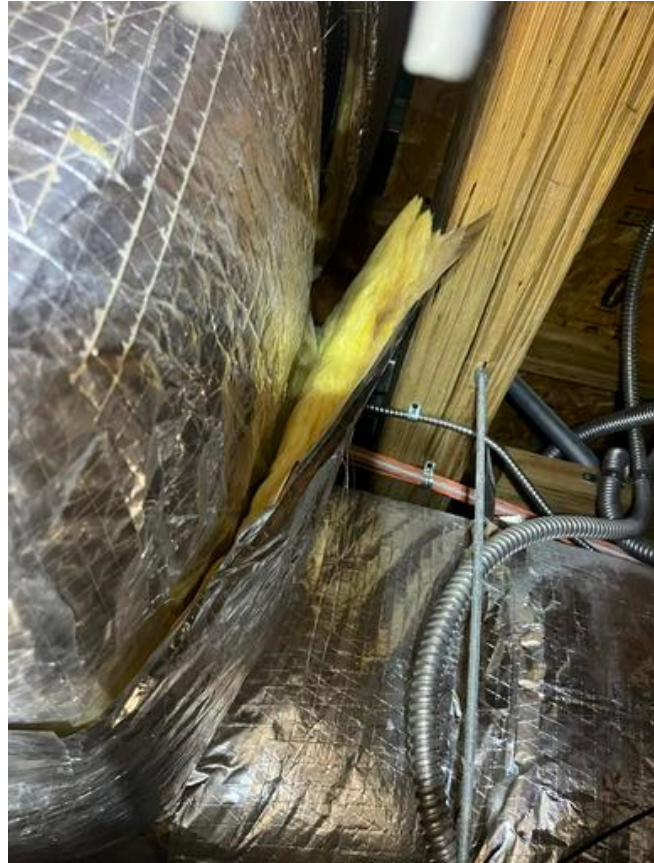
**#39 [DUCT 508] [EXIST] Ductwork is not fully insulated.**

AC1 & AC6 insulation seams should be taped with no open insulation. Vapor barrier should be taped at on all diffusers.

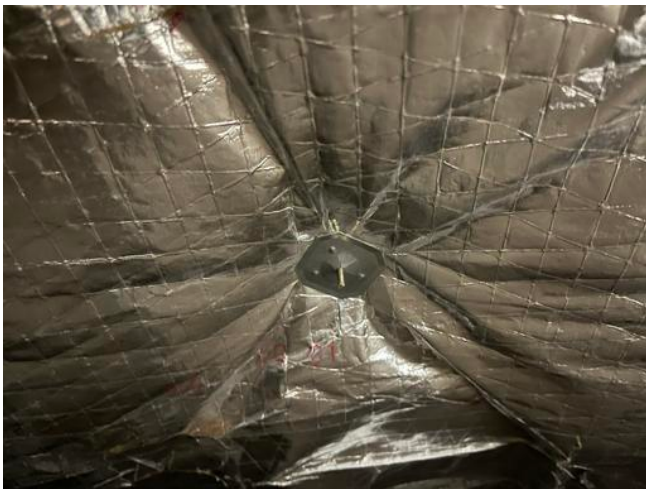
IMG\_6180

### #38 [DUCT 501] [NEW] Insulation stick pins.

AC1 supply and return ductwork stickpins should be covered with tape or mastic.

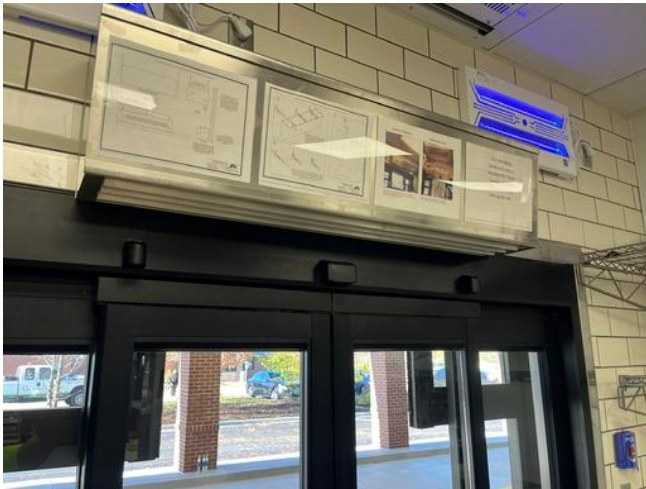
IMG\_6147

### #37 [CURT 502] [NEW] Air curtain diverter box.

Air curtain diverter box is unable to be installed correctly due to door sensors. Diverter box should be bolted to wall, slid forward, and flush with door header.

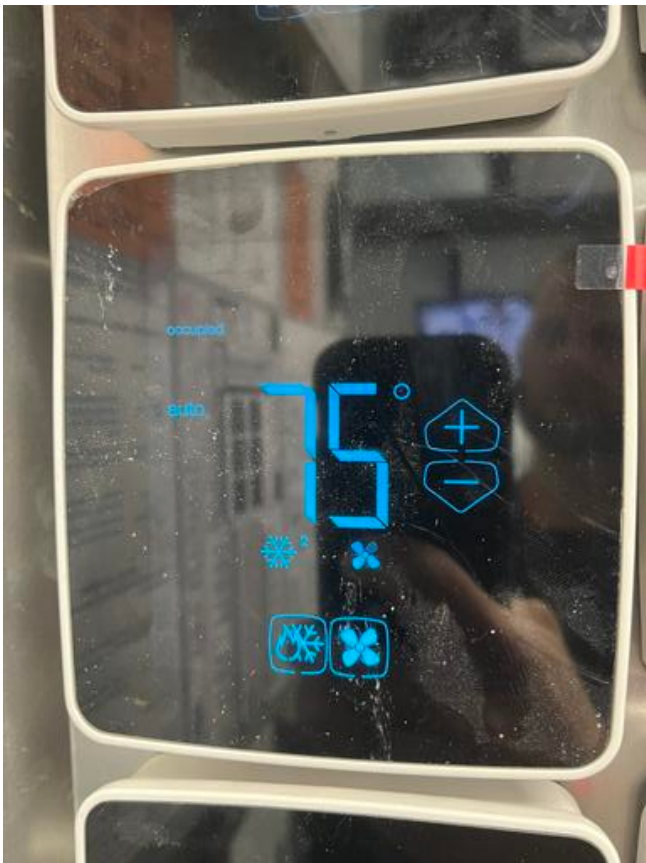
IMG\_6174

**#36 [CNTL 016] [NEW] CRITICAL – Sensor communication.**

AC3 thermostat and temp.  
sensor are not  
communicating.

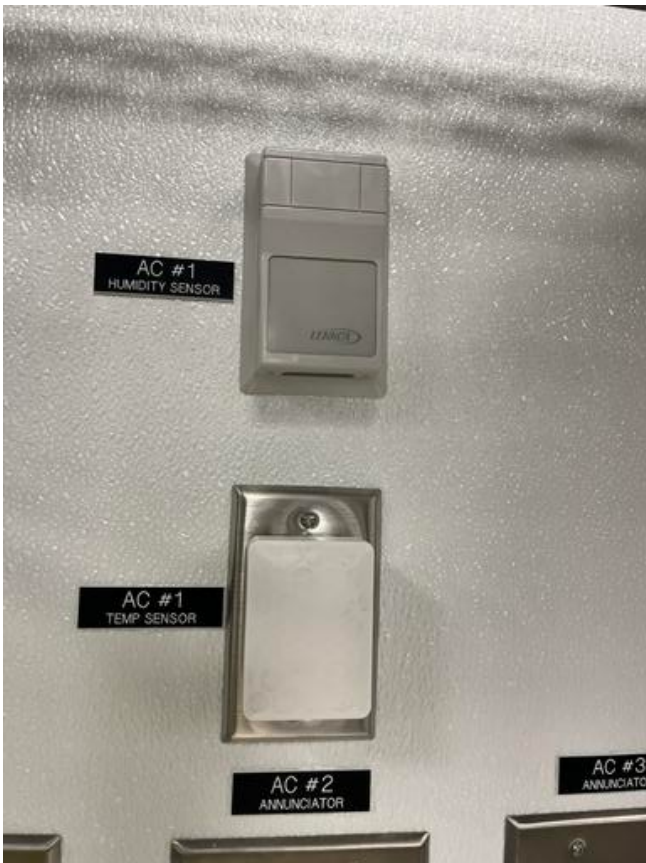
IMG\_6009

### #35 [CNTL 508] [NEW] Controls labeling.

All temperature, humidity and annunciator sensors should have hard plastic labels installed like shown in the picture below.
