Report: TAB Report
Function: Test, Adjust, & Balance
Date: 02/05/2025
Completed By: National TAB

02-03-25 CHIPOTLE #5144 GRANVILLE, OH

Project: 02-03-25 CHIPOTLE #5144 GRANVILLE, OH

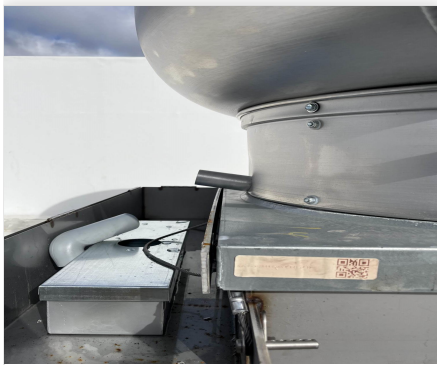
Issue Name : KEF drain spout damaged.
Description : KEF drain spout is damaged and at an upward angle preventing proper drainage.
Created By : National TAB **Assigned To :** National TAB - Dan Hertenstein
Status : Open
Priority : Medium **Asset Tag :** EF1
Originated Date : 02/04/2025 - Cody Collett - National TAB
