# Issue List

### 05-29-23 CULVERS - GRAIN VALLEY, MO

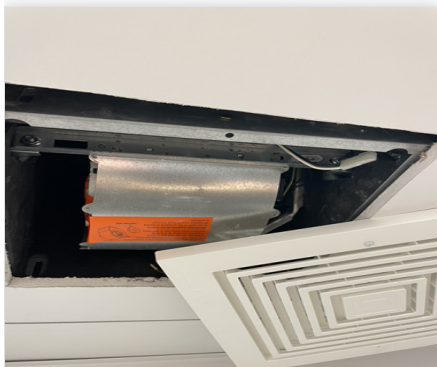
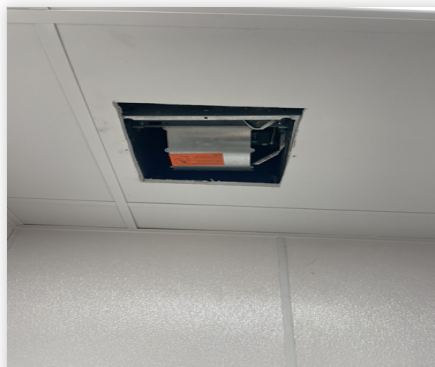
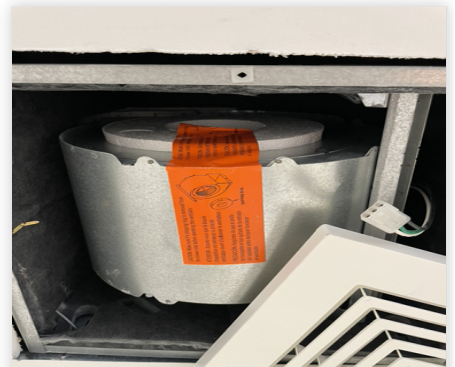
**Issue Name :** EF1A Mop Sink Fan not functioning  
**Description :** EF1A Mop Sink fan is not functioning per the EC. The fan is going to need to be replaced. This will very slightly affect building pressure, but not enough to be concerned.  
**Created By :** National TAB                      **Assigned To :** National TAB - Jacob Davidson  
**Status :** Open  
**Originated Date :** 05/22/2023 - Jacob Davidson - National TAB

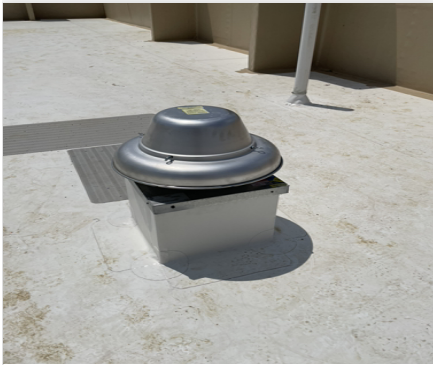
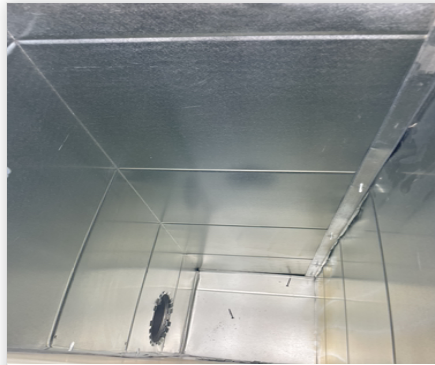
**Issue Name :** PRV1 no backdraft damper installed  
**Description :** INFO ONLY: PRV1 does not have a backdraft damper which is required for restroom exhaust fans. This does not affect the scope of the tab  
**Created By :** National TAB                      **Assigned To :** National TAB - Jacob Davidson  
**Status :** Open  
**Originated Date :** 05/22/2023 - Jacob Davidson - National TAB

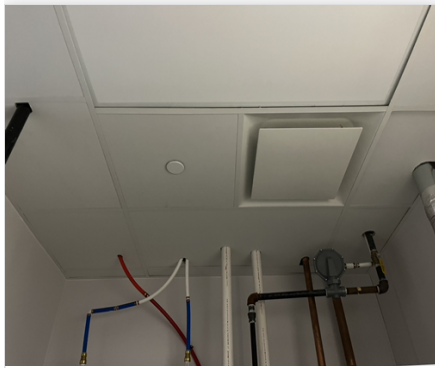
**Diffuser**  
05/23/2023

**Issue Name :** RTU2 diffuser 2-16 very low on flow, takeoff not accessible  
**Description :** Diffuser 2-16 on the GRD for the electrical room is very low on flow at 124 of 600 CFM. This value hasn't changed with moving air around which implies the damper is closed at takeoff, however tech is unable to reach takeoff to check for a damper due to ceiling restrictions.  
**Created By :** National TAB                      **Assigned To :** National TAB - Jacob Davidson  
**Status :** Open  
**Originated Date :** 05/23/2023 - Jacob Davidson - National TAB

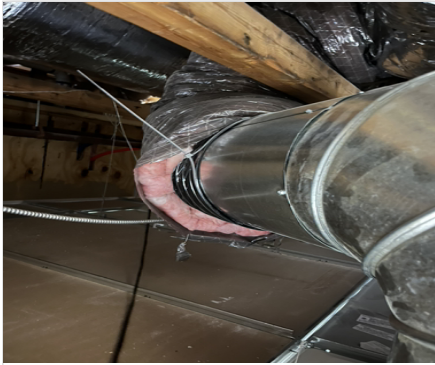
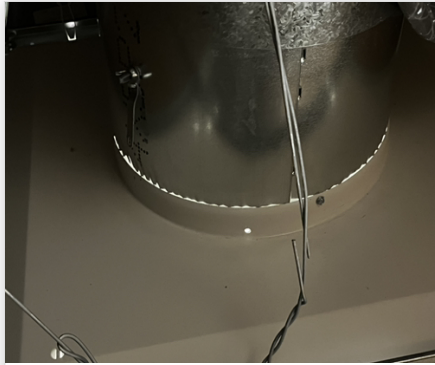
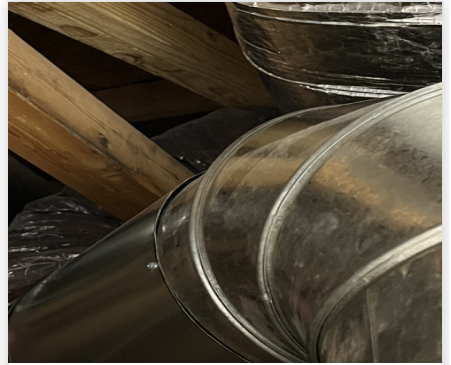
**Issue Name :** RTU2 low flow, solid duct not sealed  
**Description :** RTU2 is low on flow at 5573 of 6225. The solid duct around many of the diffusers is not sealed and air is escaping above ceiling as a result. Some of the takeoffs and solid duct zip ties are loose as well. These ducts need to be sealed and flex needs to be checked to make sure it stays attached.  
**Created By :** National TAB                      **Assigned To :** National TAB - Jacob Davidson  
**Status :** Open  
**Originated Date :** 05/23/2023 - Jacob Davidson - National TAB

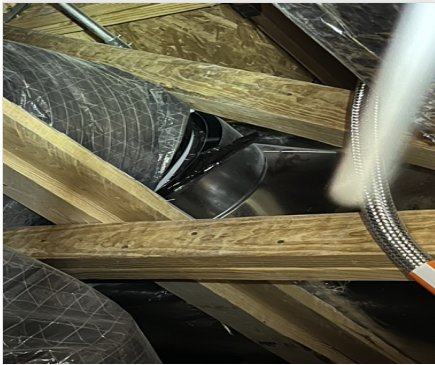
**Disconnected**  
**05/23/2023**

**Issue Name :** RTU2 Return Takeoff Disconnected  
**Description :** Flex duct is disconnected at take off for return in the back of kitchen.  
**Created By :** National TAB                      **Assigned To :** National TAB - Jacob Davidson  
**Status :** Open  
**Originated Date :** 05/23/2023 - Jacob Davidson - National TAB
