National TAB
1329 E. KEMPER ROAD
SUITE 4210
CINCINNATI, OH 45246

Report: TAB REPORT
Function: Test, Adjust, & Balance
Date: 05/31/2023

PROJECT
05-29-23 CULVERS - GRAIN VALLEY, MO

Captive-Aire Region #60

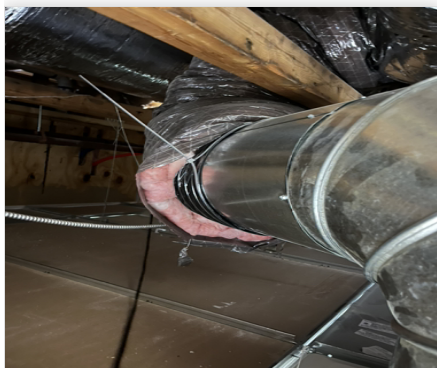
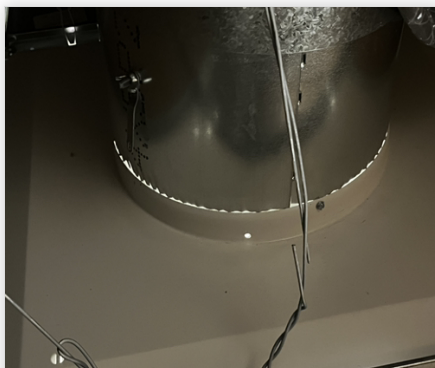
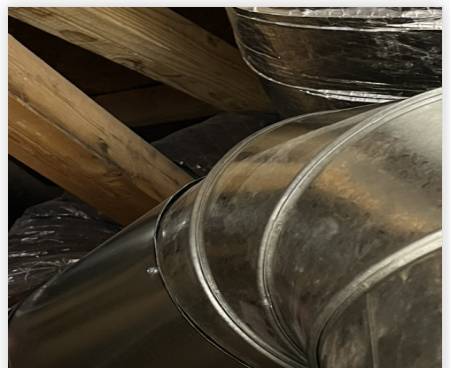
Issue Name : 1. RTU-2 Supply Airflow Low
Description : RTU2 is low on supply airflow at 5573 / 6225 cfm due to leakage from unsealed ductwork. The solid duct around many of the diffusers is not sealed and air is escaping above ceiling as a result. Some of the takeoffs and solid duct zip ties are loose as well. These ducts need to be sealed and flex needs to be checked to make sure it stays attached.
Created By : National TAB **Assigned To :** National TAB - Jacob Davidson
Status : Open
Originated Date : 05/23/2023 - Jacob Davidson - National TAB

Loosezip
05/23/2023

Lightfromdiffuser.jpe..
05/23/2023

Flexductwhereairescap..
05/23/2023

Notes: MOTOR SETPOINT: 57.0 HZ [1] UNIT IS LOW ON FLOW DUE TO DUCT LEAKAGE, SEE ISSUE. DIFFUSERS WERE BALANCED FOR HOOD SMOKE CAPTURE PERFORMANCE AND COMFORT.

- **06/13/2023 National TAB - Michael McDonnell**
 - Diffusers were balanced for comfort and hood performance due to low airflow.

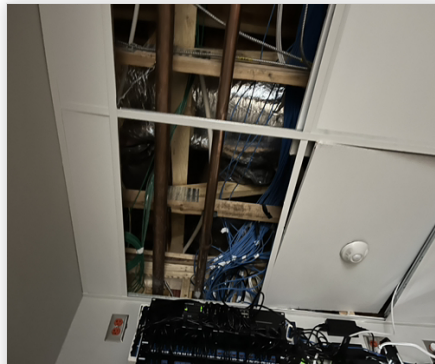
Issue Name : 2. RTU-2 Diffuser 2-16 Low on Airflow, Damper Inaccessible
Description : Diffuser 2-16 on the GRD for the electrical room is very low on flow at 175/600 CFM. Suspect the damper is closed at takeoff. Tech is unable to reach takeoff to check for a damper due to ceiling restrictions.
Created By : National TAB **Assigned To :** National TAB - Jacob Davidson
Status : Open
Originated Date : 05/23/2023 - Jacob Davidson - National TAB

Diffuser
05/23/2023

Takeoff
05/23/2023

Asset	Notes	Date
SGRD16	[1] SUSPECT DAMPER IS CLOSED. NOT ACCESSIBLE DUE TO CEILING OBSTRUCTIONS.	06/13/2023

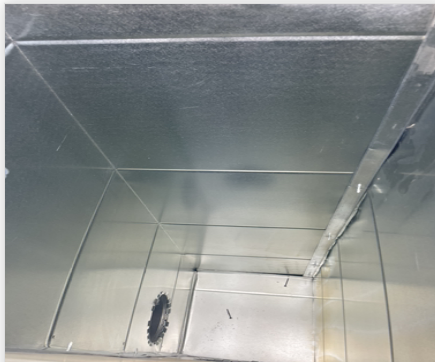
Issue Name : 5. PRV-1 No Backdraft Damper Installed
Description : PRV1 does not have a backdraft damper which is required for restroom exhaust fans. Recommend damper is installed. This does not affect the scope of the tab
Created By : National TAB **Assigned To :** National TAB - Jacob Davidson
Status : Open
Originated Date : 05/22/2023 - Jacob Davidson - National TAB

PRV1
05/22/2023

Nodamper
05/22/2023

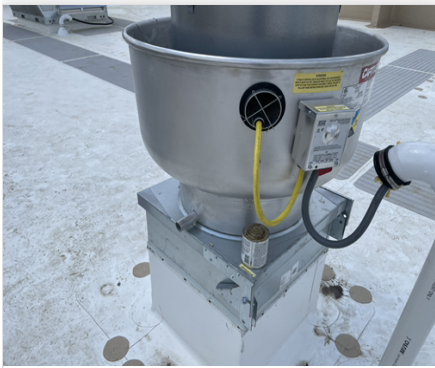
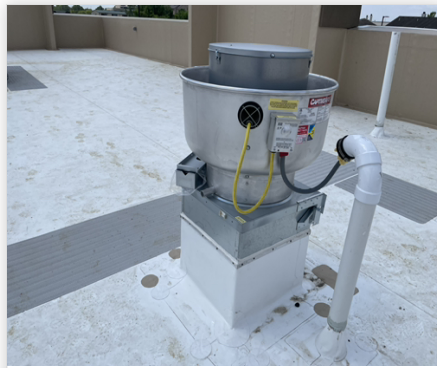
Issue Name : 6. PRV-2 and PRV-3 Grease Cups Not Installed

Description : Grease capture cups are not installed on either PRV2 or PRV3. In addition, the hinge kit on PRV3 is supposed to be installed opposite of the grease spout and is installed to the side of it. Recommend this is corrected. This will not impact TAB.

PRV3
05/22/2023

PRV2
05/22/2023
