**National TAB
1329 E. KEMPER ROAD
SUITE 4210
CINCINNATI, OH 45246**

**Report: TAB REPORT
Function: Test, Adjust, & Balance
Date: 05/31/2023**

**PROJECT
05-29-23 CULVERS - GRAIN VALLEY, MO**

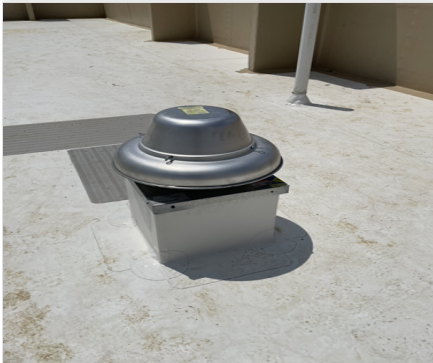
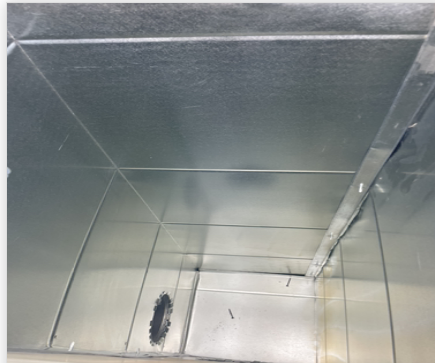
Issue Name : PRV1 no backdraft damper installed
Description : INFO ONLY: PRV1 does not have a backdraft damper which is required for restroom exhaust fans. This does not affect the scope of the tab
Created By : National TAB **Assigned To :** National TAB - Jacob Davidson
Status : Open
Originated Date : 05/22/2023 - Jacob Davidson - National TAB

PRV1
05/22/2023

Nodamper
05/22/2023

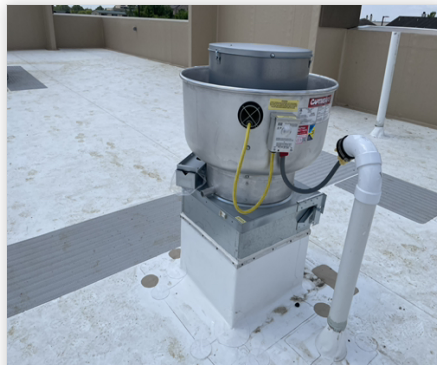
Description : INFO ONLY Grease capture cups are not installed on either PRV2 or PRV3. In addition, the hinge kit on PRV3 is supposed to be installed opposite of the grease spout and is installed to the side of it. This will not affect TAB.

PRV3
05/22/2023

PRV2
05/22/2023

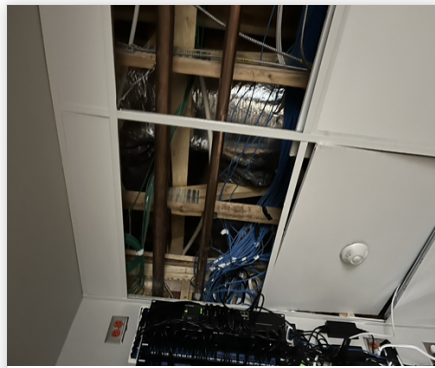
Issue Name : RTU2 diffuser 2-16 very low on flow, takeoff not accessible
Description : Diffuser 2-16 on the GRD for the electrical room is very low on flow at 124 of 600 CFM. This value hasn't changed with moving air around which implies the damper is closed at takeoff, however tech is unable to reach takeoff to check for a damper due to ceiling restrictions.
Created By : National TAB **Assigned To :** National TAB - Jacob Davidson
Status : Open
Originated Date : 05/23/2023 - Jacob Davidson - National TAB

Diffuser
05/23/2023

Takeoff
05/23/2023

Asset									
Asset Name	Location	Type	Size	DESIGN CFM	AK	CFM(1)	CFM(2)	FINAL CFM	% to design
SGRD1	KITCHEN	SD-5	10"	200	1	364	245	214	107.0
SGRD2	KITCHEN	SD-5	12"	375	1	449	323	349	93.1
SGRD3	KITCHEN	SD-5	12"	400	1	481	426	398	99.5
SGRD4	KITCHEN	SD-5	12"	400	1	527	375	397	99.3
SGRD5	KITCHEN	SD-5	10"	250	1	309	300	249	99.6
SGRD6	KITCHEN	SD-5	10"	275	1	191	336	260	94.5
SGRD7	KITCHEN	SD-1	12"	600	1	346	272	563	93.8
SGRD8	KITCHEN	SD-1	12"	600	1	423	438	403	67.2
SGRD9	KITCHEN	SD-5	12"	350	1	457	354	330	94.3
SGRD10	KITCHEN	SD-5	12"	350	1	296	350	336	96.0
SGRD11	KITCHEN	SD-5	12"	350	1	351	320	294	84.0
SGRD12	DRY GOODS	SD-1	12"	600	1	323	582	554	92.3
SGRD13	DRY GOODS	SD-1	10"	200	1	276	163	181	90.5
SGRD14	TOILET	SD-4	6"	75	1	97	46	68	90.7
SGRD15	KITCHEN	SD-1	12"	600	1	258	489	451	75.2
SGRD16	UTILITY ROOM	SD-1	12"	600	1	129	194	175	29.2
