National TAB  
1329 E. KEMPER ROAD  
SUITE 4210  
CINCINNATI, OH 45246

**Report: TAB REPORT**  
**Function: Test, Adjust, & Balance**  
**Date: 05/31/2023**

**PROJECT**  
**05-29-23 CULVERS - GRAIN VALLEY, MO**

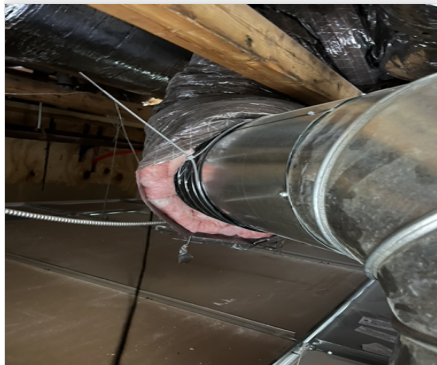
**Loosezip**  
05/23/2023

**Issue Name :** 1. RTU-2 Supply Airflow Low  
**Description :** RTU2 is low on supply airflow at 5573 / 6225 cfm due to leakage from unsealed ductwork. The solid duct around many of the diffusers is not sealed and air is escaping above ceiling as a result. Some of the takeoffs and solid duct zip ties are loose as well. These ducts need to be sealed and flex needs to be checked to make sure it stays attached.  
**Created By :** National TAB                      **Assigned To :** National TAB - Jacob Davidson  
**Status :** Open  
**Originated Date :** 05/23/2023 - Jacob Davidson - National TAB

- **06/13/2023    National TAB - Michael McDonnell**
  - Diffusers were balanced for comfort and hood performance due to low airflow.

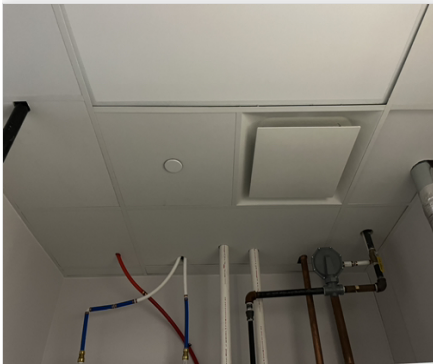
**Diffuser**  
05/23/2023

**Issue Name :** 2. RTU-2 Diffuser 2-16 Low on Airflow, Damper Inaccessible  
**Description :** Diffuser 2-16 on the GRD for the electrical room is very low on flow at 175/600 CFM. Suspect the damper is closed at takeoff. Tech is unable to reach takeoff to check for a damper due to ceiling restrictions.  
**Created By :** National TAB                      **Assigned To :** National TAB - Jacob Davidson  
**Status :** Open  
**Originated Date :** 05/23/2023 - Jacob Davidson - National TAB

Asset	Notes	Date
SGRD16	[1] SUSPECT DAMPER IS CLOSED. NOT ACCESSIBLE DUE TO CEILING OBSTRUCTIONS.	06/13/2023

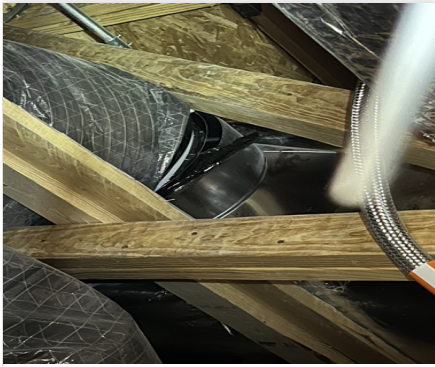
**Disconnected**  
**05/23/2023**

**Issue Name :** 3. RTU-2 Return Disconnected  
**Description :** Flex duct is disconnected at take off for return in the back of kitchen. Recommend duct is reconnected and secured.  
**Created By :** National TAB                      **Assigned To :** National TAB - Jacob Davidson  
**Status :** Open  
**Originated Date :** 05/23/2023 - Jacob Davidson - National TAB

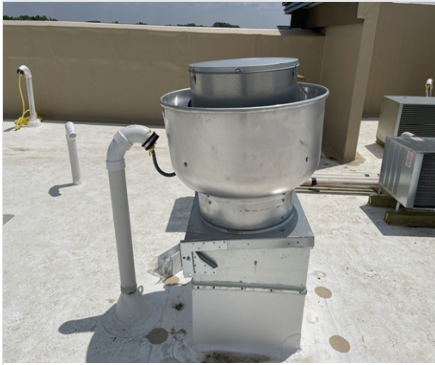
**PRV3hinge**  
**05/22/2023**

**Issue Name :** 4. PRV-3 Hinge Kit Orientation  
**Description :** PRV3 hinge kit is installed on the same side as the conduit pipe, preventing the fan from leaning back. This will inhibit/prevent proper grease duct cleaning. Recommend hinge location is corrected. Static pressure could not be measured as a result.  
**Created By :** National TAB                      **Assigned To :** National TAB - Jacob Davidson  
**Status :** Open  
**Originated Date :** 05/22/2023 - Jacob Davidson - National TAB

Notes: [1] HINGE KIT ORIENTATION INCORRECT. RECOMMEND CORRECTION. STATIC PRESSURE COULD NOT BE MEASURED.

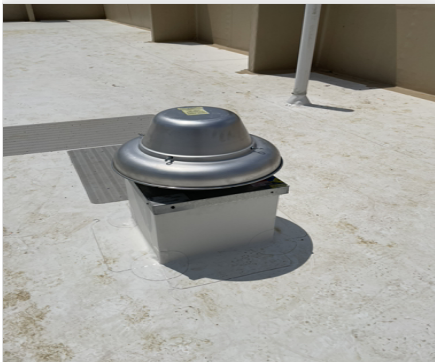
**PRV1**  
05/22/2023

**Issue Name :** 5. PRV-1 No Backdraft Damper Installed  
**Description :** PRV1 does not have a backdraft damper which is required for restroom exhaust fans. Recommend damper is installed. This does not affect the scope of the tab  
**Created By :** National TAB **Assigned To :** National TAB - Jacob Davidson  
**Status :** Open  
**Originated Date :** 05/22/2023 - Jacob Davidson - National TAB

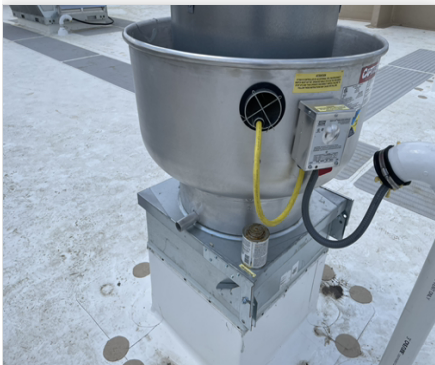
**PRV3**  
05/22/2023

**Issue Name :** 6. PRV-2 and PRV-3 Grease Cups Not Installed  
**Description :** Grease capture cups are not installed on either PRV2 or PRV3. In addition, the hinge kit on PRV3 is supposed to be installed opposite of the grease spout and is installed to the side of it. Recommend this is corrected. This will not impact TAB.  
**Created By :** National TAB                      **Assigned To :** National TAB - Jacob Davidson  
**Status :** Open  
**Originated Date :** 05/22/2023 - Jacob Davidson - National TAB
