Issue List

05-29-23 CULVERS - GRAIN VALLEY, MO

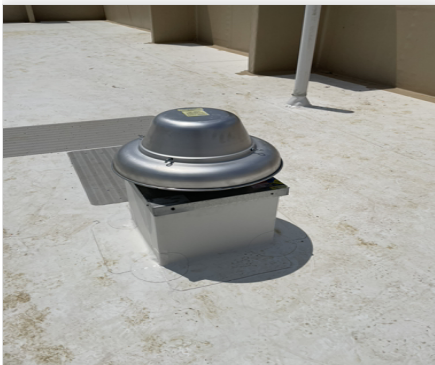
PRV1
05/22/2023

Issue Name : PRV1 no backdraft damper installed
Description : INFO ONLY: PRV1 does not have a backdraft damper which is required for restroom exhaust fans. This does not affect the scope of the tab
Created By : National TAB **Assigned To :** National TAB - Jacob Davidson
Status : Open
Originated Date : 05/22/2023 - Jacob Davidson - National TAB

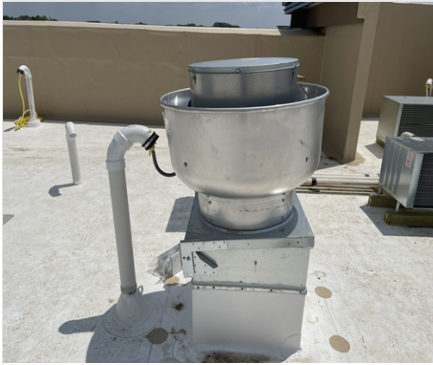
PRV3hinge
05/22/2023

Issue Name : PRV3 cannot be raised up to look down grease duct
Description : PRV3 hinge kit is installed on the same side as the conduit pipe which is preventing the unit from leaning back. Hinge kit needs to be installed on the opposite side of the grease spout. This will prevent duct cleaning and getting unit pressure.
Created By : National TAB **Assigned To :** National TAB - Jacob Davidson
Status : Open
Originated Date : 05/22/2023 - Jacob Davidson - National TAB

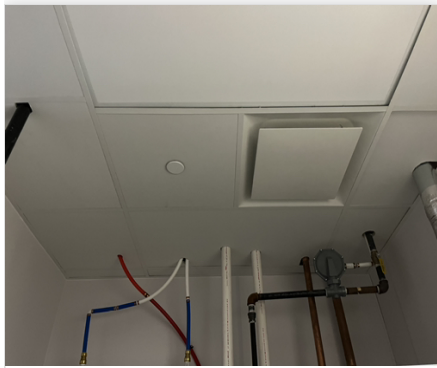
Diffuser
05/23/2023

Issue Name : RTU2 diffuser 2-16 very low on flow, takeoff not accessible
Description : Diffuser 2-16 on the GRD for the electrical room is very low on flow at 124 of 600 CFM. This value hasn't changed with moving air around which implies the damper is closed at takeoff, however tech is unable to reach takeoff to check for a damper due to ceiling restrictions.
Created By : National TAB **Assigned To :** National TAB - Jacob Davidson
Status : Open
Originated Date : 05/23/2023 - Jacob Davidson - National TAB
