**Report: TAB REPORT**  
**Function: Test, Adjust, & Balance**  
**Date: 01/18/2023**

## 01-16-23 FREDDY'S - CLARKSVILLE, TN

900 MLK BLVD

FFC Kentucky LLC

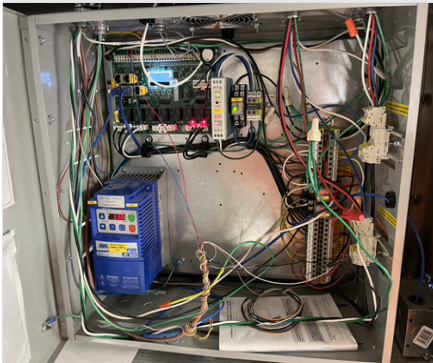
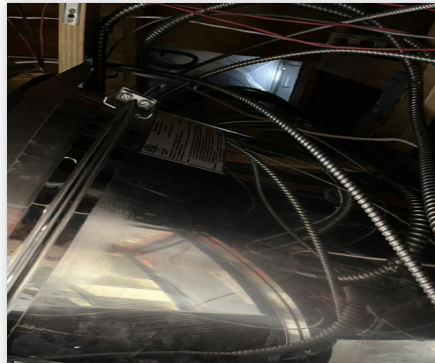
**Issue Name :** KEF1 HD1 low flow

**Description :** Hood is reading 1200 of 1600 design at FLA of 4.0A of 4.03A. Rotation on motor is correct as well. On arrival to site, Captive Aire was still working on the motor on the roof, but tech did not get a chance to talk to them before they left site. On looking above ceiling, there appears to be daylight coming through where fan sits on curb.

Notes: FAN IS AT FLA WITH MOTOR GOING THE CORRECT DIRECTION. UNABLE TO INCREASE FLOW ANYMORE. HOOD CAPTURE IS 100%

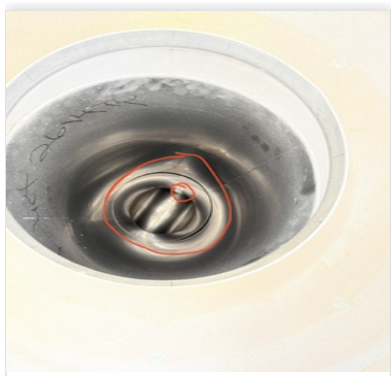
Duct.jpeg

- **01/18/2023 National TAB - Will Turnbough**
  - Alignment on fan is off by about 2". This is effectively reducing the duct size from 14" to 12". The alignment needs to be corrected. There is leakage at the base of the fan partially due to the misalignment that needs to be corrected by installing gasket under the base of the fan. Looking down the duct there are seams visible where leakage could occur and grease could accumulate. These need to be corrected.
- **01/18/2023 National TAB - Jacob Davidson**
  - Hood captured 100% with heat from griddle off even with flow out of design.
- **01/18/2023 National TAB - Jacob Davidson**
  - Daylight from roof was vented curb, which is normal. Tech was not able to find any obstructions that would limit flow. Tech is unable to increase flow anymore than where it is without risk of damaging the motor.

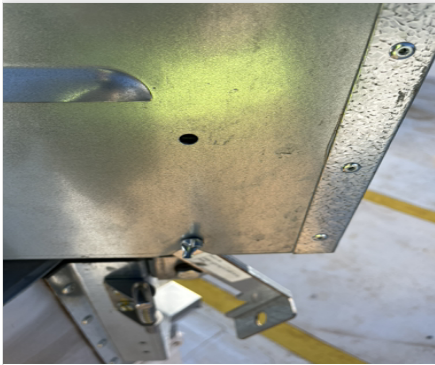
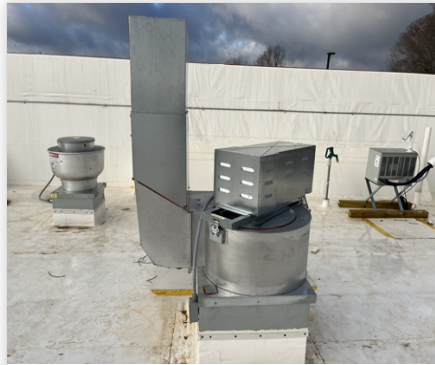
**Issue Name :** KEF1 missing butterfly bolts for motor cover

**Description :** Motor cover is missing the butterfly bolts that keep the cover attached. None extra were found by the unit.

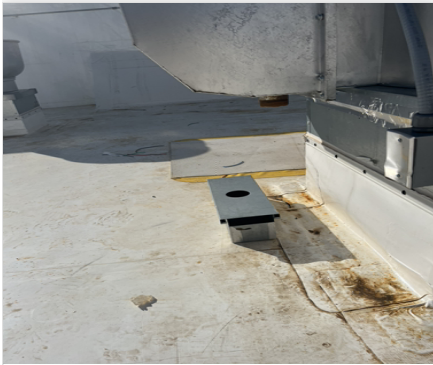
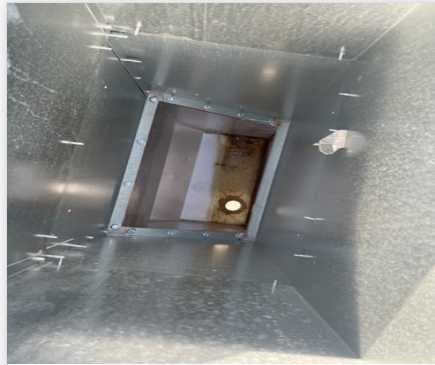
**Issue Name :** KEF1 no grease cup

**Description :** Grease cup is not attached to the fan so grease that builds up will drip on the roof.

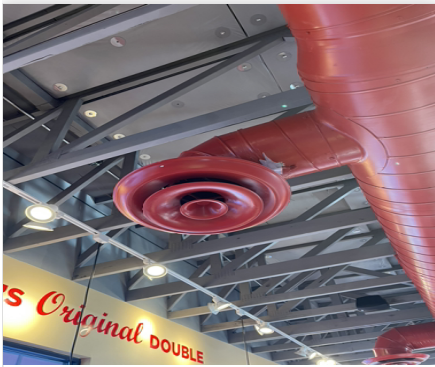
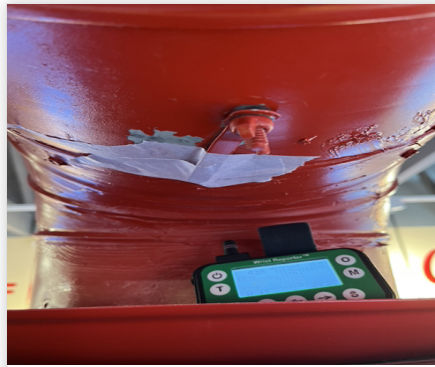
**Issue Name :** RTU1 diffuser 8 broken damper

**Description :** Damper is broken and free spinning in the duct. For balancing, tech taped the handle down and marked where it needs to be when it is replaced.

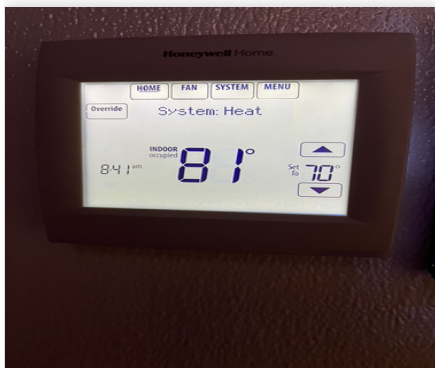
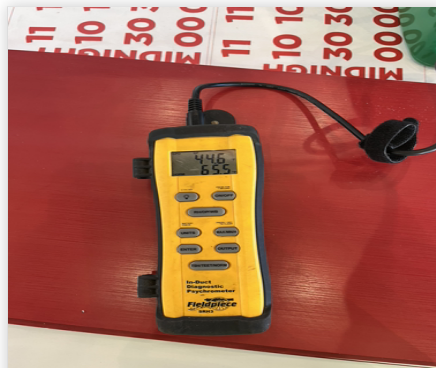
**Issue Name :** RTU1 thermostat issue

**Description :** Thermostat reads that space is 81 degrees and does not need heat, however when measuring the space with psychrometer, temperature was only 65.5

- **01/18/2023**    **National TAB - Will Turnbough**
  - Recommend the mechanical contractor service.

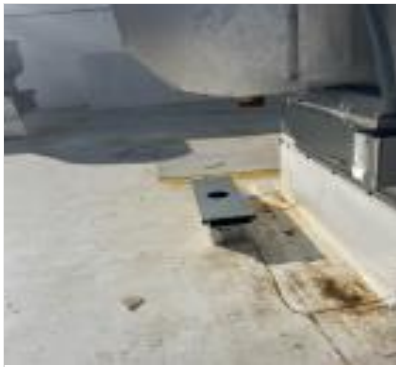
Cup.jpeg

Rotation is correct?	YES
Belts are tight?	NA
Grease cup installed on hood fan?	NOT INSTALLED ON EF1

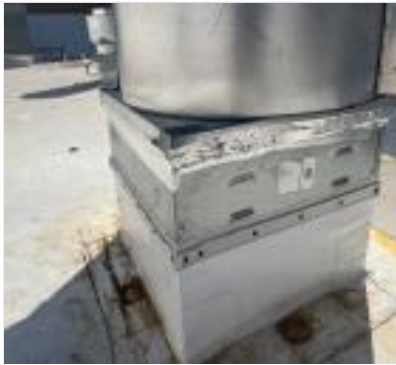
Seam.jpeg

Hinge kit installed installed on hood fan?	YES
Lean fan back. Is grease duct installation adequate and is duct ran all the way to the base of the fan?	YES
Flex conduit is long enough so that fan can be completely tilted back?	YES
There is no major leakage around base of fan?	SMALL LEAKAGE. TECH TAPED THE SEAM.

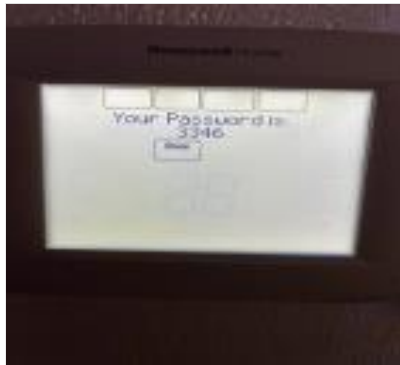
Password.jpeg

All three thermostats have correct time/date? (if not set correctly)	YES
Occupied Time: 8am-11:55pm	YES
Occupied Fan ON	YES
Occupied cooling 74	YES
Occupied heating 68	YES
Unoccupied Time 11:55pm-8am	YES
Unoccupied Fan Auto	YES
Unoccupied cooling 79	YES
Unoccupied heating 63	YES
Set a Partial Screen Lock for Thermostats (i.e., make sure temperature is adjustable but not schedule)	YES
Password is set to 999 for Partial Screen Lock?	UNABLE TO CHANGE PASSWORD FROM 3346
