01-16-23 FREDDY'S - CLARKSVILLE, TN

Issue Name : KEF1 HD1 low flow

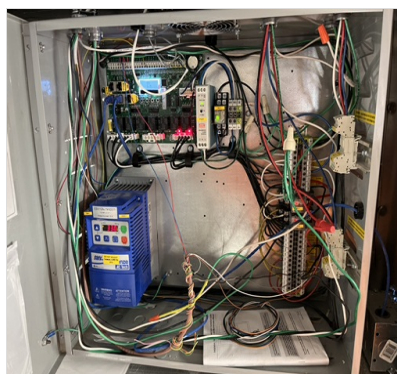
Hoodpanel.jpeg

Description : Hood is reading 1200 of 1600 design at FLA of 4.0A of 4.03A. Rotation on motor is correct as well. On arrival to site, Captive Aire was still working on the motor on the roof, but tech did not get a chance to talk to them before they left site. On looking above ceiling, there appears to be daylight coming through where fan sits on curb.

- **01/18/2023** **National TAB - Jacob Davidson**
 - Hood captured 100% with heat from griddle off even with flow out of design.

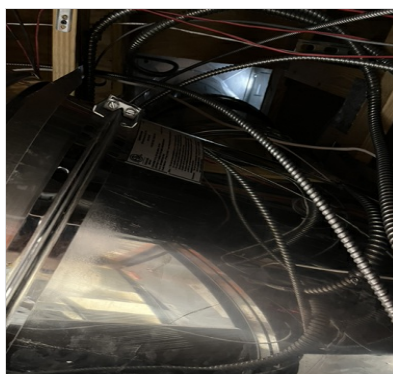
Lightfromroof.jpeg

- **01/18/2023** **National TAB - Jacob Davidson**
 - Daylight from roof was vented curb, which is normal. Tech was not able to find any obstructions that would limit flow. Tech is unable to increase flow anymore than where it is without risk of damaging the motor.

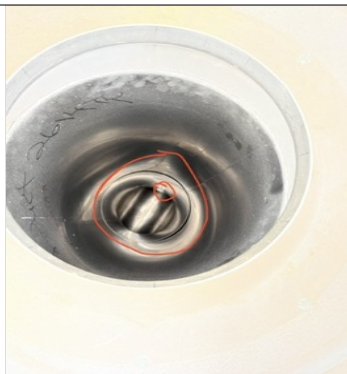
Duct.jpeg

- **01/18/2023** **National TAB - Will Turnbough**
 - Alignment on fan is off by about 2". This is effectively reducing the duct size from 14" to 12". The alignment needs to be corrected. There is leakage at the base of the fan partially due to the misalignment that needs to be corrected by installing gasket under the base of the fan. Looking down the duct there are seams visible where leakage could occur and grease could accumulate. These need to be corrected.
