**Report: Deficiency\_Report**  
**Function: Test, Adjust, & Balance**  
**Date: 07/22/2024**  
**Completed By: National TAB**

**PROJECT**  
**07-22-24 WAWA #5422 OCALA, FL**

2277 SW Hwy 484

OCALA, FL

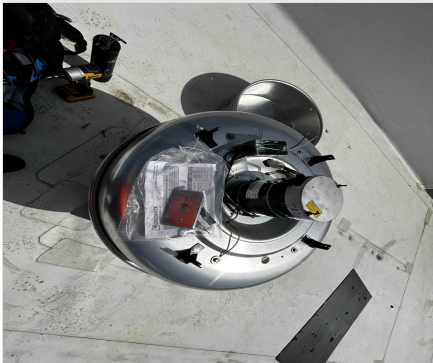
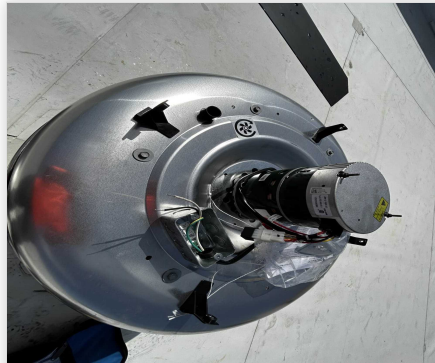
**Issue Name :** EF-1  
**Description :** EXHAUST FAN 1 HAS NOT BEEN WIRED. THERE IS NO POWER TO MOTOR AND POWER DISCONNECT HAS NOT BEEN ASSEMBLED.  
**Created By :** National TAB                      **Assigned To :** National TAB - Will Turnbough  
**Status :** Closed  
**Priority :** **Urgent**                                      **Asset Tag :**  
**Originated Date :** 07/22/2024 - Kristopher Passley - National TAB

- **07/24/2024 National TAB - Kristopher Passley**
  - EF-1 POWER HAS BEEN CONNECTED.

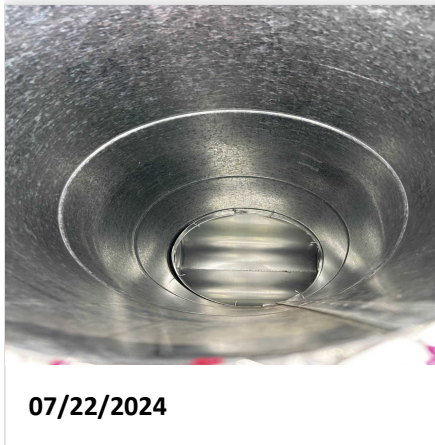
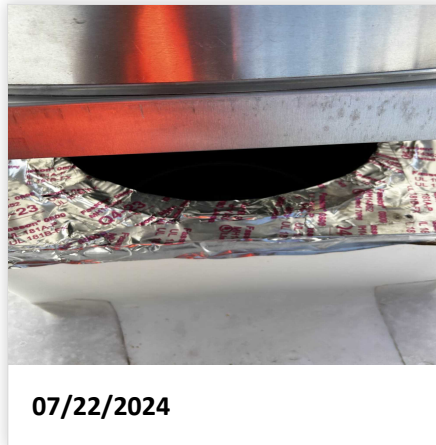
**Issue Name :** EF-1 GRAVITY DAMPER  
**Description :** GRAVITY DAMPER FOR EXHAUST FAN 1 IS NOT INSTALLED. RECOMMEND MECHANICAL TO INSTALL ONE PER PLAN DESIGN.  
**Created By :** National TAB                      **Assigned To :** National TAB - Will Turnbough  
**Status :** Closed  
**Priority :** Medium                                      **Asset Tag :**  
**Originated Date :** 07/22/2024 - Kristopher Passley - National TAB

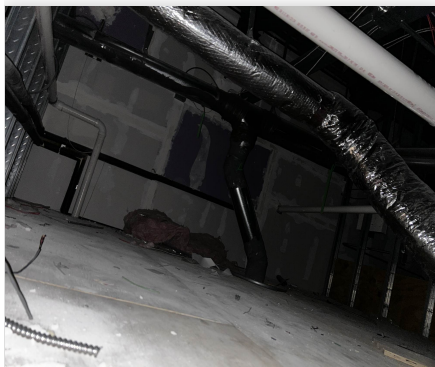
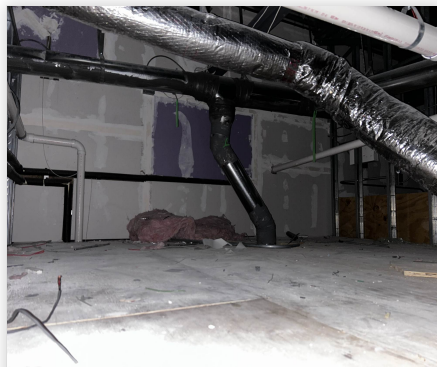
**Issue Name :** RESTROOM EXHAUST DAMPERS  
**Description :** DAMPERS FOR THE RESTROOM EXHAUST VENTS, EF1-5,EF1-6,EF1-7 (SEE GRD LAYOUT), ARE IN AN AREA THAT IS INACCESSIBLE ABOVE HARD CEILING. NEED DAMPERS TO BE ACCESSIBLE IN ORDER TO BRING EXHAUST AIRFLOW INTO DESIGN.  
**Created By :** National TAB                      **Assigned To :** National TAB - Will Turnbough  
**Status :** Closed  
**Priority :** Urgent                                      **Asset Tag :**  
**Originated Date :** 07/24/2024 - Kristopher Passley - National TAB

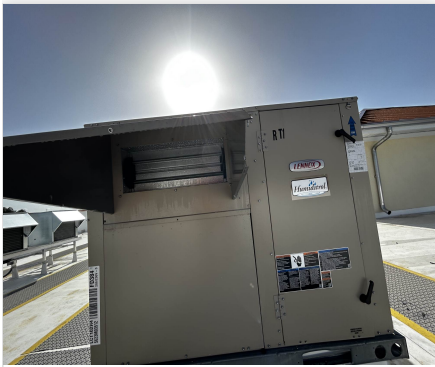
**Issue Name :** RTU-1 OA FILTER  
**Description :** OUTSIDE AIR FILTER HAS NOT BEEN INSTALLED ON RTU-1.  
**Created By :** National TAB                      **Assigned To :** National TAB - Will Turnbough  
**Status :** Closed  
**Priority :** Medium                                      **Asset Tag :**  
**Originated Date :** 07/22/2024 - Kristopher Passley - National TAB

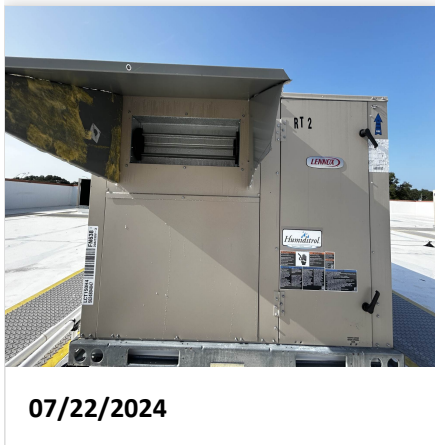
**Issue Name :** RTU-2 OA FILTER  
**Description :** RTU-2 OUTSIDER AIR FILTER IS NOT INSTALLED.  
**Created By :** National TAB                      **Assigned To :** National TAB - Will Turnbough  
**Status :** Closed  
**Priority :** Medium                                      **Asset Tag :**  
**Originated Date :** 07/22/2024 - Kristopher Passley - National TAB
