# 636 TAB PUNCH LIST

Prepared by Ben Searles

Jul 25, 2025

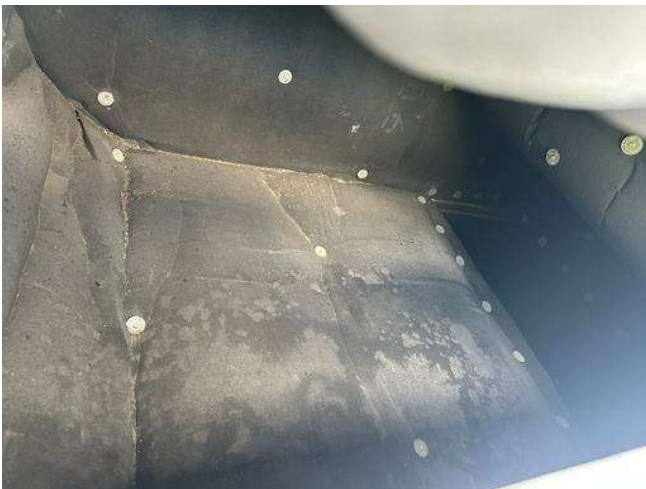
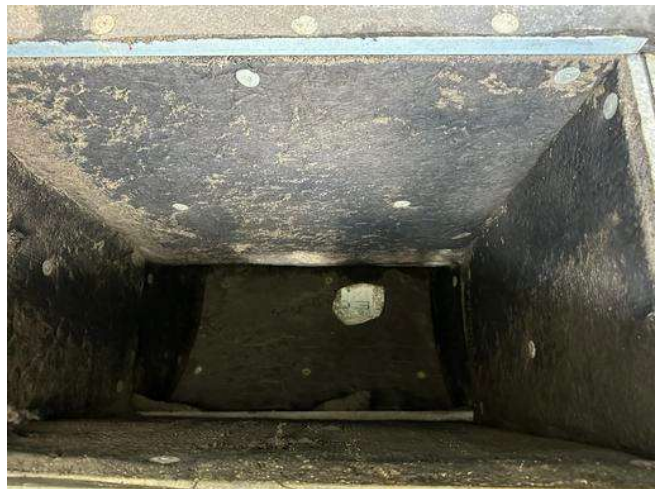
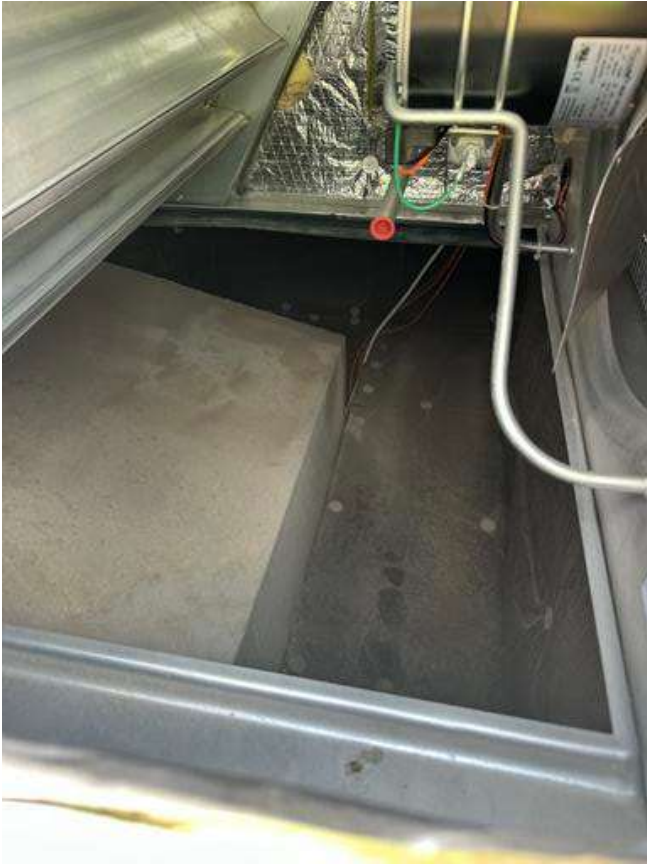
## #273 [UNIT 016] [EXIST] Equipment curb adapters.

AC1 and AC3 both have high static pressures due to the restrictions from the curb adapters. Both units are within design airflow.

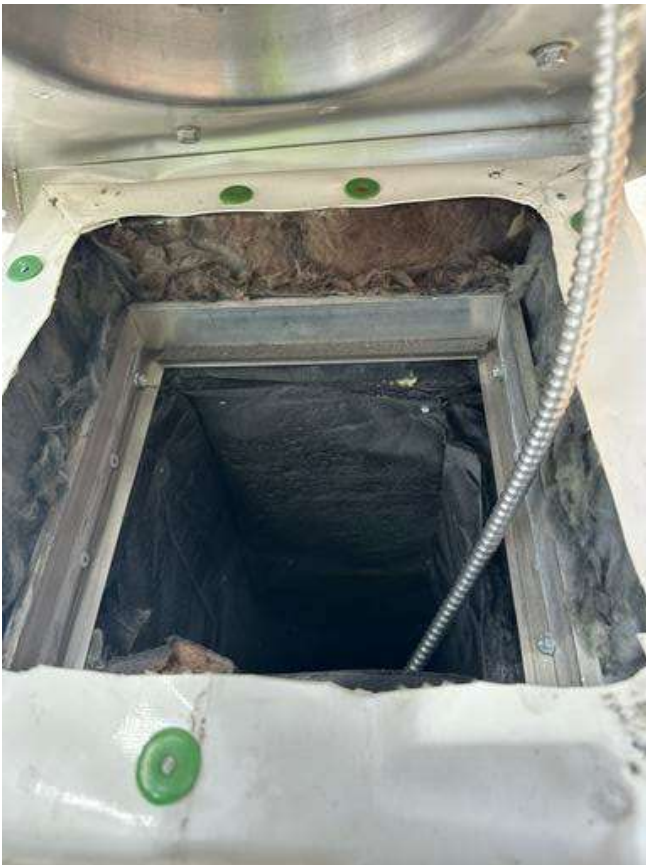
## #272 [EXHA 500] [EXIST] Restroom rectangular duct riser.

Restroom exhaust's rectangular duct riser is missing the backdraft damper.

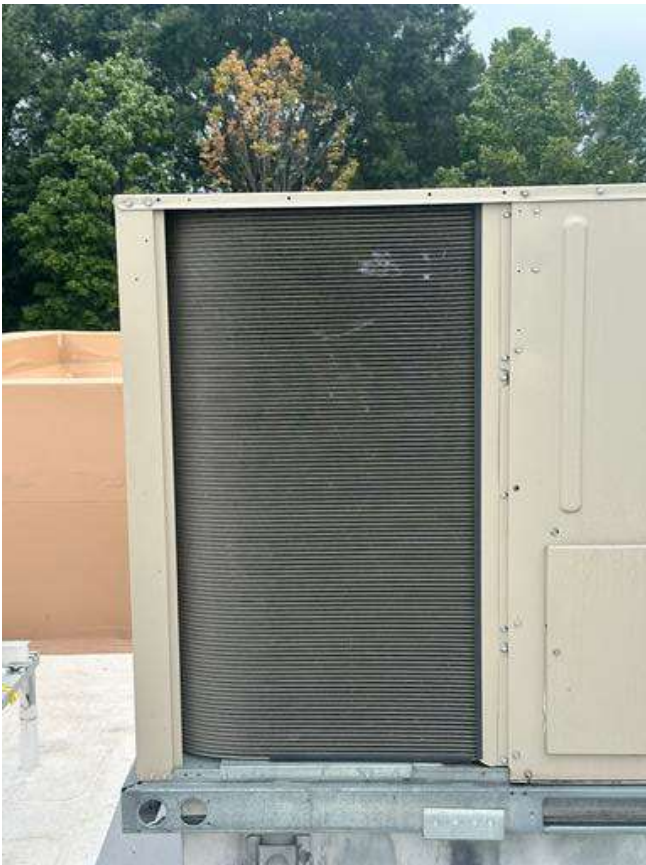
## #271 [UNIT 512] [EXIST] Equipment hail guards.

AC1's hail guards are missing.

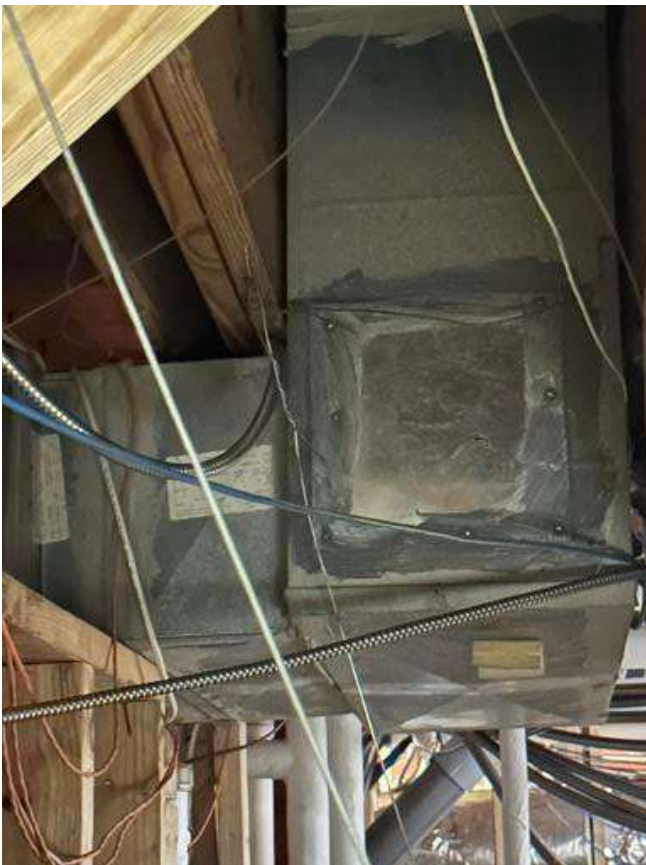
## #270 [DUCT 508] [EXIST] Ductwork is not fully insulated.

Ductwork has exposed metal ductwork in some areas needs to be fully wrapped.

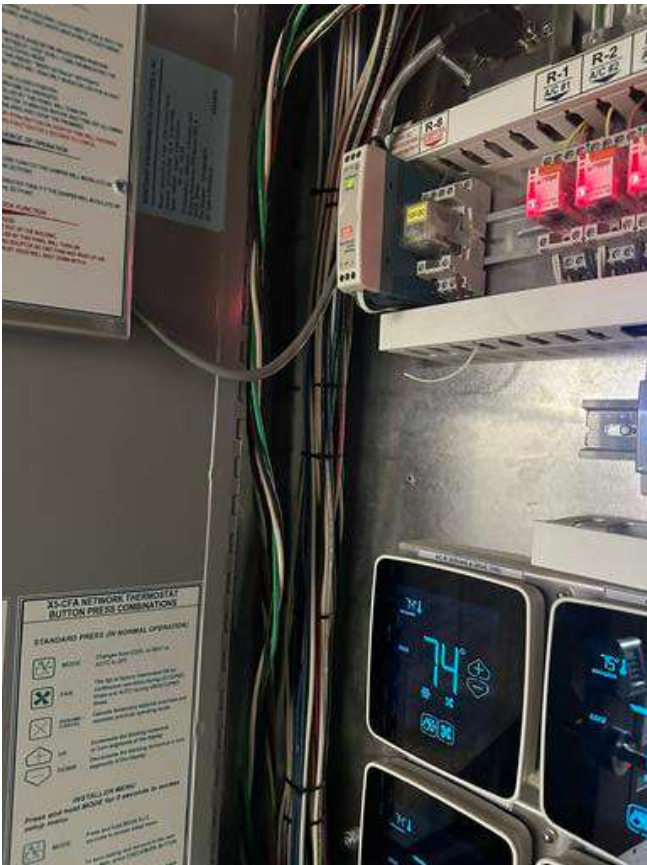
## #269 [CNTL 512] [NEW] SEC Line voltage cover.

<b>Status</b>	<b>Start Date</b>
Open	Jul 25, 2025
<b>Type</b>	<b>Created</b>
Planned Work	Jul 25, 2025 12:22 PM bens@nationaltab.com
<b>Description</b>	<b>Last Updated</b>
Line voltage cover in SEC low voltage panel is missing and needs to be installed (EC).	Jul 25, 2025 12:26 PM

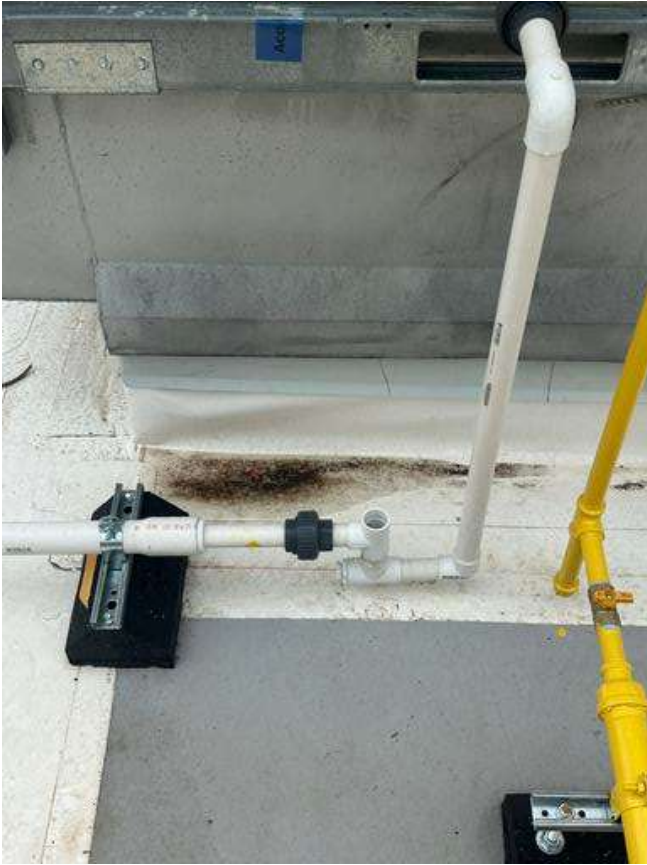
**#268 [UNIT 517] [NEW] Condensate piping construction.**

Equipment condensate piping or p-trap is not constructed per normal CFA specifications. There should be no reduction in size until after the second union to the unit.

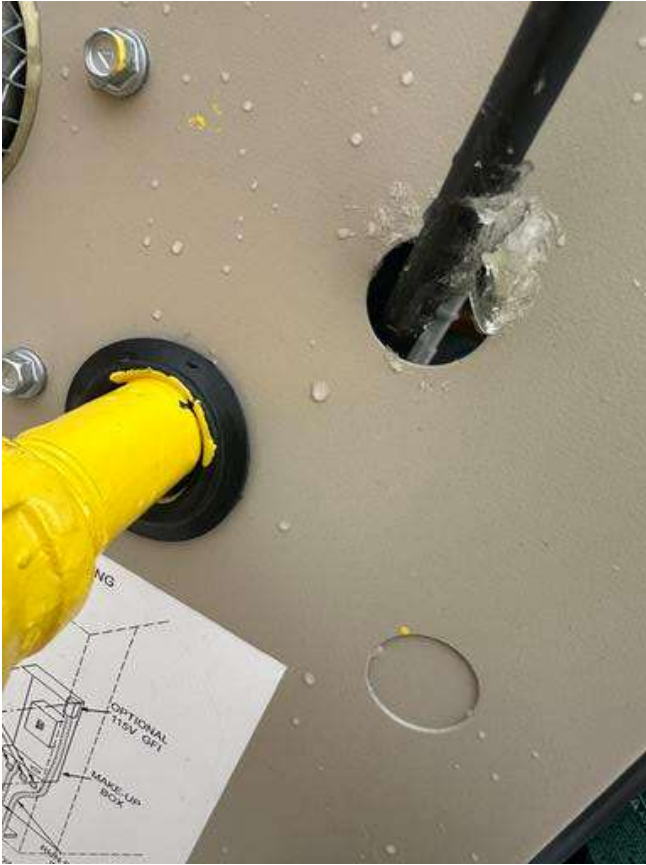
**#267 [UNIT 999] [NEW] (MISC) AC4 grommet missing.**

There is a penetration on the outside of the panel door with a wire leading to what appears to be a sensor. This hole is not sealed properly and will allow water to enter the unit.

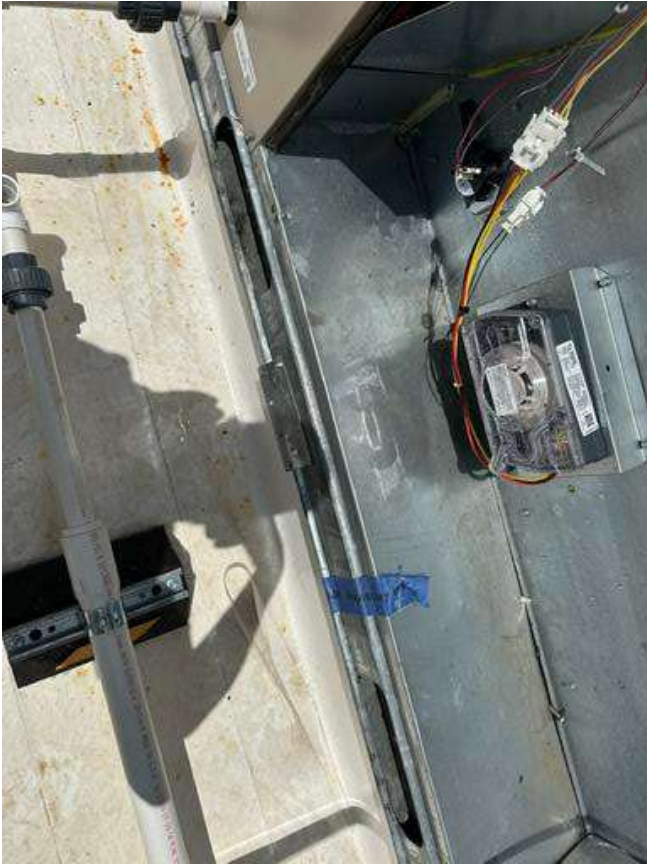
**#266 [UNIT 999] [NEW] (MISC) AC2 water buildup.**

There is a buildup of water on the lower portion in the blower door. This is believed to be due to the restrictions from the condensate line, but it is recommended to re-inspect the inside of the door to ensure the issue has been solved when the drain is changed.

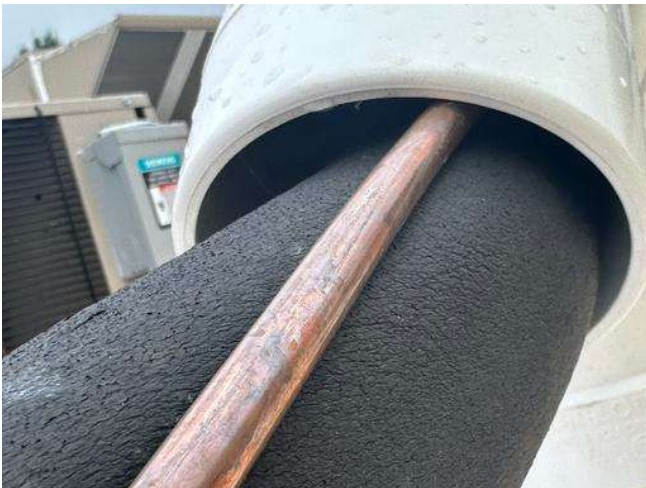
## #261 [REFG 511] [NEW] PVC pipe chase (gooseneck) installation.

PVC pipe chase risers are not sealed with spray foam and silicone to prevent weather/pest infiltration.

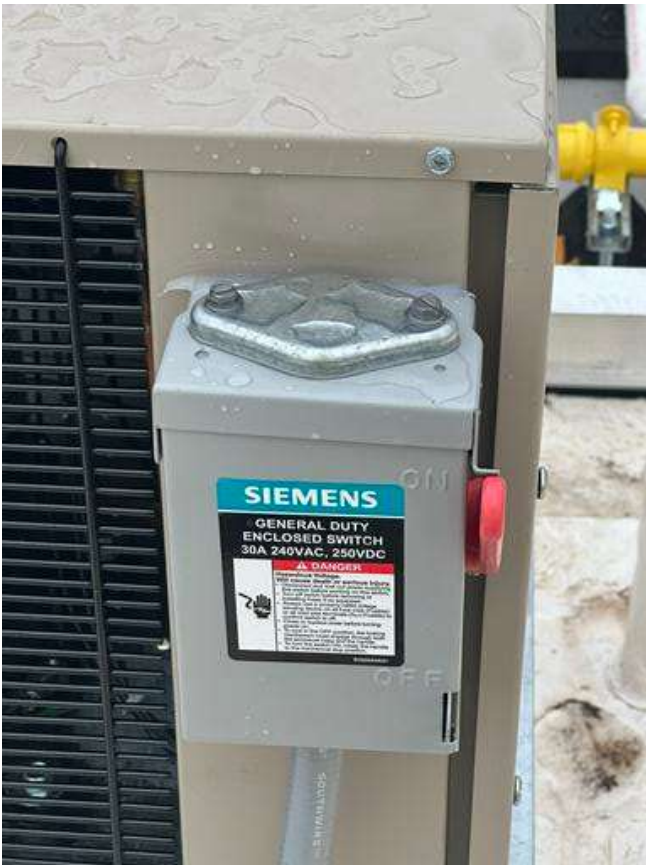
## #260 [REFG 516] [NEW] Condenser electrical disconnects.

<b>Status</b> Open	<b>Start Date</b> Jul 25, 2025
<b>Type</b> Planned Work	<b>Created</b> Jul 25, 2025 12:22 PM bens@nationaltab.com
<b>Description</b> Electrical disconnects are not properly labeled.	<b>Last Updated</b> Jul 25, 2025 12:27 PM
