**Report: Deficiency Report**  
**Function: Test, Adjust, & Balance**  
**Date: 12/11/2024**  
**Completed By: National TAB**

## 12-09-2024 FREDDY'S - HUNTSVILLE, AL

HLI FOODS

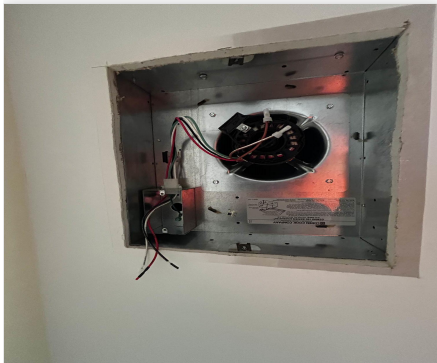
**Issue Name :** EF-1  
**Description :** EF-1 is not wired to power. Unable to balance unit until this is resolved.  
**Created By :** National TAB                      **Assigned To :** National TAB - Kristopher Passley  
**Status :** Closed  
**Priority :** Urgent                                      **Asset Tag :**  
**Originated Date :** 12/12/2024 - Kristopher Passley - National TAB

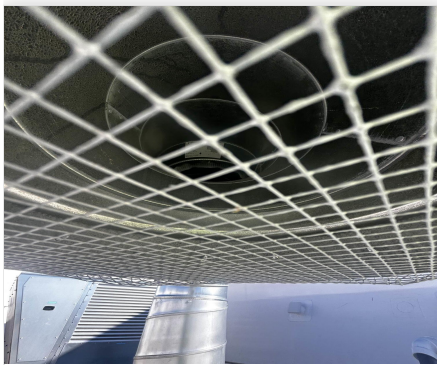
**Issue Name :** EF-1 & EF-2 Backdraft damper  
**Description :** Back draft damper is not installed. Recommend mechanical install as per plans. See plans MP0>14. Exhaust fans:> "B"  
**Created By :** National TAB                      **Assigned To :** National TAB - Kristopher Passley  
**Status :** Open  
**Priority :** High                                      **Asset Tag :**  
**Originated Date :** 12/12/2024 - Kristopher Passley - National TAB

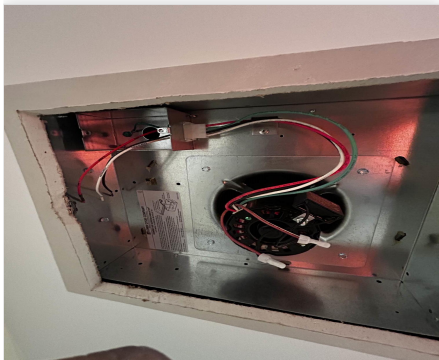
**Issue Name :** EF-2  
**Description :** EF-2 is not wired to power. Unable to balance unit until this is resolved.  
**Created By :** National TAB                      **Assigned To :** National TAB - Kristopher Passley  
**Status :** Closed  
**Priority :** Urgent                                      **Asset Tag :**  
**Originated Date :** 12/12/2024 - Kristopher Passley - National TAB

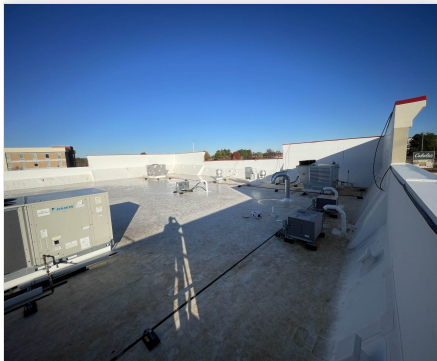
**Issue Name :** Gas Piping  
**Description :** See Plans MP0> 7. PIPING> H. NATURAL GAS> 2) GAS PIPING PAINTING  
All black steel gas piping located exterior to the building shall be primed and painted to either match adjacent exterior where located on or near exterior wall and painted safety yellow where located on the roof.  
**Created By :** National TAB                      **Assigned To :** National TAB - Kristopher Passley  
**Status :** Open  
**Priority :** Medium                                      **Asset Tag :**  
**Originated Date :** 12/12/2024 - Kristopher Passley - National TAB

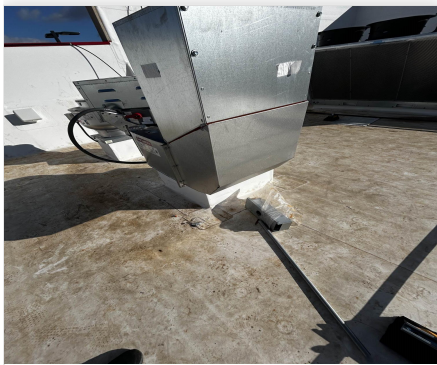
**Issue Name :** KEF-1 Grease Pan  
**Description :** Grease pan was not installed on KEF-1. Recommend having mechanical install.  
**Created By :** National TAB                      **Assigned To :** National TAB - Kristopher Passley  
**Status :** Open  
**Priority :** Medium                                      **Asset Tag :**  
**Originated Date :** 12/12/2024 - Kristopher Passley - National TAB

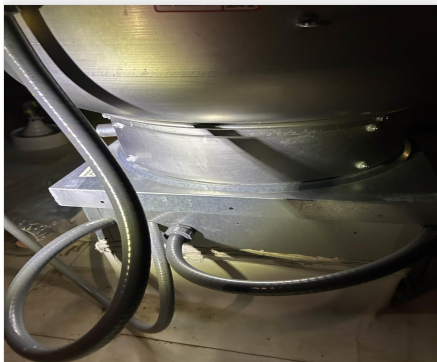
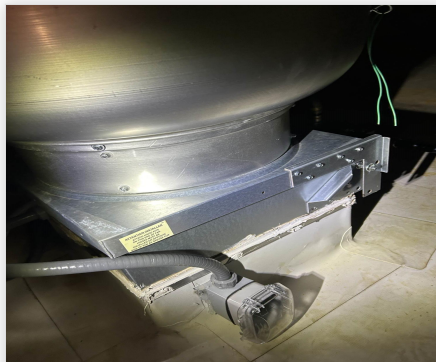
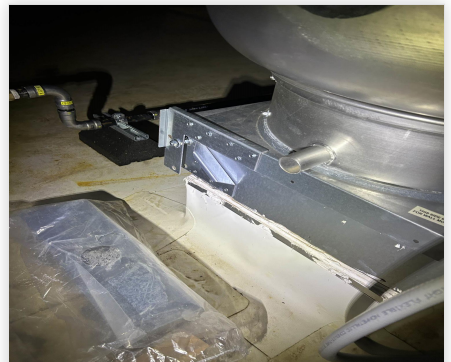
**Issue Name :** KEF-2 Bolts  
**Description :** KEF-3 is currently not bolted to the curb.  
**Created By :** National TAB                      **Assigned To :** National TAB - Kristopher Passley  
**Status :** Open  
**Priority :** Medium                                      **Asset Tag :**  
**Originated Date :** 12/12/2024 - Kristopher Passley - National TAB

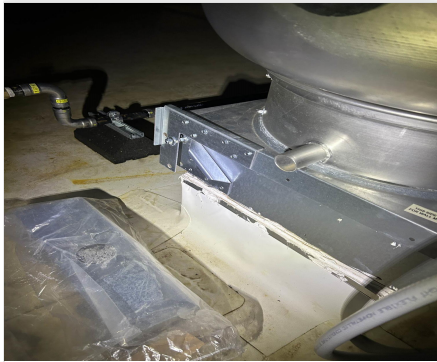
**Issue Name :** KEF-2 Grease Pan  
**Description :** Grease pan was not installed on KEF-2. Recommend having mechanical install.  
**Created By :** National TAB                      **Assigned To :** National TAB - Kristopher Passley  
**Status :** Open  
**Priority :** Medium                                      **Asset Tag :**  
**Originated Date :** 12/12/2024 - Kristopher Passley - National TAB

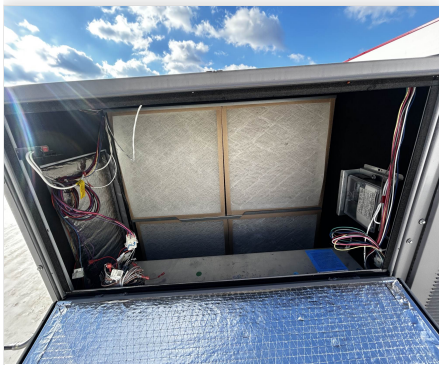
**Issue Name :** RTU-1 Final Filter  
**Description :** Factory final filters are currently installed in RTU-1. Recommend installed MERV 8 or better filters in unit. 4 count 20"X20"X2"  
**Created By :** National TAB                      **Assigned To :** National TAB - Kristopher Passley  
**Status :** Open  
**Priority :** High                                      **Asset Tag :**  
**Originated Date :** 12/12/2024 - Kristopher Passley - National TAB
