**Report: Punchlist**  
**Function: Test, Adjust, & Balance**  
**Date: 11/26/2025**  
**Completed By: National TAB**

## 11-24-25 CHIPOTLE #5571 MIDDLEBURG, FL

Project: 11-24-25 CHIPOTLE #5571 MIDDLEBURG, FL

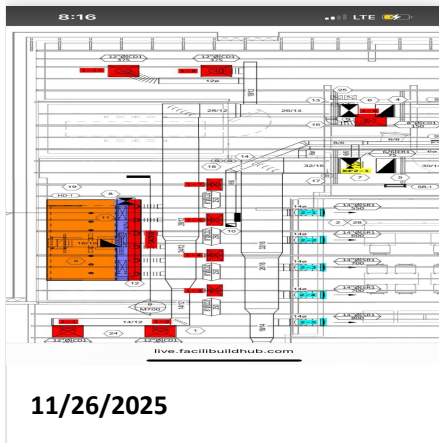
**Issue Name :** Diffuser noise  
**Description :** Diffusers 8 9 and 10 (the office and dishwashing areas) create noise. Possibly due to 4 way deflectors. Not at a level likely to be noticeable or bothersome during store operation. No further action recommended at this time.

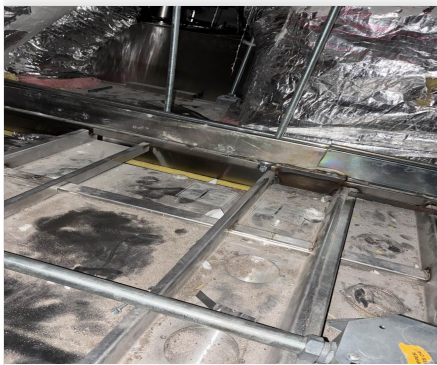
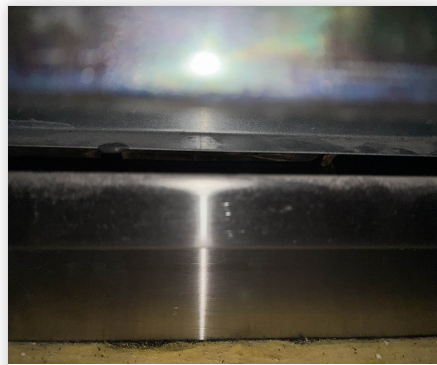
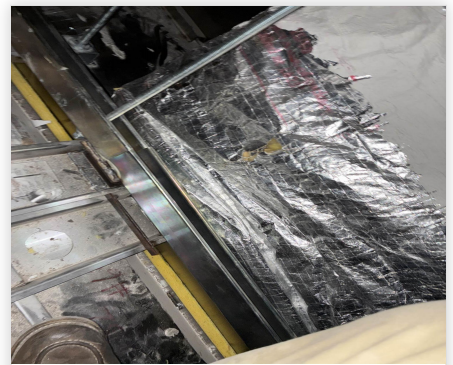
**Issue Name :** MAU leak above hood  
**Description :** There is a moderate air leak where the middle PSP riser joins to the hood.  
**Created By :** National TAB                      **Assigned To :** National TAB - Dan Hertenstein  
**Status :** Open  
**Priority :** **Urgent**                                      **Asset Tag :**  
**Originated Date :** 11/26/2025 - Jackson Gunnels - National TAB

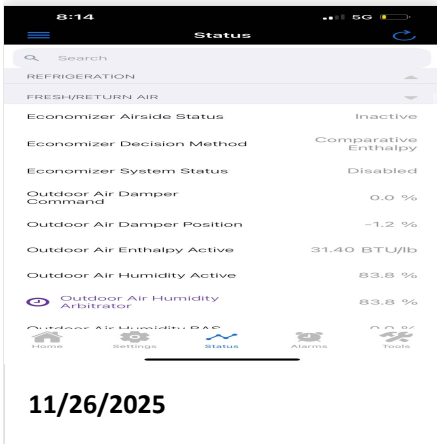
**Issue Name :** RTU2 Economizer  
**Description :** Unit 2 ECONOMIZER does not respond to commands. Returns value of -1.3. Inspected actuator connector, wiring is correct.  
**Created By :** National TAB                      **Assigned To :** National TAB - Dan Hertenstein  
**Status :** Open  
**Priority :** **Urgent**                                      **Asset Tag :** RTU2  
**Originated Date :** 11/26/2025 - Jackson Gunnels - National TAB
