Report: TAB Report
Function: Test, Adjust, & Balance
Date: 03/27/2024

PROJECT
04-01-24 CULVERS-ARCADIA, FL

Project: 04-01-24 CULVERS-ARCADIA, FL

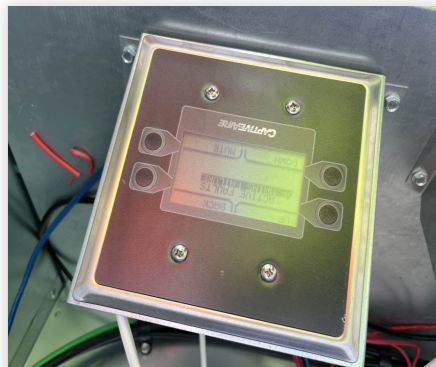
Issue Name : RTUs Alarming
Description : When units are powered on they initially alarm "DF Mains Failure". This alarm does not appear to have an effect on unit functionality.
Created By : National TAB **Assigned To :** National TAB - Stephen Tassinaro
Status : Open
Priority : Medium **Asset Tag :**
Originated Date : 03/27/2024 - Stephen Tassinaro - National TAB
