**Report: TAB Report**  
**Function: Test, Adjust, & Balance**  
**Date: 03/27/2024**

**PROJECT**  
**04-01-24 CULVERS-ARCADIA, FL**

2455 SE Highway 70

Arcadia , FL 34265

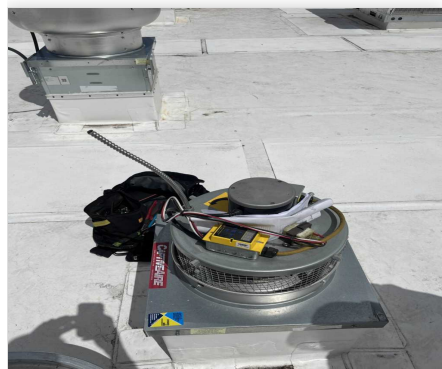
IMG\_2494  
03/25/2024

**Issue Name :** PRV-1 Not Functional  
**Description :** PRV-1 is not wired at the rooftop. Unable to balance until resolved.  
**Created By :** National TAB                      **Assigned To :** National TAB - Stephen Tassinaro  
**Status :** Open  
**Priority :** Urgent                                      **Asset Tag :**  
**Originated Date :** 03/25/2024 - Stephen Tassinaro - National TAB

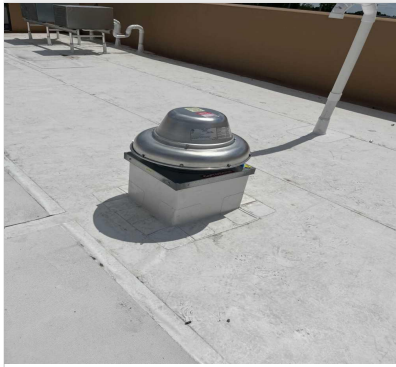
**PRV1**  
**03/27/2024**

BACKDRAFT DAMPER INSTALLED BY MC DURING TAB. FAN NOT RUNNING TO DETERMINE FUNCTIONALITY.

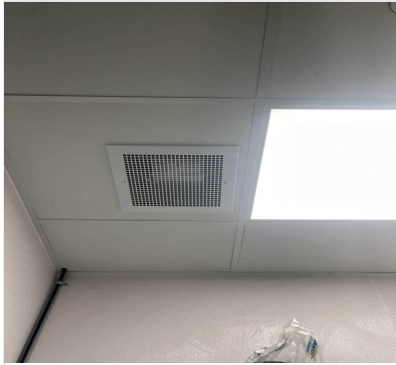
**EFA1**  
**03/27/2024**

| <b>Description :</b> | The mop sink exhaust fan, EFA-1, is not wired. There is no electrician on site to complete. Fan not balanced. | | |
