Report: TAB Report
Function: Test, Adjust, & Balance
Date: 03/27/2024

PROJECT
04-01-24 CULVERS-ARCADIA, FL

Project: 04-01-24 CULVERS-ARCADIA, FL

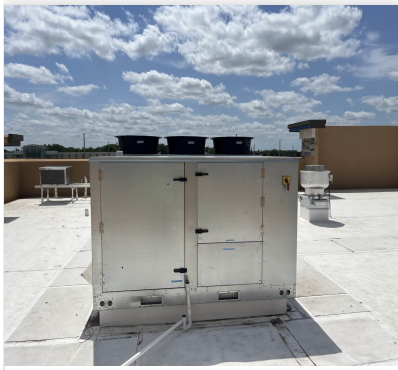
RTU2
03/27/2024

Issue Name : RTU-2 Low FLOW
Description : RTU 2 airflow is 4670CFM out of 6150CFM design (76%) after proportional diffuser balancing. Currently the motor is set to 56Hz, the current limit appears to be 61Hz. This is not a sufficient speed increase to bring the unit within 10% of 6150CFM (Design per mechanical plans).
Created By : National TAB **Assigned To :** National TAB - Stephen Tassinaro
Status : Open
Priority : Urgent **Asset Tag :**
Originated Date : 03/25/2024 - Stephen Tassinaro - National TAB

- **03/26/2024 National TAB - Stephen Tassinaro**
 - Unit is proportionally balanced at 76% of design, excluding diffuser 13 (see specific issue for this diffuser). Motor currently at 24.2-24.4amps, FLA is 24.3A.

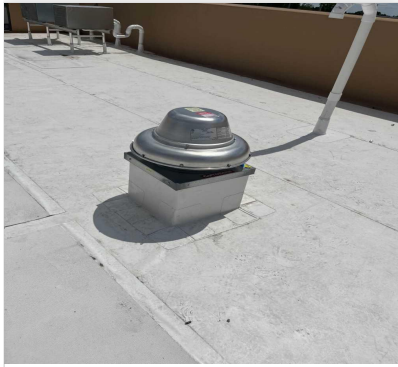
PRV1
03/27/2024

Issue Name : PRV-1 No Backdraft Damper
Description : There is no backdraft damper installed in the PRV-1 duct. Recommend installing.
Created By : National TAB **Assigned To :** National TAB - Stephen Tassinaro
Status : Open
Priority : [Medium](#) **Asset Tag :**
Originated Date : 03/25/2024 - Stephen Tassinaro - National TAB

Issue Name : PRV-1 Not Functional
Description : PRV-1 is not wired at the rooftop. Unable to balance until resolved.
Created By : National TAB **Assigned To :** National TAB - Stephen Tassinaro
Status : Open
Priority : Urgent **Asset Tag :**
Originated Date : 03/25/2024 - Stephen Tassinaro - National TAB

Notes:
FAN NOT WIRED.

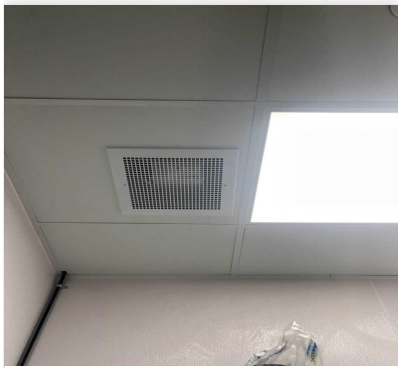
EFA1
03/27/2024

Issue Name : EFA1 Not Wired
Description : The mop sink exhaust fan, EFA-1, is not wired. There is no electrician on site to complete. Fan not balanced.
Created By : National TAB **Assigned To :** National TAB - Stephen Tassinaro
Status : Open
Priority : Urgent **Asset Tag :**
Originated Date : 03/26/2024 - Stephen Tassinaro - National TAB

Notes:
FAN NOT WIRED.
