**Report: TAB Report**  
**Function: Test, Adjust, & Balance**  
**Date: 03/27/2024**

**PROJECT**  
**04-01-24 CULVERS-ARCADIA, FL**

Project: 04-01-24 CULVERS-ARCADIA, FL

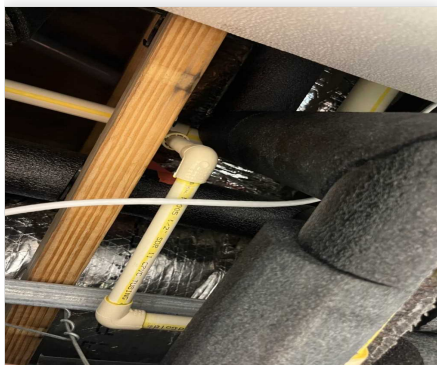
Diffuser2\_13  
03/27/2024

**Issue Name :** Diffuser 2-13 Damper Issue  
**Description :** RTU 2 Diffuser 13 damper has very limited accessibility. NTi tech was able to turn the damper 90 degrees but there was minimal change in airflow. Currently 111CFM out of 350CFM design (32%). MC was able to free damper handle but there was no improvement in airflow. Takeoff may need to be relocated, or a scoop may need to be added to improve flow

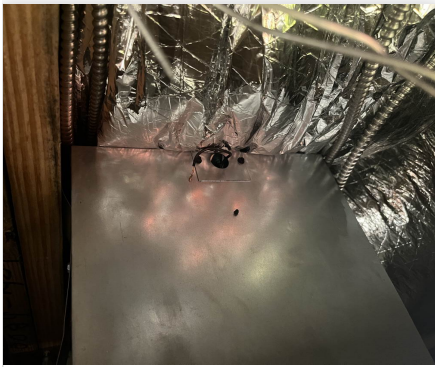
EFA1\_NotWired  
03/27/2024

**Issue Name :** EFA1 Not Wired  
**Description :** The mop sink exhaust fan, EFA-1, is not wired. There is no electrician on site to complete. Fan not balanced.  
**Created By :** National TAB                      **Assigned To :** National TAB - Stephen Tassinaro  
**Status :** Open  
**Priority :** Urgent                                      **Asset Tag :**  
**Originated Date :** 03/26/2024 - Stephen Tassinaro - National TAB

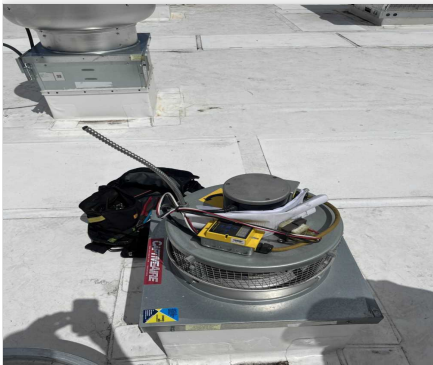
IMG\_2494  
03/25/2024

**Issue Name :** PRV-1 Not Functional  
**Description :** PRV-1 is not wired at the rooftop. Unable to balance until resolved.  
**Created By :** National TAB                      **Assigned To :** National TAB - Stephen Tassinaro  
**Status :** Open  
**Priority :** Urgent                                      **Asset Tag :**  
**Originated Date :** 03/25/2024 - Stephen Tassinaro - National TAB

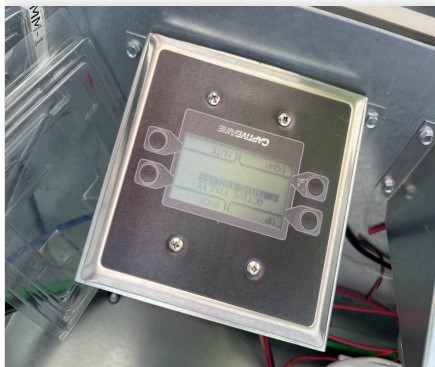
**RTU1\_Alarm**  
**03/27/2024**

**Issue Name :** RTUs Alarming  
**Description :** When units are powered on they initially alarm "DF Mains Failure". This alarm does not appear to have an effect on unit functionality.  
**Created By :** National TAB                      **Assigned To :** National TAB - Stephen Tassinaro  
**Status :** Open  
**Priority :** Medium                                      **Asset Tag :**  
**Originated Date :** 03/27/2024 - Stephen Tassinaro - National TAB
