Report: Deficiency Report
Function: Test, Adjust, & Balance
Date: 03/25/2024

PROJECT
04-01-24 CULVERS-ARCADIA, FL

Issue List

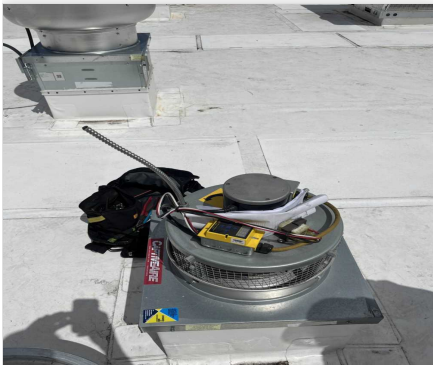
IMG_2494
03/25/2024

Issue Name : PRV-1 Not Functional
Description : PRV-1 is not wired at the rooftop. Unable to balance until resolved.
Created By : National TAB **Assigned To :** National TAB - Stephen Tassinaro
Status : Open
Priority : Urgent **Asset Tag :**
Originated Date : 03/25/2024 - Stephen Tassinaro - National TAB
