Report: TAB Report
Function: Test, Adjust, & Balance
Date: 03/27/2024

PROJECT
04-01-24 CULVERS-ARCADIA, FL

2455 SE Highway 70

Arcadia , FL 34265

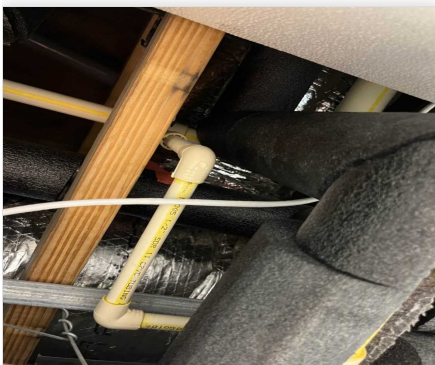
Diffuser2_13
03/27/2024

Issue Name : Diffuser 2-13 Damper Issue
Description : RTU 2 Diffuser 13 damper has very limited accessibility. NTi tech was able to turn the damper 90 degrees but there was minimal change in airflow. Currently 111CFM out of 350CFM design (32%). MC was able to free damper handle but there was no improvement in airflow. Takeoff may need to be relocated, or a scoop may need to be added to improve flow

Asset	Notes	Date	Written By
SGRD1	Diffusers proportionally balanced to 87% of design.	03/27/2024	Stephen Tassinaro
SGRD13	MC was able to free damper handle but there was no improvement in airflow. Takeoff may need to be relocated, or a scoop may need to be added to improve flow.	03/27/2024	Stephen Tassinaro

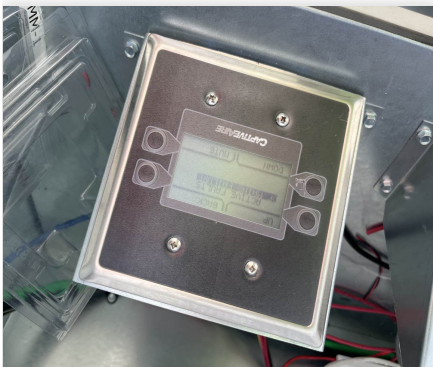
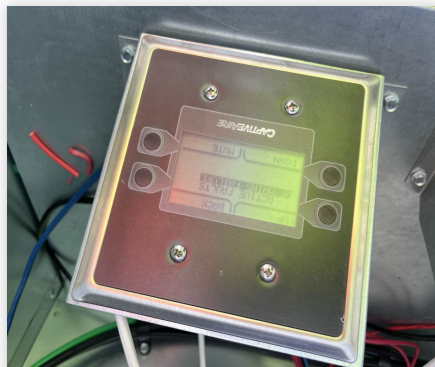
Issue Name : RTUs Alarming
Description : When units are powered on they initially alarm "DF Mains Failure". This alarm does not appear to have an effect on unit functionality.
Created By : National TAB **Assigned To :** National TAB - Stephen Tassinaro
Status : Open
Priority : Medium **Asset Tag :**
Originated Date : 03/27/2024 - Stephen Tassinaro - National TAB

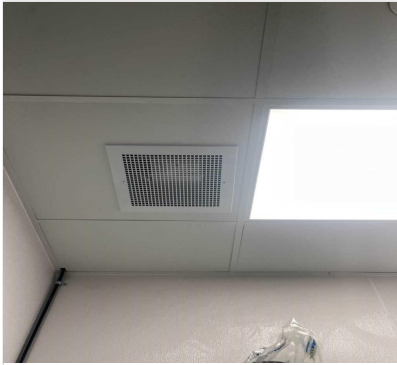
EFA1
03/27/2024

BACKDRAFT DAMPER INSTALLED BY MC DURING TAB. FAN NOT RUNNING TO DETERMINE FUNCTIONALITY.
