## 12-05 CULVERS - LAKE CITY, FL

### Project Issue Information

**Issue Name :** RTU30A CFM is above design.

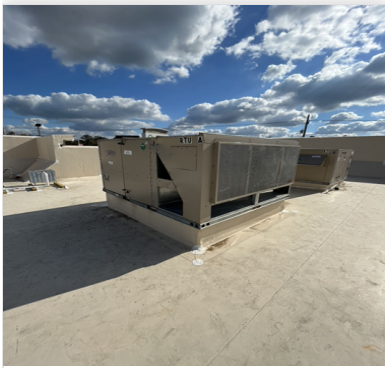
RTU.jpeg

**Description :** Currently running at 4062 cfm out of a designed 3250. Motor sheave turned to minimum setting, however cfm is still too high and motor is overamping. Recommended to replace fan sheave to a BK90 with 1.1875" bore. New fan sheave will require a BX57 or BX58 belt.
