Report: Deficiency Report
Function: Test, Adjust, & Balance
Date: 11/11/2024
Completed By: National TAB

11-11-24 WAWA #5438 ALACHUA, FL

16304 NW US HWY 441

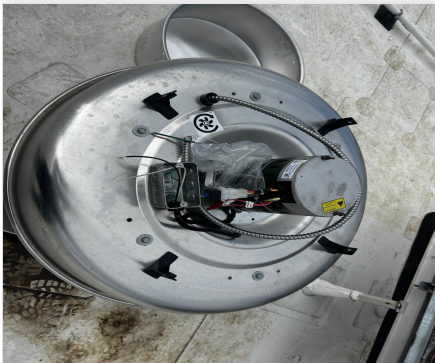
Issue Name : EF-1 Power
Description : EF-1 doesn't not have power. Recommend electrician wire power to the fan.
Created By : National TAB **Assigned To :** National TAB - Kristopher Passley
Status : Closed
Priority : **Urgent** **Asset Tag :**
Originated Date : 11/11/2024 - Kristopher Passley - National TAB

- **11/13/2024 National TAB - Kristopher Passley**
 - Issue is resolved: EF-1 now has power.

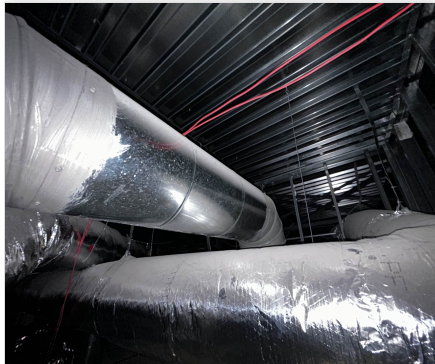
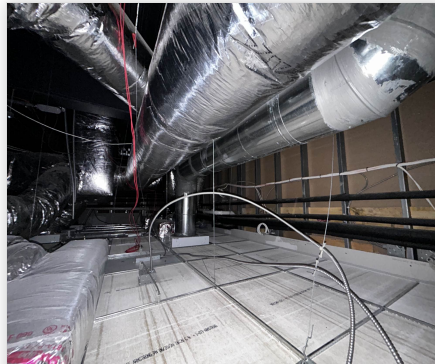
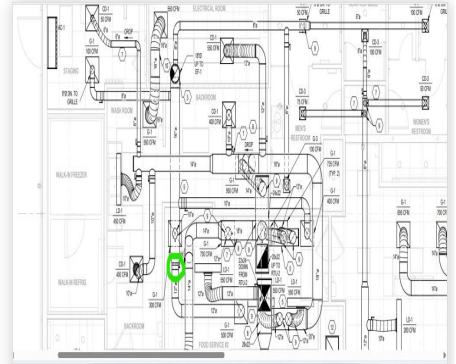
Issue Name : EF-1 Vent 1 Damper
Description : Damper missing from EF-1 Vent 1. This vent is 113.4% high and is preventing other vents from being in design. Recommend having mechanical install damper to allow all vents to be in design.
Created By : National TAB **Assigned To :** National TAB - Kristopher Passley
Status : Open
Priority : Urgent **Asset Tag :**
Originated Date : 11/13/2024 - Kristopher Passley - National TAB

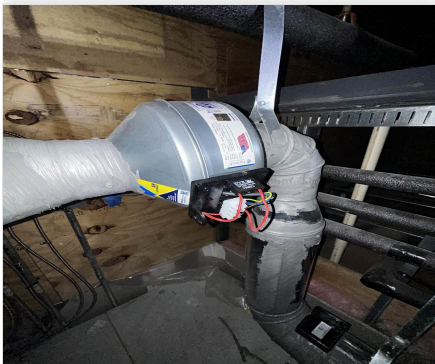
Issue Name : EF-2 Power
Description : EF-2 doesn't not have power. Recommend electrician wire power to the fan.
Created By : National TAB **Assigned To :** National TAB - Kristopher Passley
Status : Closed
Priority : Urgent **Asset Tag :**
Originated Date : 11/11/2024 - Kristopher Passley - National TAB

- **11/13/2024 National TAB - Kristopher Passley**
 - Issue is resolved. EF-2 now has power.

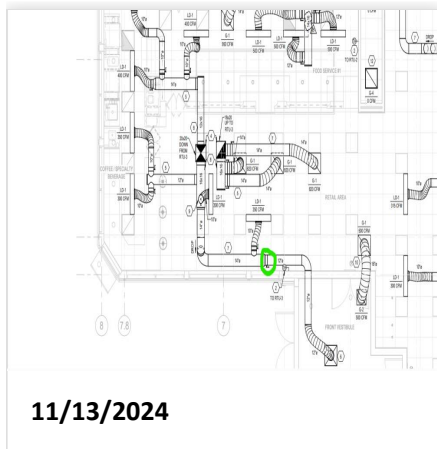
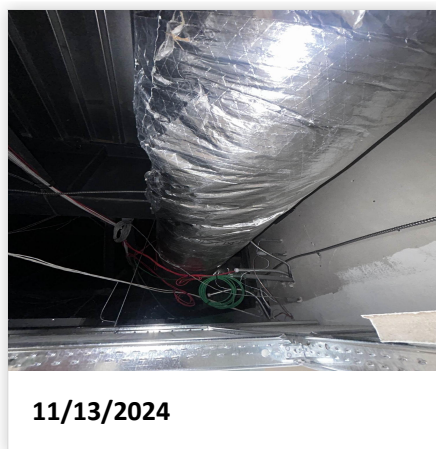
Issue Name : RTU-3 Diffuser 1 Damoer
Description : Damper missing from RTU-3 Diffuser 1. Diffuser is at 120% and needs airflow to be reduced to have diffuser with design. Recommend mechanical install damper as per plan.
Created By : National TAB **Assigned To :** National TAB - Kristopher Passley
Status : Open
Priority : Urgent **Asset Tag :**
Originated Date : 11/13/2024 - Kristopher Passley - National TAB

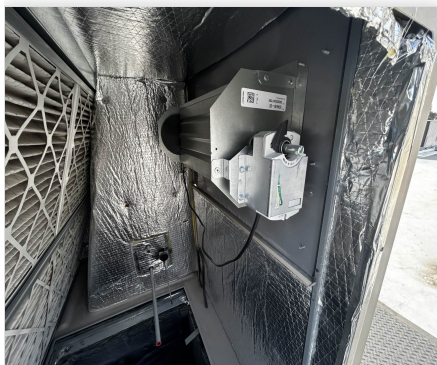
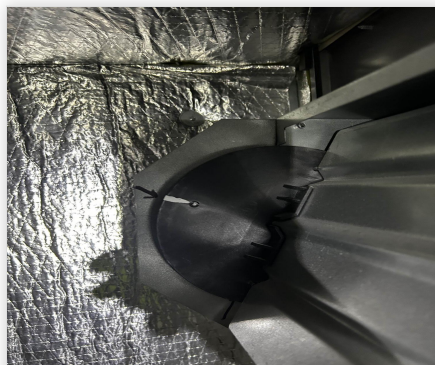
Issue Name : RTU-3 Outside Air Damper
Description : RTU-3 Outside Air damper is non-functional. When calibrating outside air in “Lennox Core” motor did not open fin. Recommend having mechanical service unit to resolve issue. Damper was manually set and marked.
Created By : National TAB **Assigned To :** National TAB - Kristopher Passley
Status : Open
Priority : Urgent **Asset Tag :**
Originated Date : 11/12/2024 - Kristopher Passley - National TAB
