**Report: TAB REPORT**  
**Function: Test, Adjust, & Balance**  
**Date: 02/29/2024**

**PROJECT**  
**02-26-24 CAVA - CHICAGO, IL (WICKER PARK)**

Project: 02-26-24 CAVA - CHICAGO, IL (WICKER PARK)

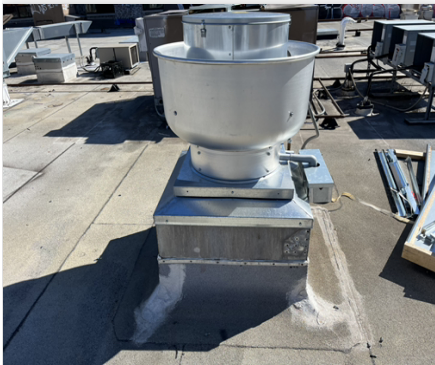
EF1  
02/28/2024

**Issue Name :** EF1 hinge kit not installed  
**Description :** Hinge kit is not installed on EF1 to lift fan up to clean in the future.  
**Created By :** National TAB                      **Assigned To :** National TAB - Jacob Davidson  
**Status :** Open  
**Priority :**    **Asset Tag :**  
**Originated Date :** 02/28/2024 - Jacob Davidson - National TAB

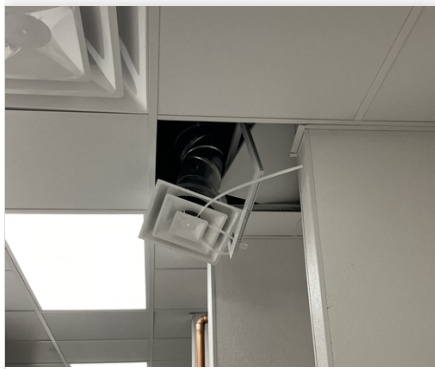
**Extradiffuser**  
**02/29/2024**

**Issue Name :** EF2 extra diffuser  
**Description :** An extra diffuser was found above ceiling for the mop sink that was not on any plans. This was required by the AHJ. Airflow measured as is.  
**Created By :** National TAB                      **Assigned To :** National TAB - Jacob Davidson  
**Status :** Open  
**Priority :** InfoOnly                                      **Asset Tag :**  
**Originated Date :** 02/29/2024 - Jacob Davidson - National TAB

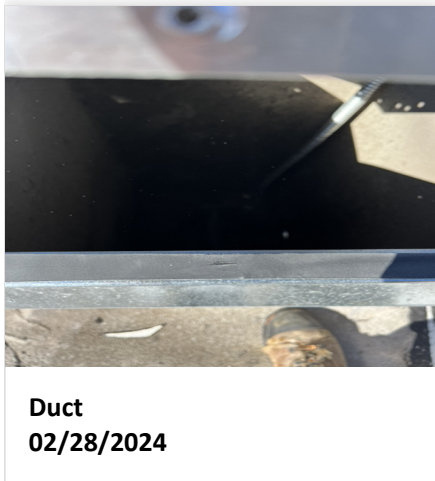
**Issue Name :** EF2 no backdraft damper  
**Description :** EF2 has no backdraft damper installed.  
**Created By :** National TAB                      **Assigned To :** National TAB - Jacob Davidson  
**Status :** Open  
**Priority :**    **Asset Tag :**  
**Originated Date :** 02/28/2024 - Jacob Davidson - National TAB

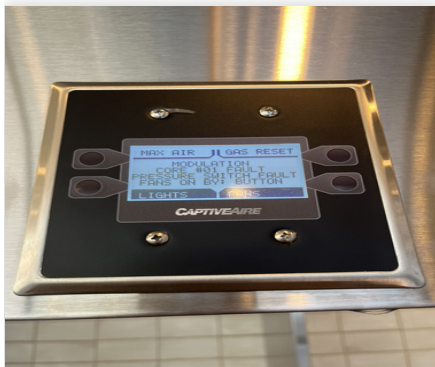
**Fault**  
**02/26/2024**

**Issue Name :** HD1 alarm faults  
**Description :** HD1 has alarm faults "Core #01 Fault" and "Pressure Switch Fault". These flash whether the fans are on or off  
**Created By :** National TAB                      **Assigned To :** National TAB - Jacob Davidson  
**Status :** Open  
**Priority :** Medium                                      **Asset Tag :**  
**Originated Date :** 02/26/2024 - Jacob Davidson - National TAB

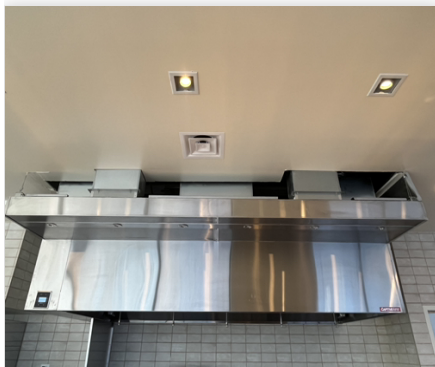
**Spaceabovehood  
02/26/2024**

**Issue Name :** HD1 space above hood needs to be sealed  
**Description :** Space above the hood isn't sealed and is open to the attic space. May interfere with getting accurate building pressure.  
**Created By :** National TAB                      **Assigned To :** National TAB - Jacob Davidson  
**Status :** Open  
**Priority :** Low                                      **Asset Tag :**  
**Originated Date :** 02/26/2024 - Jacob Davidson - National TAB

- **02/27/2024 National TAB - Jacob Davidson**
  - Spoke to GC and parts for the rest of the hood are on order. If needed, plastic can cover the space temporarily for testing.

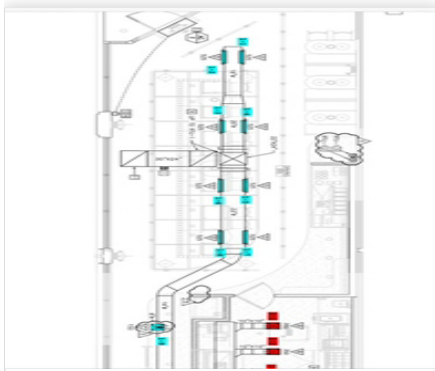
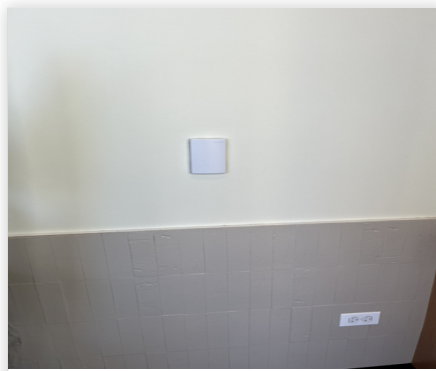
**Issue Name :** RTU1 missing humidity sensor in space  
**Description :** RTU1 is scheduled for humidity control but there is no humidity sensor in the space where the plans call for it.  
**Created By :** National TAB                      **Assigned To :** National TAB - Jacob Davidson  
**Status :** Open  
**Priority :** High                                      **Asset Tag :**  
**Originated Date :** 02/29/2024 - Jacob Davidson - National TAB

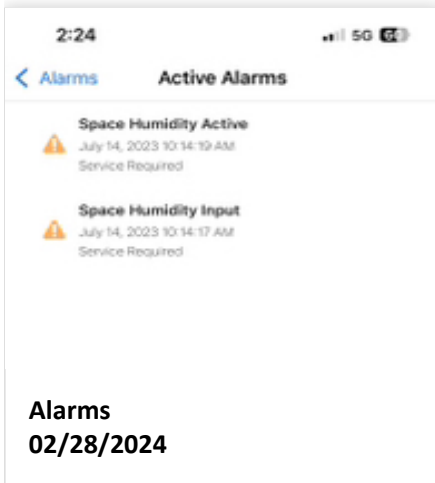
**Issue Name :** RTU1 space humidity alarm  
**Description :** RTU1 has a space humidity input alarm on its controller that needs to be investigated. Likely due to the humidity sensor not being installed.  
**Created By :** National TAB                      **Assigned To :** National TAB - Jacob Davidson  
**Status :** Open  
**Priority :** High                                      **Asset Tag :**  
**Originated Date :** 02/28/2024 - Jacob Davidson - National TAB

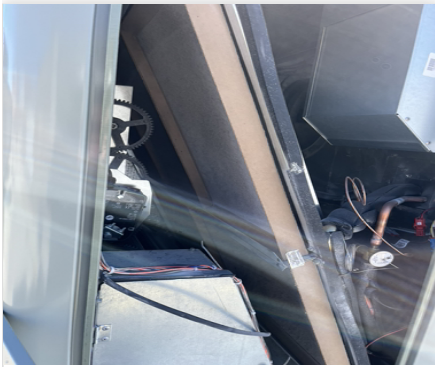
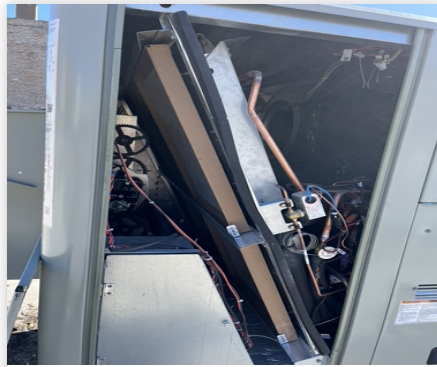
**Issue Name :** RTU1/RTU2 final filters needed  
**Description :** RTU1 and RTU2 need their final MERV pleated filters. Both units take 3 16X24X2 filters and 2 18X24X2 filters.  
**Created By :** National TAB                      **Assigned To :** National TAB - Jacob Davidson  
**Status :** Open  
**Priority :** Low                                      **Asset Tag :**  
**Originated Date :** 02/28/2024 - Jacob Davidson - National TAB

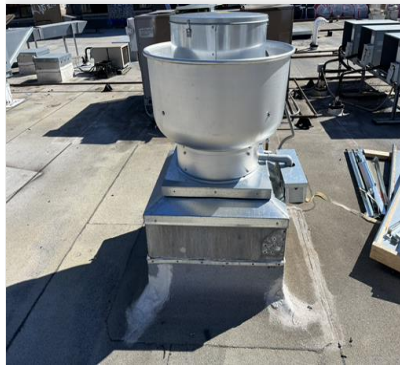
**Nohingekit  
02/28/2024**

Fan is properly hinged and supported when hinged fully back for grease duct access (for Halton fans, ensure the base mounted disconnect is not hitting the fan base/curb when fully hinged back)

Fail

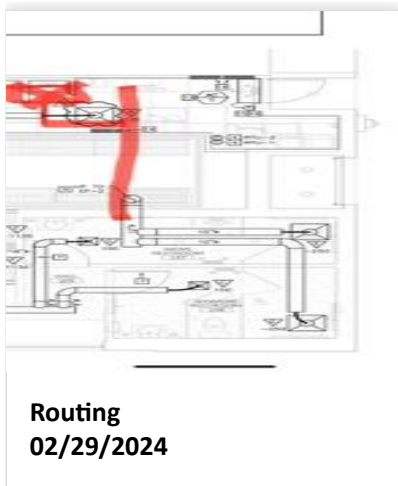
Restroom duct is routed and sized per plan

Fail

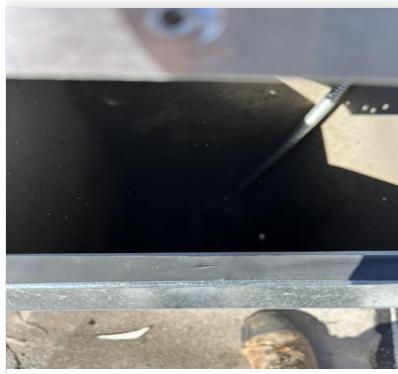
**Nodamper(1)**  
**02/29/2024**

Gravity damper is installed, opens and closes freely, and is sealed to prevent air leakage

Fail

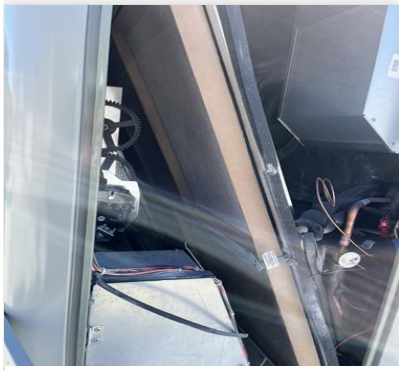
**Filters**  
**02/28/2024**

Evaporator coil filters are properly installed with specified MERV rating

Fail

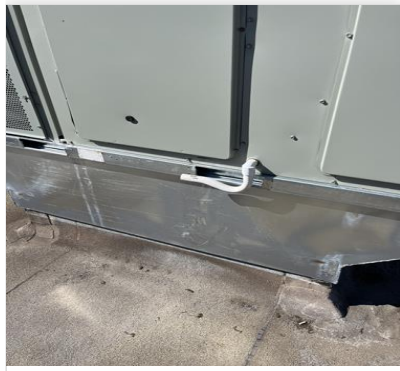
**Ptrap**  
**02/28/2024**

Economizer damper is installed properly	Pass
<b>Comment:</b>	
Economizer OA temperature / enthalpy sensors installed and wired	Pass
<b>Comment:</b>	
Thermostat and humidity (if applicable) control wires wired to RTU terminals	Fail
<b>Comment:</b>	
Condensate drain installed per specification	N/A
<b>Comment:</b>	
Condensate line drains away from unit to a approved roof drain	Fail
<b>Comment:</b>

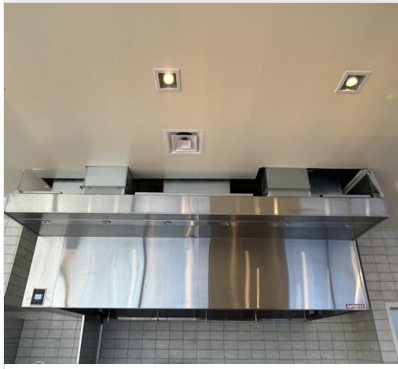
**Hoodwrap**  
**02/29/2024**

Ceiling Wrappers are installed and the ceiling grid is fixed to the top of the ceiling wrappers Fail

Parts of ceiling wrapper were either damaged or stolen. They are on order to replace.

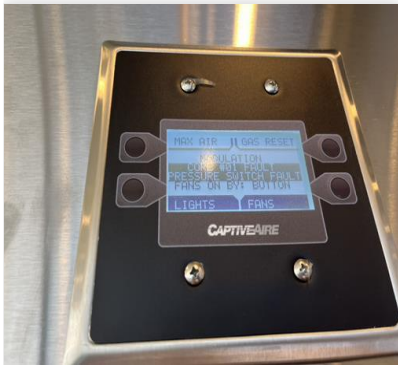
**Faults**  
**02/29/2024**

Hood control panel has been identified and is located as per plan, is accessible, and contains all components and temperature sensors to meet local interlock (normal and abnormal conditions) and heat auto on/off functionality. Fail

HMI has CORE#01 FAULT and PRESSURE SWITCH FAULT
