Report: TAB Report
Function: Test, Adjust, & Balance
Date: 03/25/2026
Completed By: National TAB

03-30-26 Culvers - Wausau, WI (Revive)

C.T. Gray Inc.

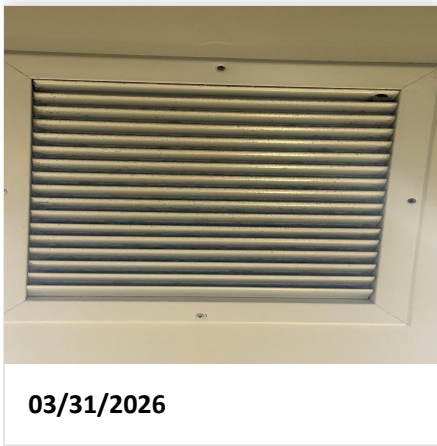
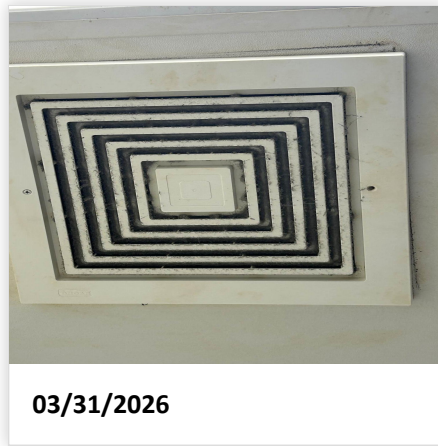
Issue Name : Dirty Exhaust Grilles
Description : Exhaust grilles in the men's and women's bathroom as well as the mop bucket area have slight build up. Cleaning is recommended, may be a cause for restriction in the future if left unattended.
Created By : National TAB **Assigned To :** National TAB - Brianna Biggs
Status : Open
Priority : Low **Asset Tag :**
Originated Date : 03/31/2026 - Luke Gustafson - National TAB

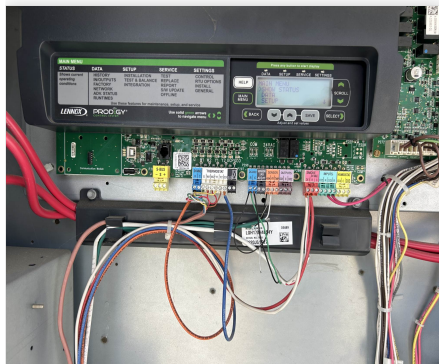
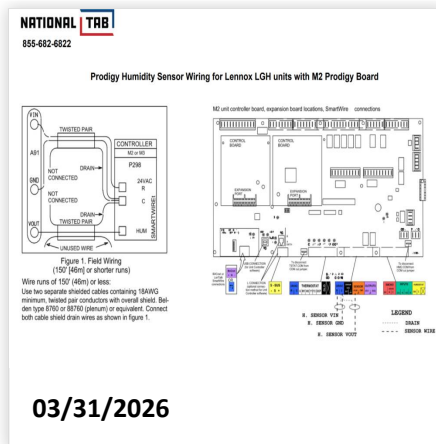
Issue Name : Incorrect Humidity Wiring
Description : Humidity wiring appears wired wrong on both RTUs, see included diagram for proper wiring.
Created By : National TAB **Assigned To :** National TAB - Brianna Biggs
Status : Open
Priority : High **Asset Tag :**
Originated Date : 03/31/2026 - Luke Gustafson - National TAB

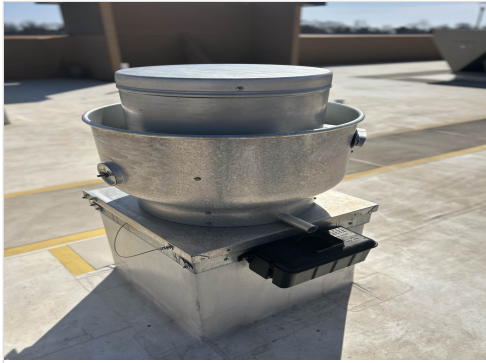
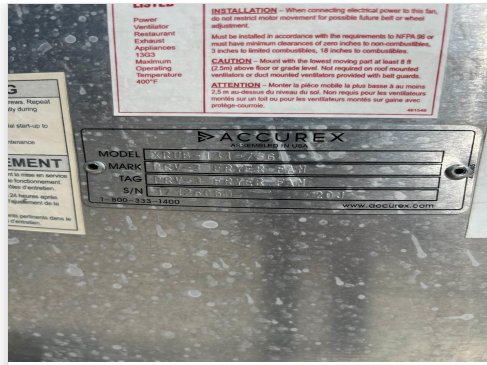
Asset: PRV-3

PRV-3, serving the fryers, was also found to be operating over 50% higher than its design. This was also contributing to the negative pressure issue by pulling too much air out of the building. PRV-3's fan speed was lowered to improve conditions, and a smoke capture test was performed to confirm the hood will still capture smoke effectively.
