**Report: TAB REPORT  
Function: Test, Adjust, & Balance  
Date: 01/30/2024**

## **12-25-23 MEZEH HAMILTON TOWNSHIP, NJ**

209 Marketplace Boulevard Block 2613, Lot 38

**Mezeh Mediterranean Grill  
3975 FAIR RIDE DR  
SUITE 430  
FAIRFAX, VA 22033**

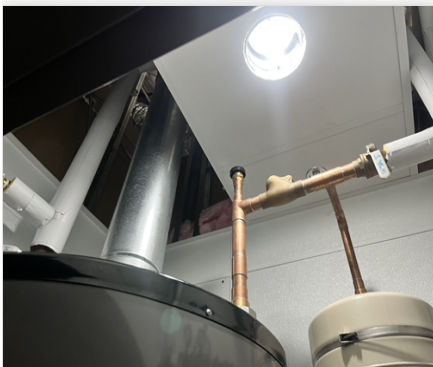
Water\_heater\_vent.jpe..  
01/30/2024

**Issue Name :** EF-4 is not installed

**Description :** EF-4 is not installed. There is a vent for the water heater in place.Recommend having Engineer on file and Mezah review to approval.

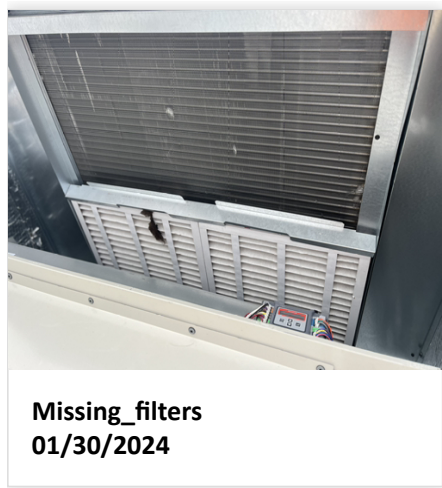
**Issue Name :** Missing filters for RTU-1  
**Description :** RTU-1 is missing 2 filters. Recommend installing filters prior to sites opening.  
**Created By :** National TAB                      **Assigned To :** National TAB - David Annan  
**Status :** Open  
**Priority :**                                              **Asset Tag :**  
**Originated Date :** 01/30/2024 - David Annan - National TAB

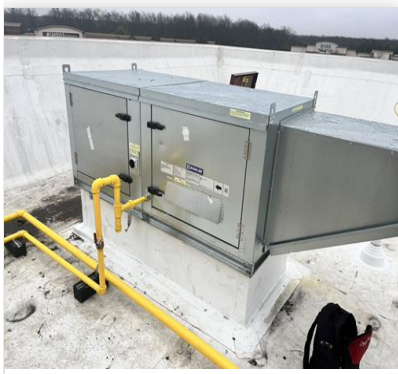
**MUA**  
**01/30/2024**

**Description :** The MUA interlock alarm is active. There are missing wires from. SF1 and SF01 to the MUA board that need to be landed. Unable to open damper manually due to the nuts stripping trying to open them. Recommend having electricians trouble shoot with CAS to land missing connections.

Motorize damper did not open due to missing wiring connections

No, MUA was does not have a reading due to the motorized damper not opening.

MUA is missing the damper wiring into the hood control panel. Was unable to manually open the damper for TAB. Would require D3 and D7 wires be landed on IL1A and IL1B.

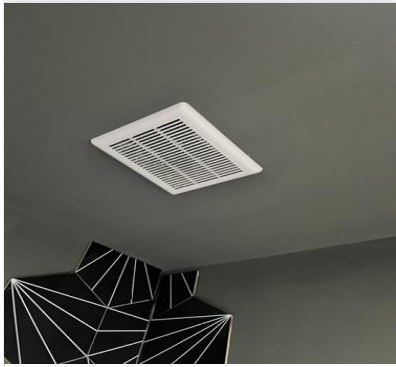
**EF-2**  
**01/30/2024**

**Issue Name :** Both restroom exhaust fans are not in spec  
**Description :** Both restroom ceiling exhaust fans are only rated for 80 CFM base on the unit tag information. Recommend having Engineer on File review unit information and test data.  
**Created By :** National TAB      **Assigned To :** National TAB - David Annan  
**Status :** Open  
**Priority :**      **Asset Tag :**  
**Originated Date :** 01/30/2024 - David Annan - National TAB

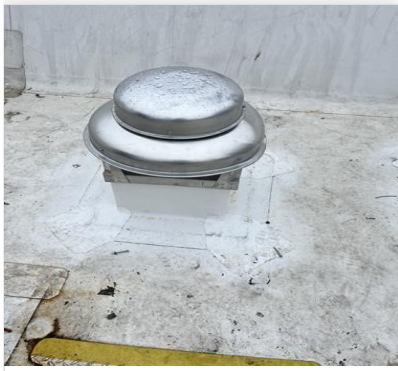
**EF-5**  
**01/30/2024**

| <b>Description :</b> | EF-5 is currently 75% of design running at the maximum fan setting. There does appear to be a total of (3) 90 rounded transitions coming from Hood-2. There is also a mesh filter located at the inlet of Hood-2. | | |
